June 15, 2021

**RE: *Asbestos Containing Material and Hazardous Materials Inspection***  
***725 S Hayford Ave., Lansing, MI 48912***  
***Parcel ID: 33-01-01-23-105-052***

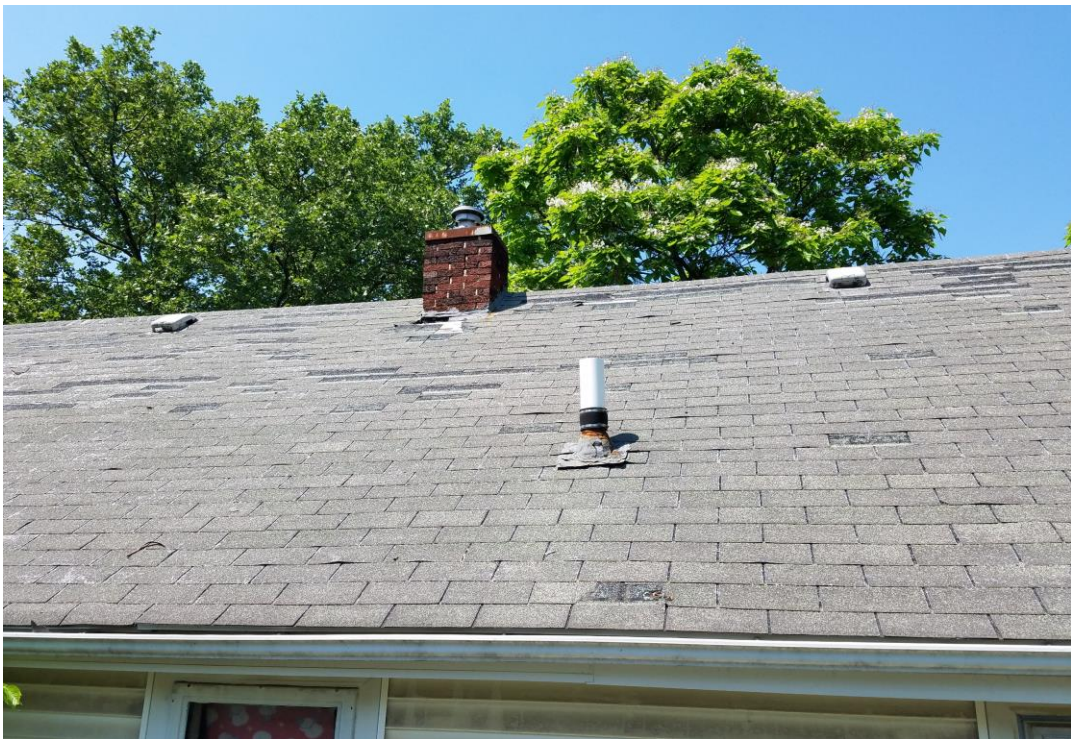
Roof Flashing samples collected during the completion of the inspection were found to contain up to 10% Chrysotile asbestos. The assessment to quantify the extent of this material identified 8 sq. ft. of Flashing materials on the Building.

**PHOTO: 2**  
**SUBJECT: Chimney and Vent Flashing**

The Category I flashing materials and resilient floor coverings (Layered Flower Vinyl and Red Brick Linoleum) are non-friable ACM's that may be left in place as long as the demolition/renovation activities are completed following the OSHA Asbestos Standards for Construction (29 CFR 1926.1101) which limits employee exposure to asbestos.

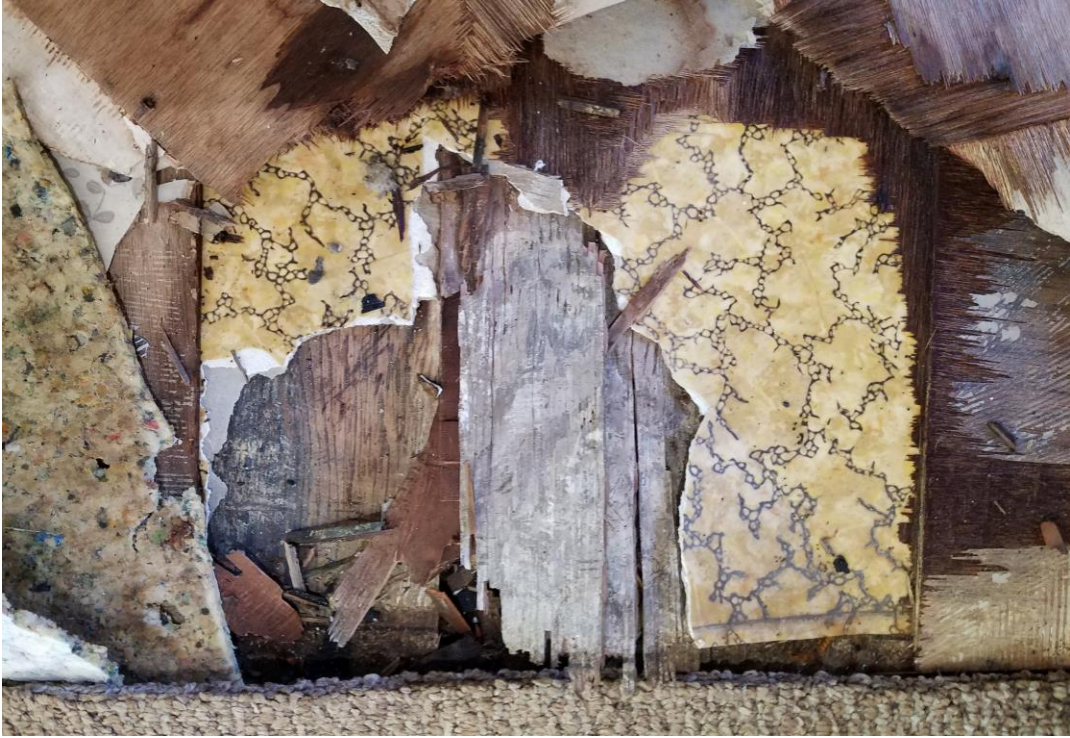
Two types of resilient floor covering (Layered Flower Vinyl and Red Brick Linoleum) located within the Building were found to contain up to 25% Chrysotile asbestos. The assessment to quantify the extent of this material identified approximately 282 sq. ft. of this material within the Building.

**SUBJECT: Layered Flowered Vinyl Layer 2/4**

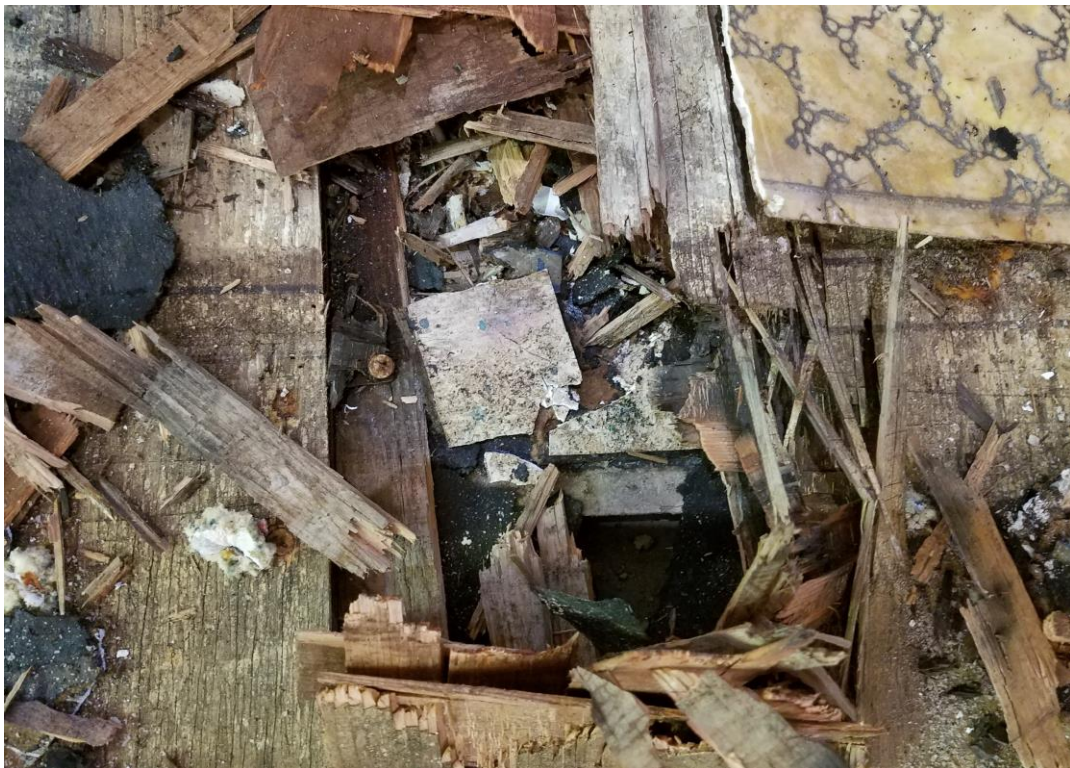
**SUBJECT: Layered Flowered Vinyl Layer 3/4 (Tile)**

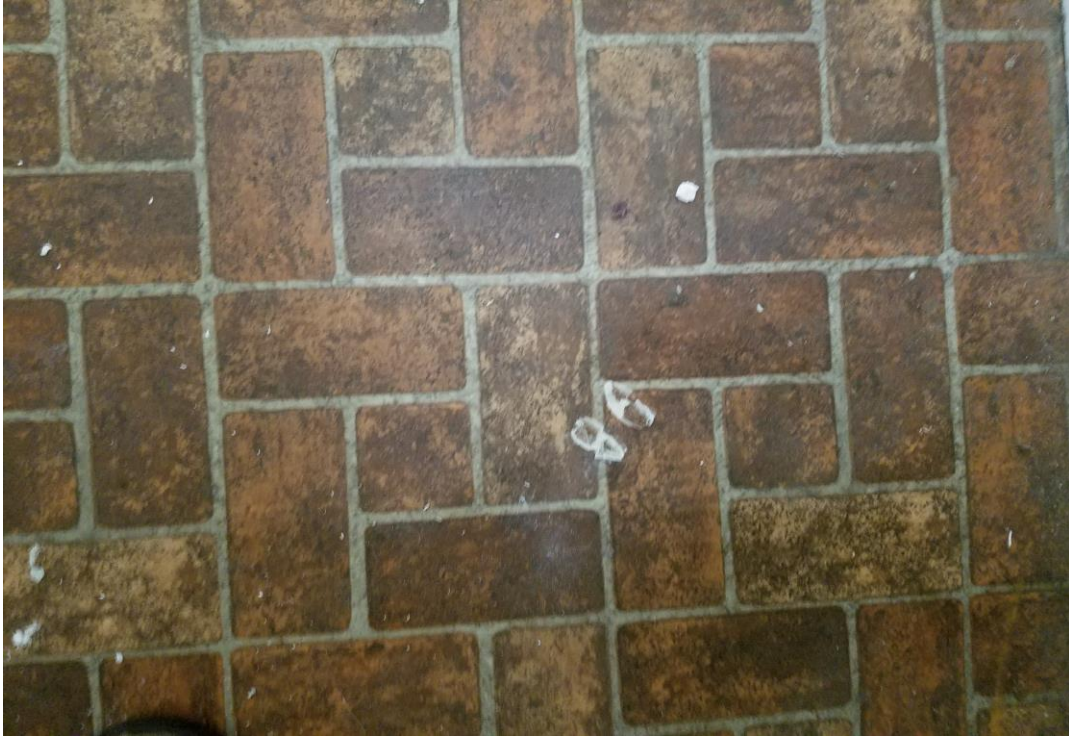
**PHOTO: 5**  
**SUBJECT: Red Brick Linoleum**

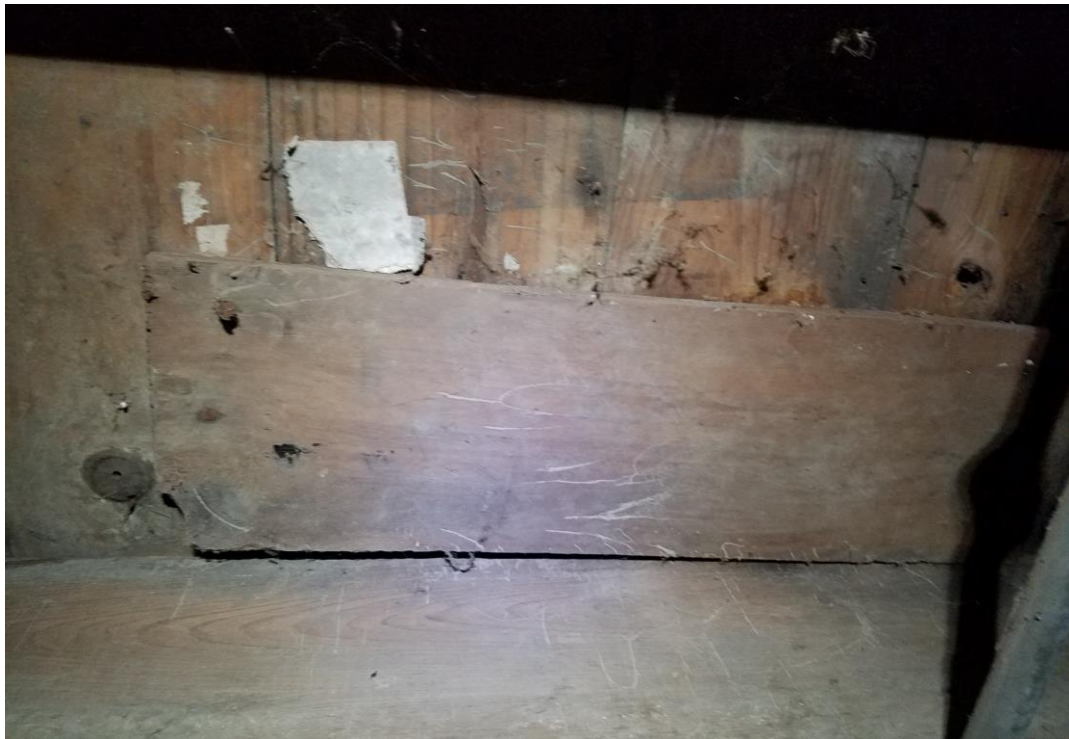
The HVAC Duct Wrap located in the Building was classified as PACM due to the age of the structure and samples were not collected.

Duct Wrap identified in the building in conjunction with the forced air heating system is classified as friable ACM. The visual assessment to quantify the extent of this material identified HVAC Duct Wrap at the following locations within the basement, first and second floors:

**PHOTO: 6**  
**SUBJECT: HVAC Paper on Basement Framing**

HVAC material identified in the Building system and listed below is classified as friable ACM and should be removed prior to any renovation/demolition activities.

- Basement (misc. HVAC wrap on Framing, 2 sq. ft., at two locations)
