**RE: *Asbestos Containing Material and Hazardous Materials Inspection  
421 Detroit St. Lansing, MI 48912  
Parcel ID: 33-21-01-14-452-005***

Project No.: 19-1159  
Ingham County Land Bank  
Parcel ID: 33-21-01-14-452-005

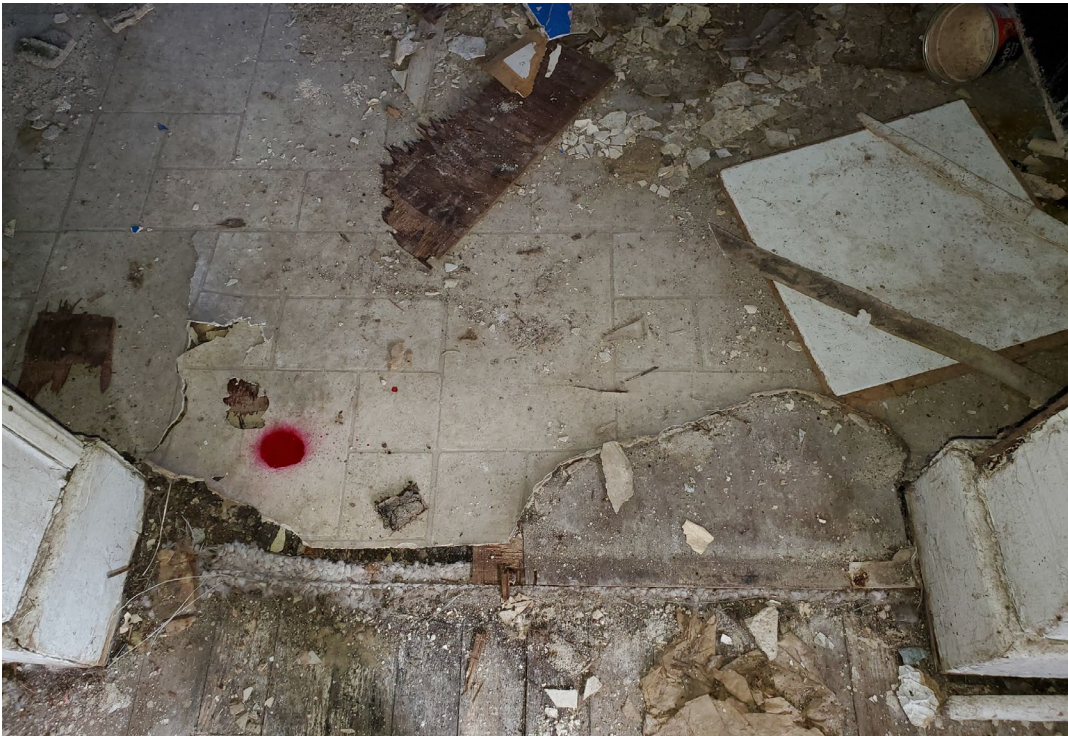
**PHOTO: 2**

Two types of resilient floor covering (Kitchen Multilayered Flooring and 9"x9" Brown Vinyl Floor Tile and Mastic) located within the kitchen, NE bedroom and stairwell were found to contain up to 10% Chrysotile asbestos. The assessment to quantify the extent of this material identified approximately 317 sq. ft. of this material within the Building.

**SUBJECT: Kitchen Multilayered Flooring**

The Category I resilient floor coverings (Kitchen Multilayered Flooring and 9"x9" Brown Vinyl Floor Tile and Mastic) are non-friable ACM's that may be left in place as long as the demolition/renovation activities are completed following the OSHA Asbestos Standards for Construction (29 CFR 1926.1101) which limits employee exposure to asbestos.

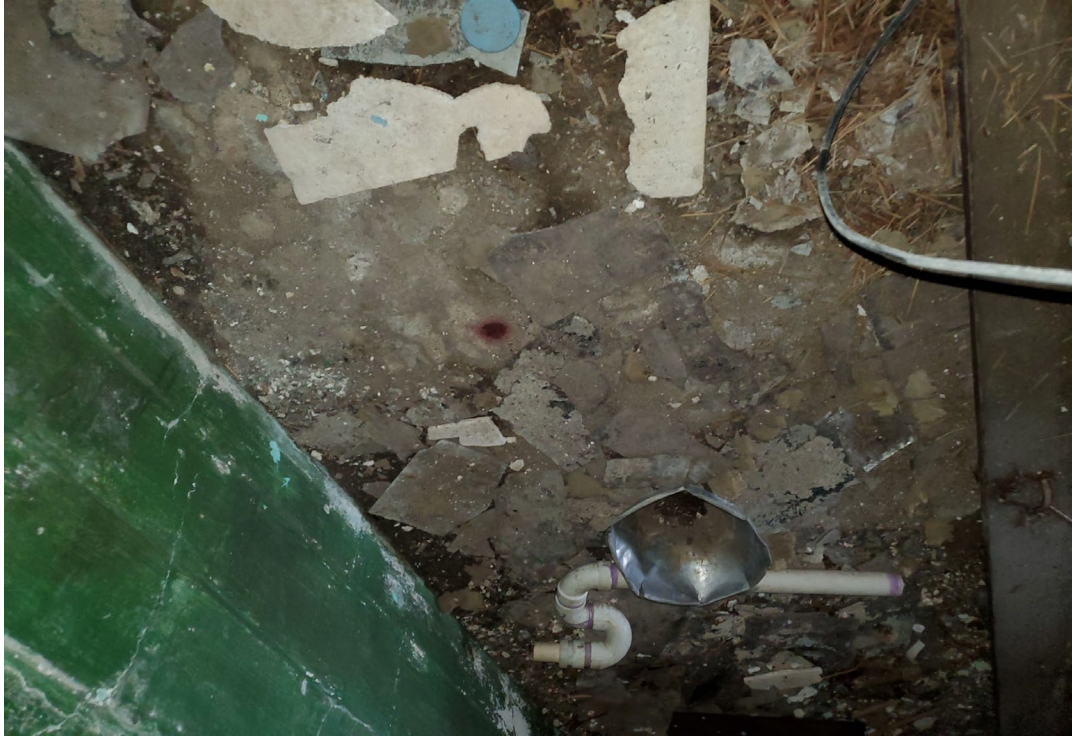
**PHOTO: 3** Basement and Stairwell Brown 9x9 Tile  
**SUBJECT:**

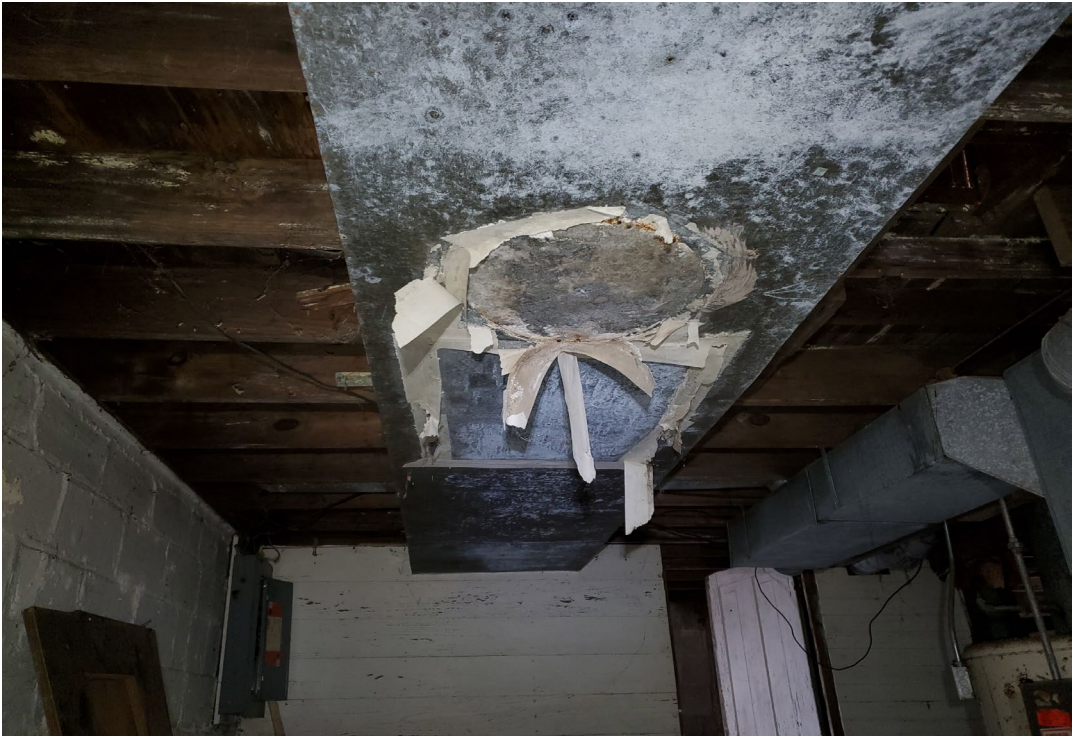
Duct Wrap identified in the building in conjunction with the forced air heating system is classified as friable ACM. The visual assessment to quantify the extent of this material identified HVAC Duct Wrap at the following locations within the basement, first and second floors:

**PHOTO: 4**  
**SUBJECT: Basement HVAC Tape on Duct and Framing**

<b>Asbestos Containing Material Description and Location</b>					
<b>Location</b>	<b>Material Description</b>	<b>Friable</b>	<b>Condition</b>	<b>Material Type</b>	<b>Approx. Quantity</b>
Basement (Tape on Ductwork, 25 sq. ft.) Living/Kitchen (1 register, 15 sq. ft.)	HVAC Duct Wrap	Yes	Fair	TSI	40 sq. ft.

HVAC material identified in the Building system and listed below is classified as friable ACM and should be removed prior to any renovation/demolition activities.

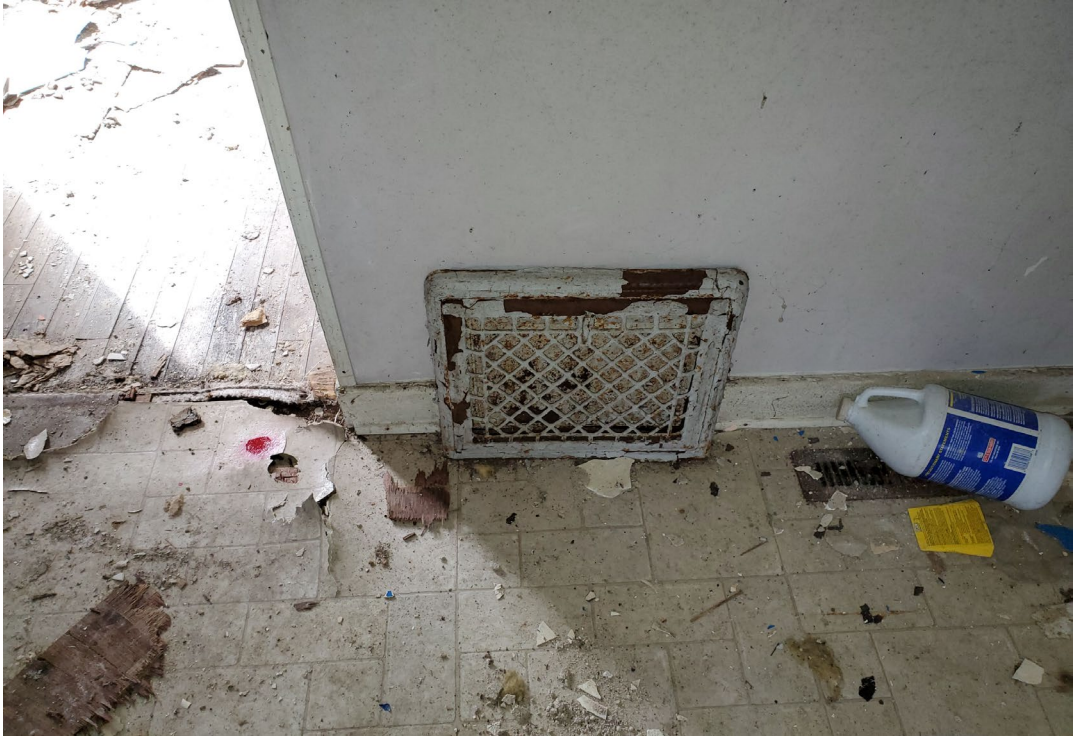
**PHOTO: 5 Living/Kitchen Register**  
**SUBJECT:**

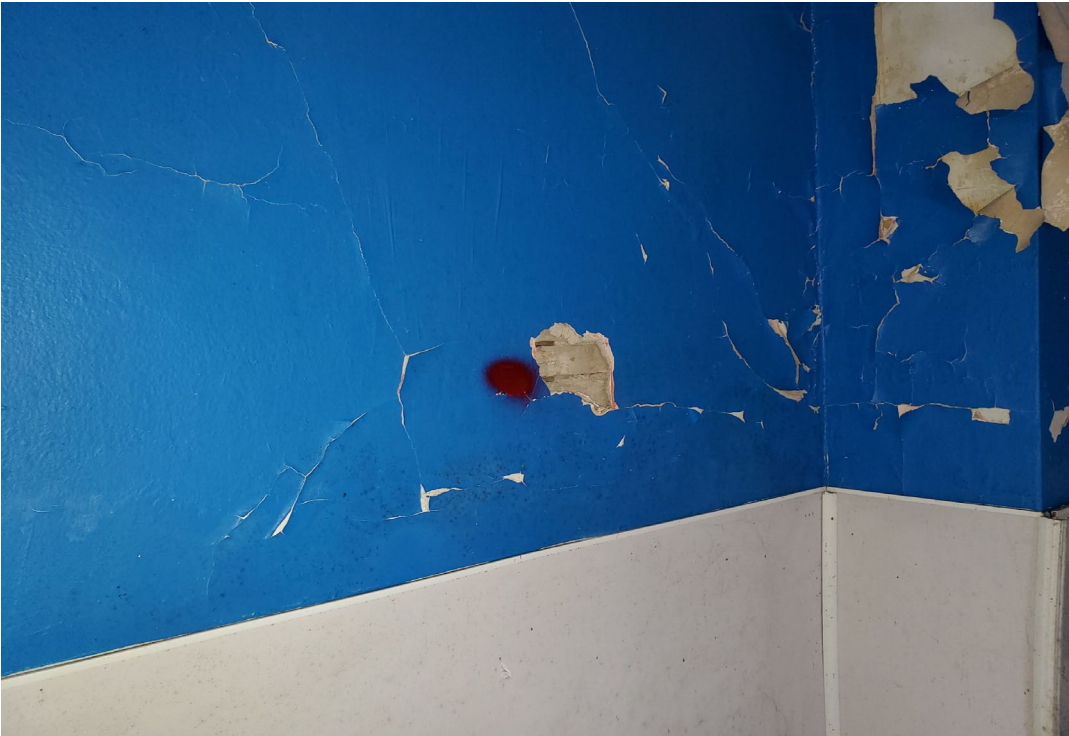
**PHOTO: 6**  
**SUBJECT: Kitchen Wall Plaster**

Plaster samples, collected from the Living Room, NW Bedroom, and Kitchen were each found to contain up to 2% asbestos following analysis. The assessment to quantify the extent of this material identified approximately 2,592 sq. ft. of plaster within the Building.

Plaster identified on the interior of the Building must be abated prior to completion of any renovation/demolition activities at the Subject Property. Any Category II non-friable ACM that has a high probability of becoming or has become crumbled, pulverized, or reduced to powder by the forces expected to act on the material in the course of renovation or demolition operations must be properly abated.
