**RE: *Asbestos Containing Material and Hazardous Materials Inspection
729 S Hayford Ave., Lansing, MI 48912
Parcel ID: 33-01-01-23-105-061***

Project No.: 19-1159
Ingham County Land Bank
Parcel ID: 33-01-01-23-105-061

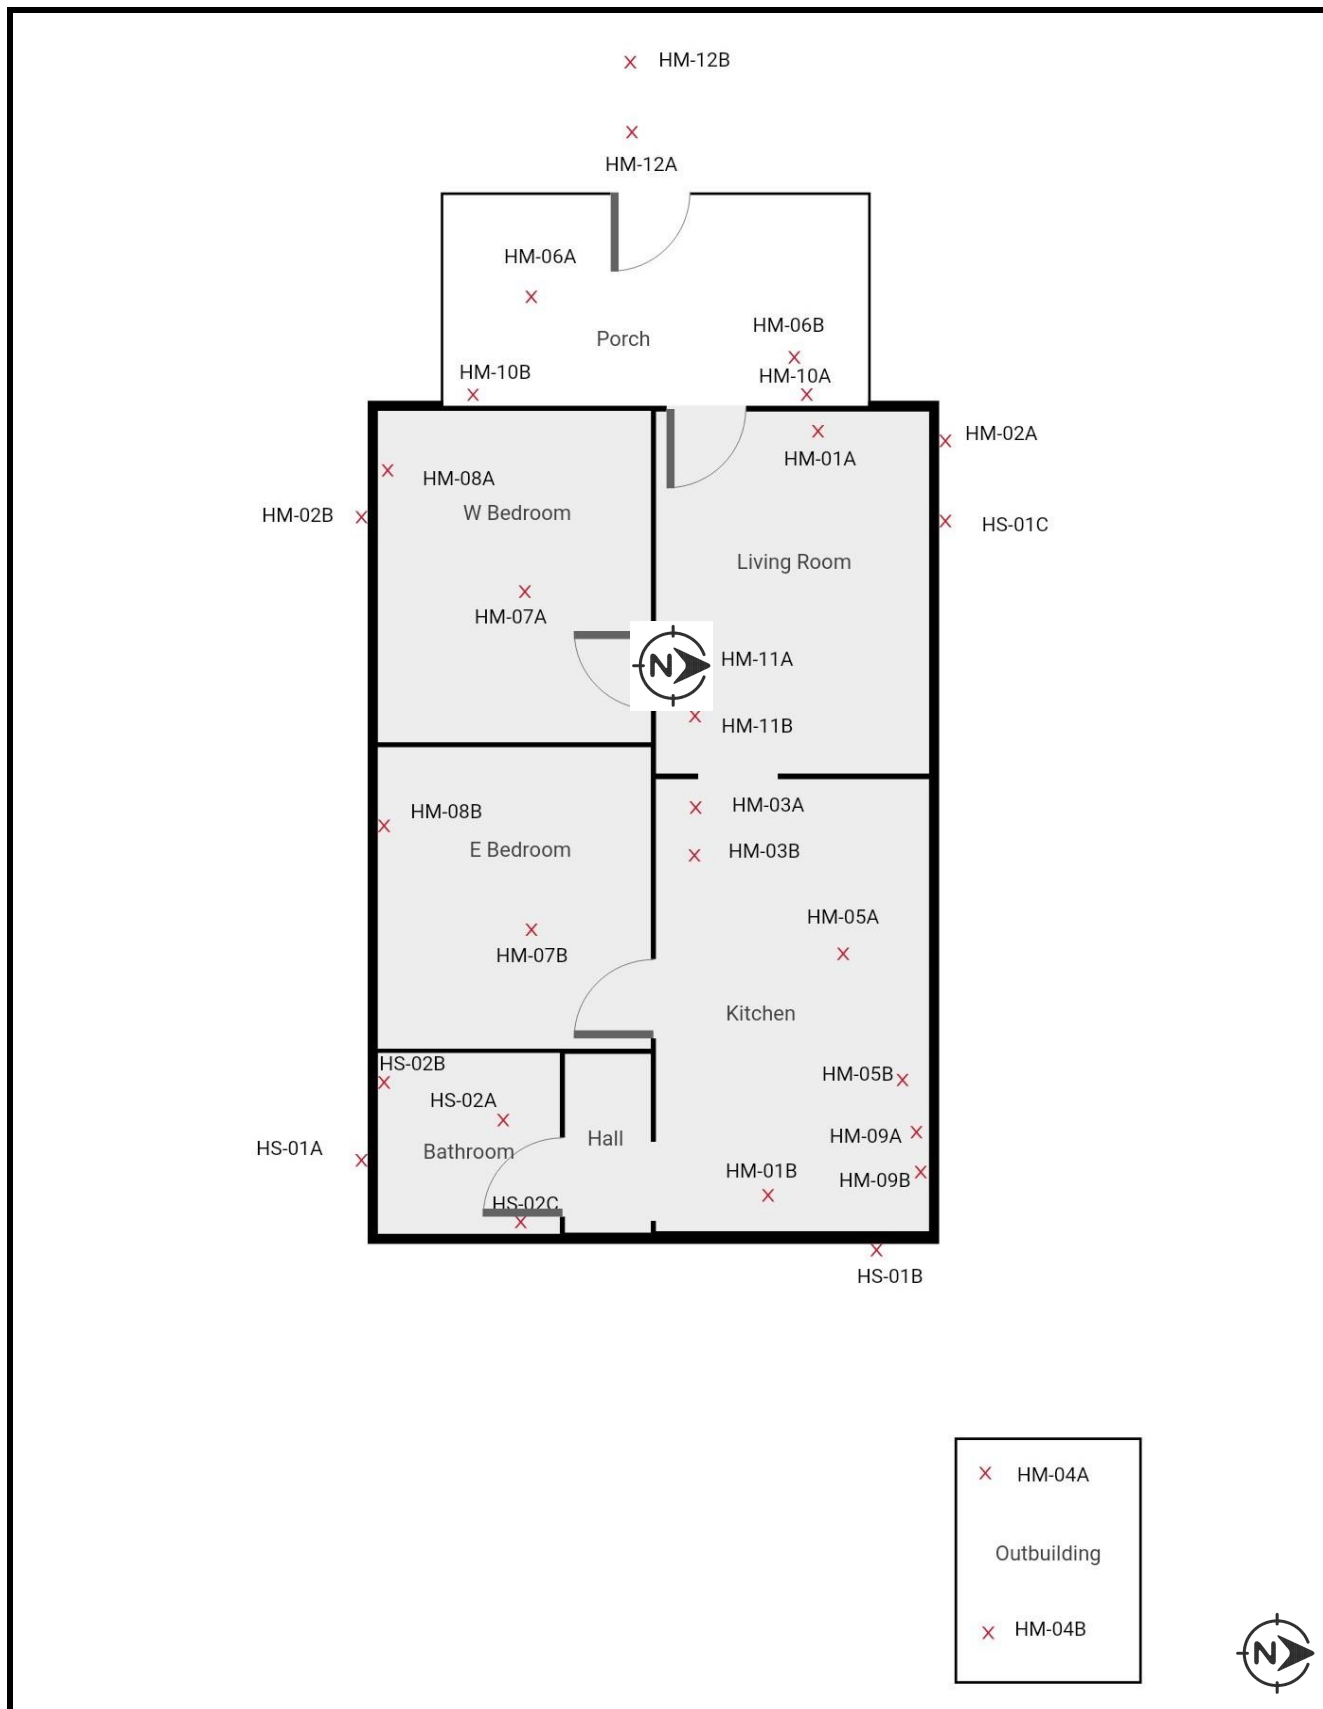
Figure 1a Site Diagram

Asbestos Sample Locations
729 S Hayford Ave.
Lansing, MI

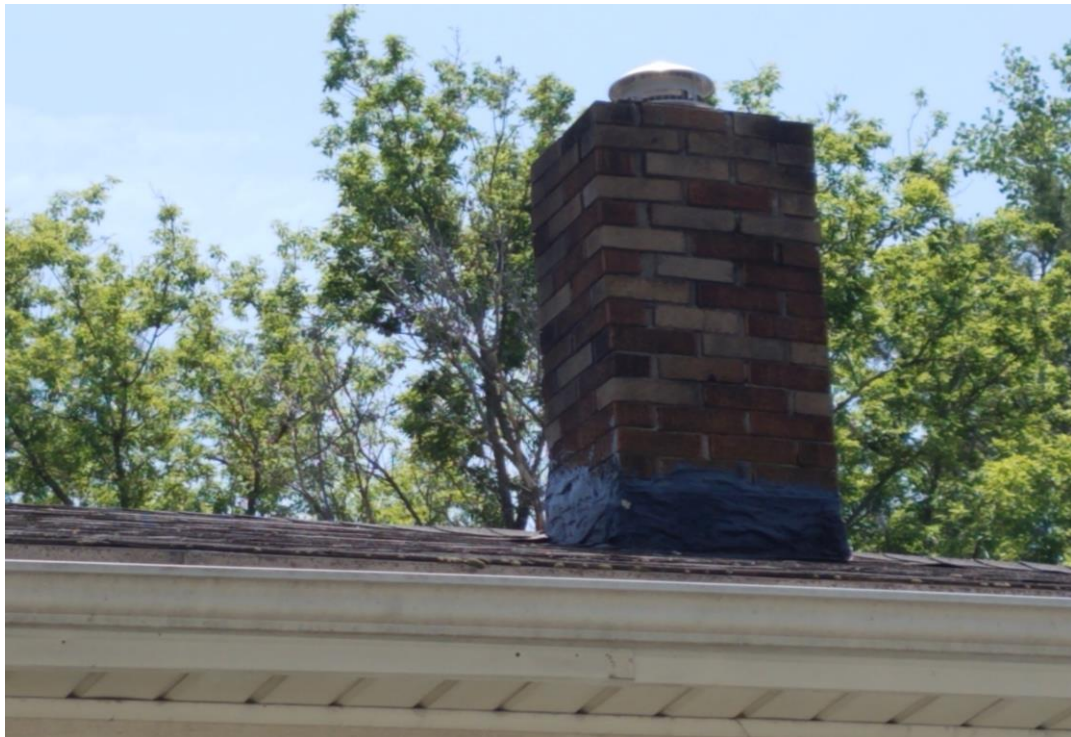
Asphalt Flashing samples collected during the completion of the inspection were found to contain up to 10% Chrysotile asbestos. The assessment to quantify the extent of this material identified 10 sq. ft. of asphalt roofing materials on the Building.

PHOTO: 2
SUBJECT: Chimey Flashing

The Category I Asphalt Flashing materials are a non-friable ACM that may be left in place as long as the demolition/renovation activities are completed following the OSHA Asbestos Standards for Construction (29 CFR 1926.1101) which limits employee exposure to asbestos.
