# PRE-DEMOLITION ENVIRONMENTAL INSPECTION SUMMARY REPORT

Ingham County Land Bank  
3024 Turner Street  
Lansing, MI 48906

Parcel:	NA
House No:	648 S Hayford, Lansing, MI 48912
Date Inspected:	4/5/2017
Inspected By:	Joe Reynolds
Inspectors State Card #	A49992

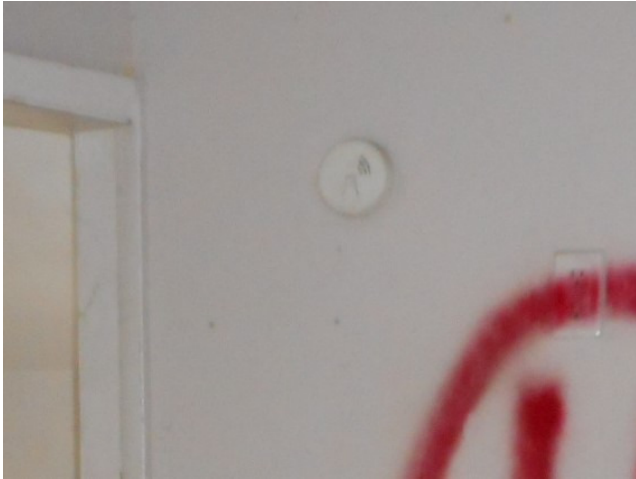
<b>Material Description</b>	<b>Quantity &amp; Units</b>	<b>Location</b>
Smoke Detector	4	Room 8, 10, 11
Thermostat	1	Room 2

Smoke Detector

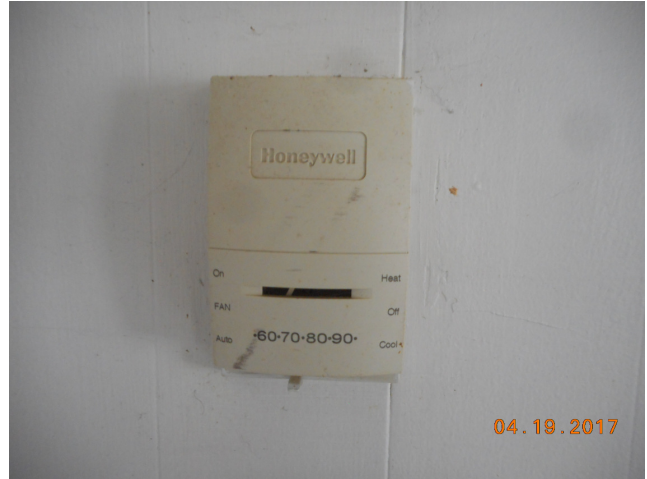
Thermostat

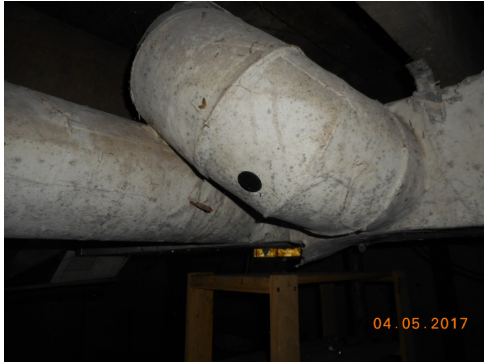
18	NF	12x12 Tile, brown pattern	Room 11	108 SF	No
19	NF	Mastic, clear (under 18)	Room 11	108 SF	No
<b>20</b>	<b>F</b>	<b>Duct wrap, grey</b>	<b>Room 2, 10, 12</b>	<b>30 LF</b>	<b>YES</b>

Duct wrap (grey)

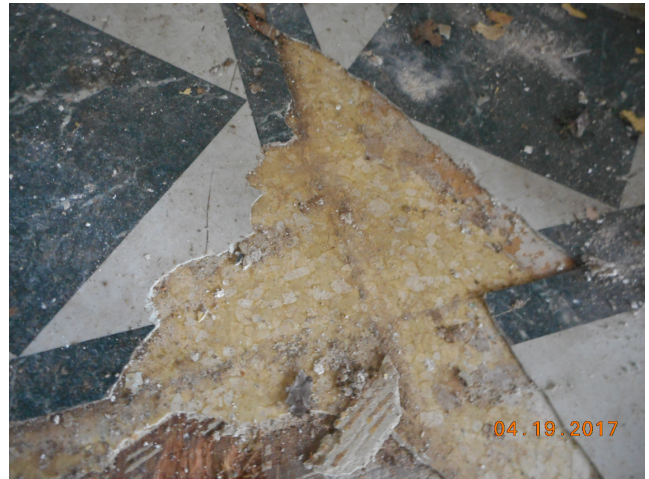
Linoleum (tan stone pattern)

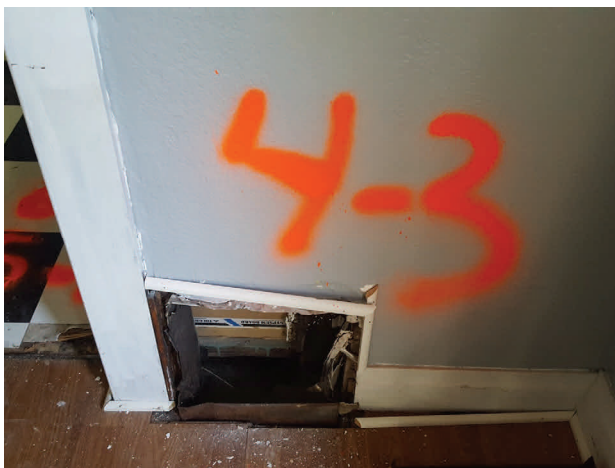
Asbestos Containing Material				
Location	Material Group	Friable/Non Friable	Asbestos	Quantity
House Vents	Vent Wrap	Friable	40% Chrysotile	15 SF

Room 3 Vent with Vent Wrap

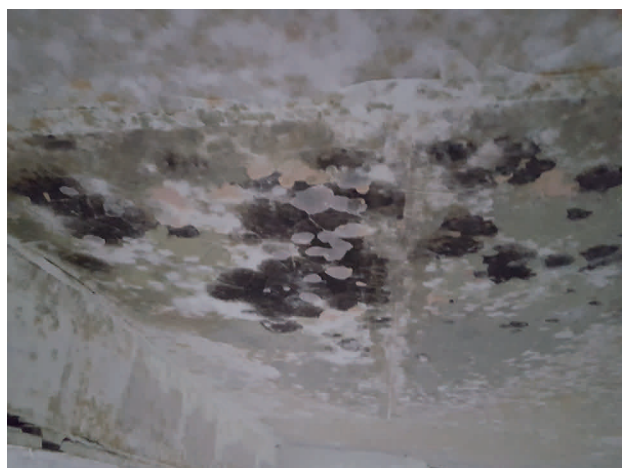
Drywall Ceiling with Mold in Basement

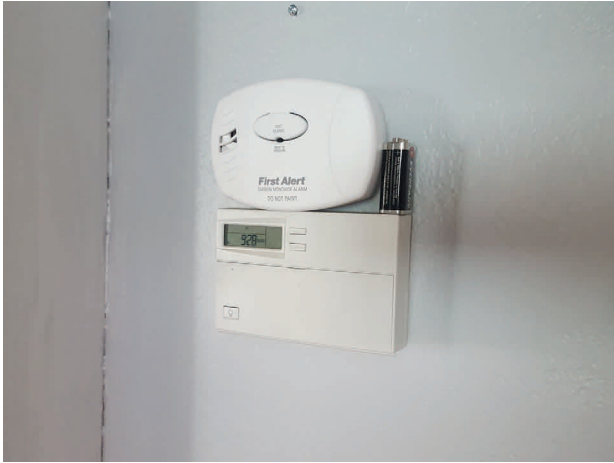
Electric Thermostat and Carbon Monoxide Detector in Hall

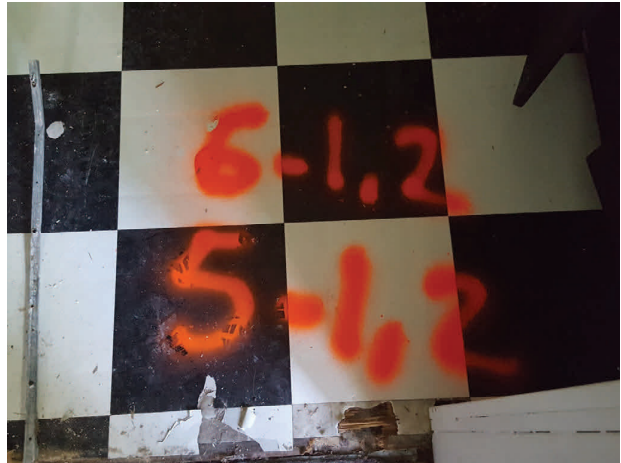
Two Flooring Layers in Room 4

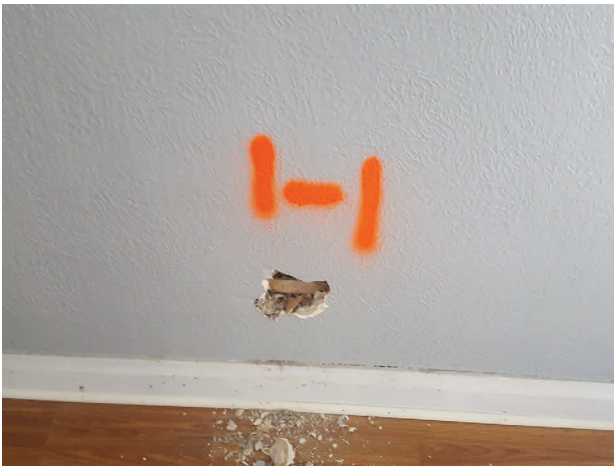
Plaster Sample from Room 2
