December 29, 2017

Ms. Roxanne Case
Grant Manager
Ingham County Land Bank
3024 Turner Street
Lansing, Ingham County, Michigan 48906

Re: Pre-Demolition Regulated Materials Survey
1556 Ballard St, Lansing, Ingham County, MI

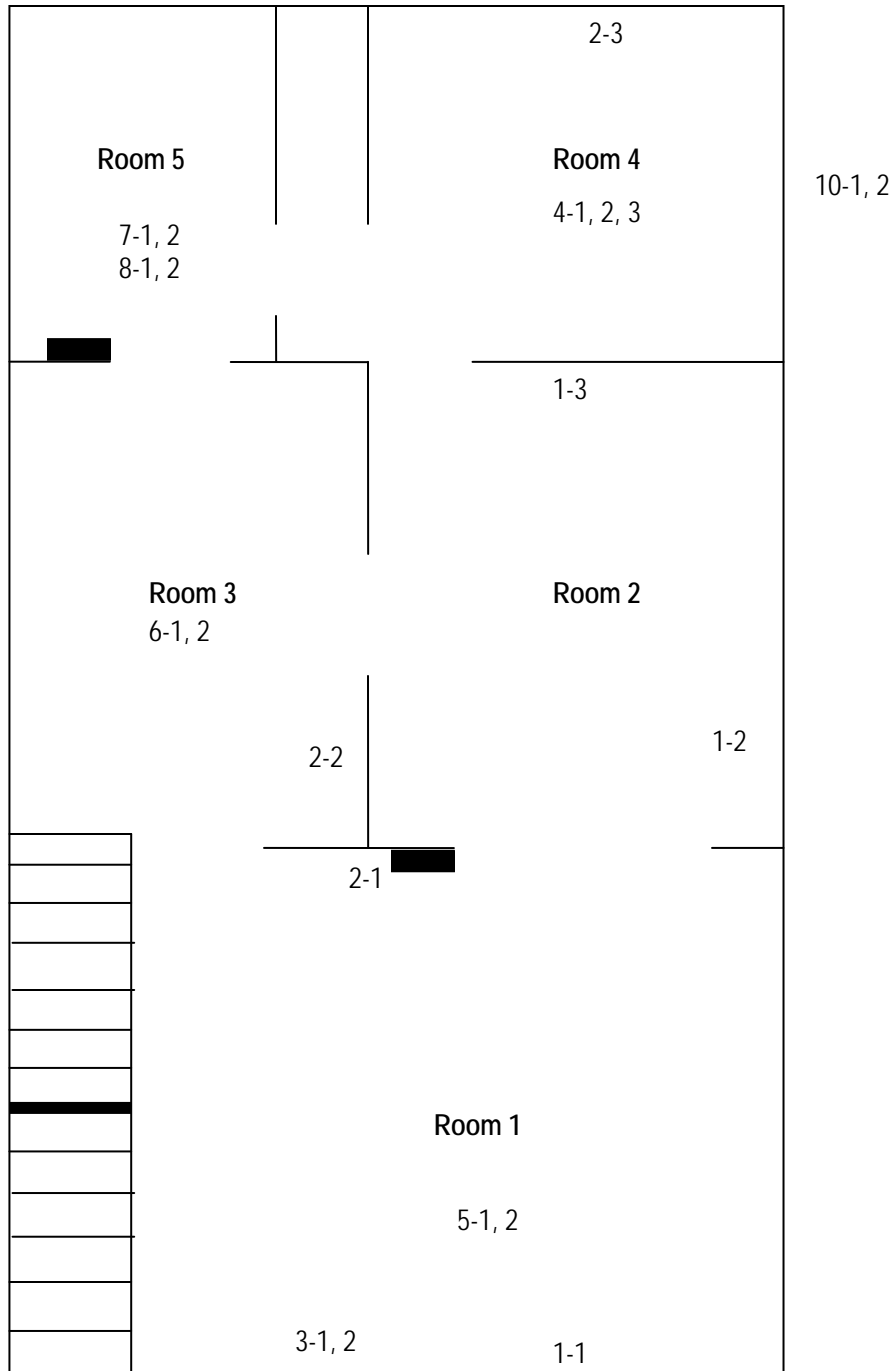
1st Floor

■ = Vent with wrap

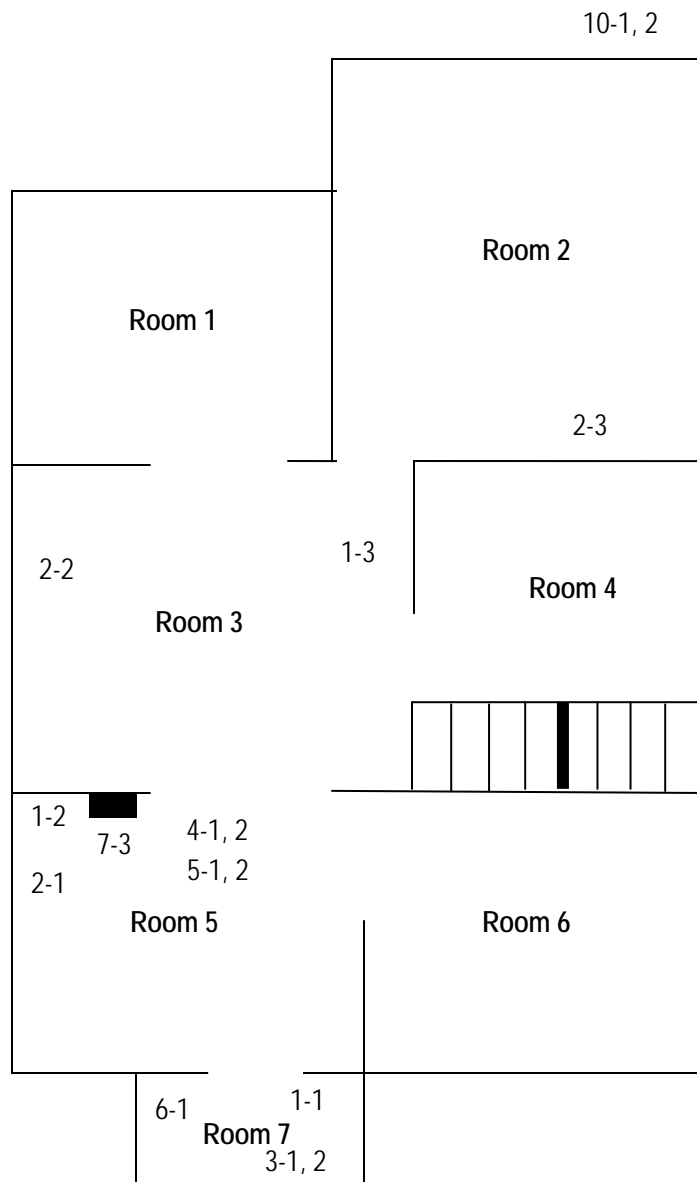
1st Floor

■ = Vent with wrap (200 SF)

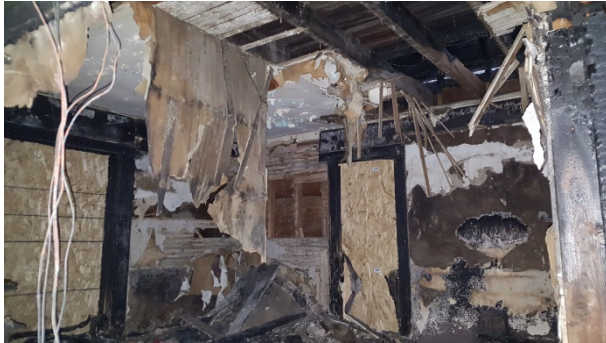
View of northwestern burned portion of house

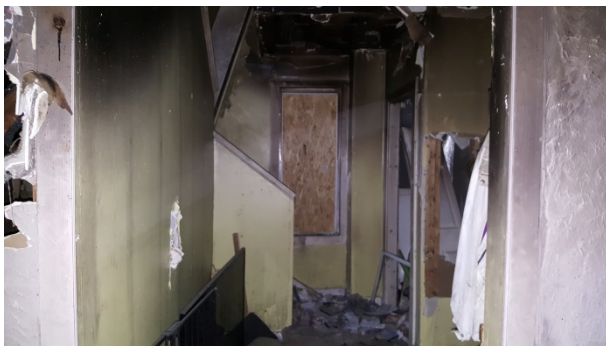
View of collapsing ceiling facing east

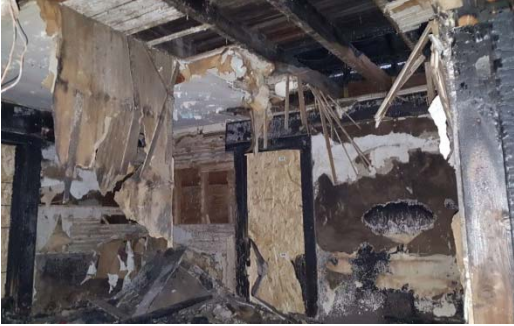
View of northwestern burned portion of house

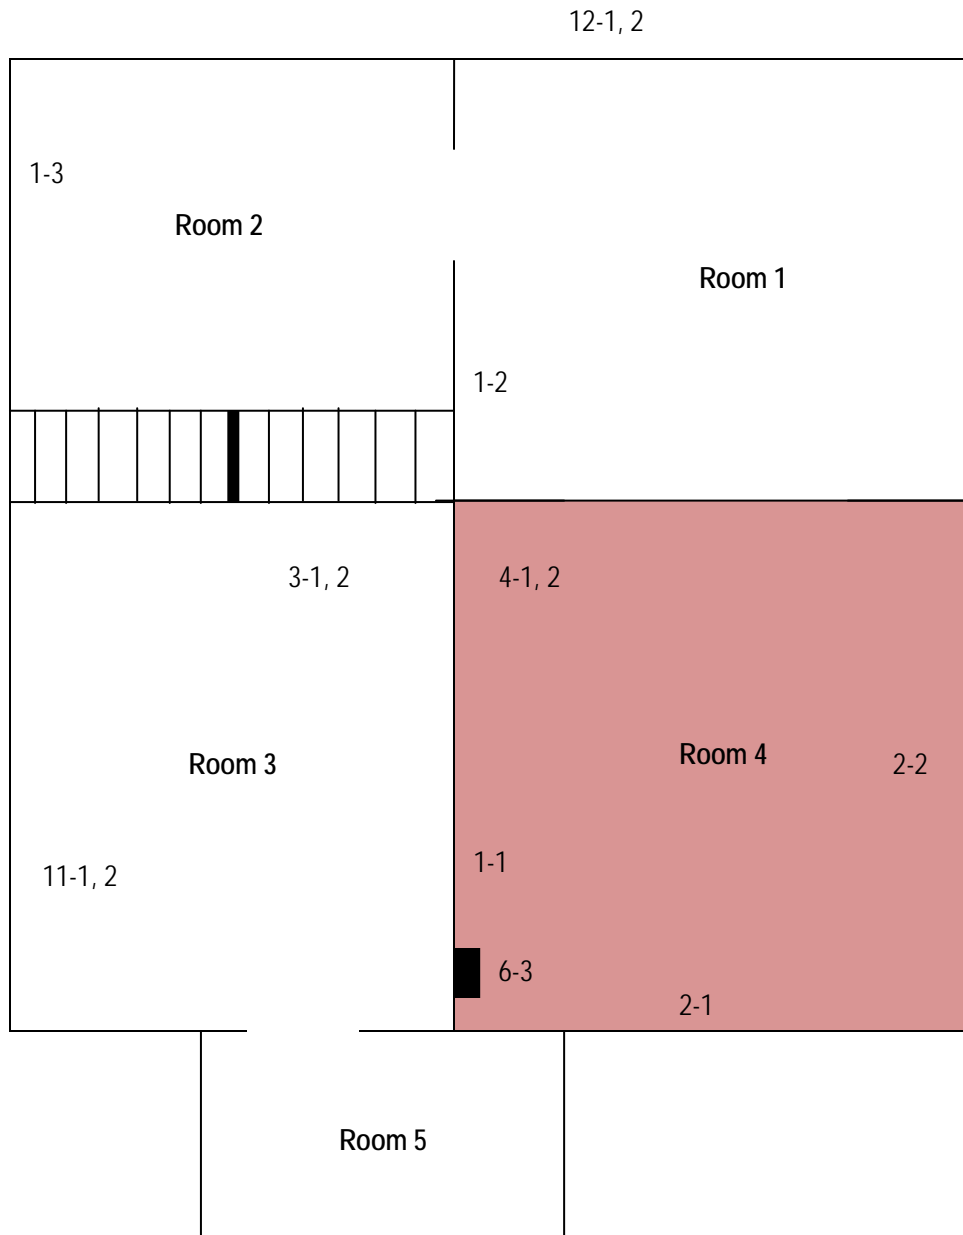
1st Floor

Red Linoleum (200 SF)

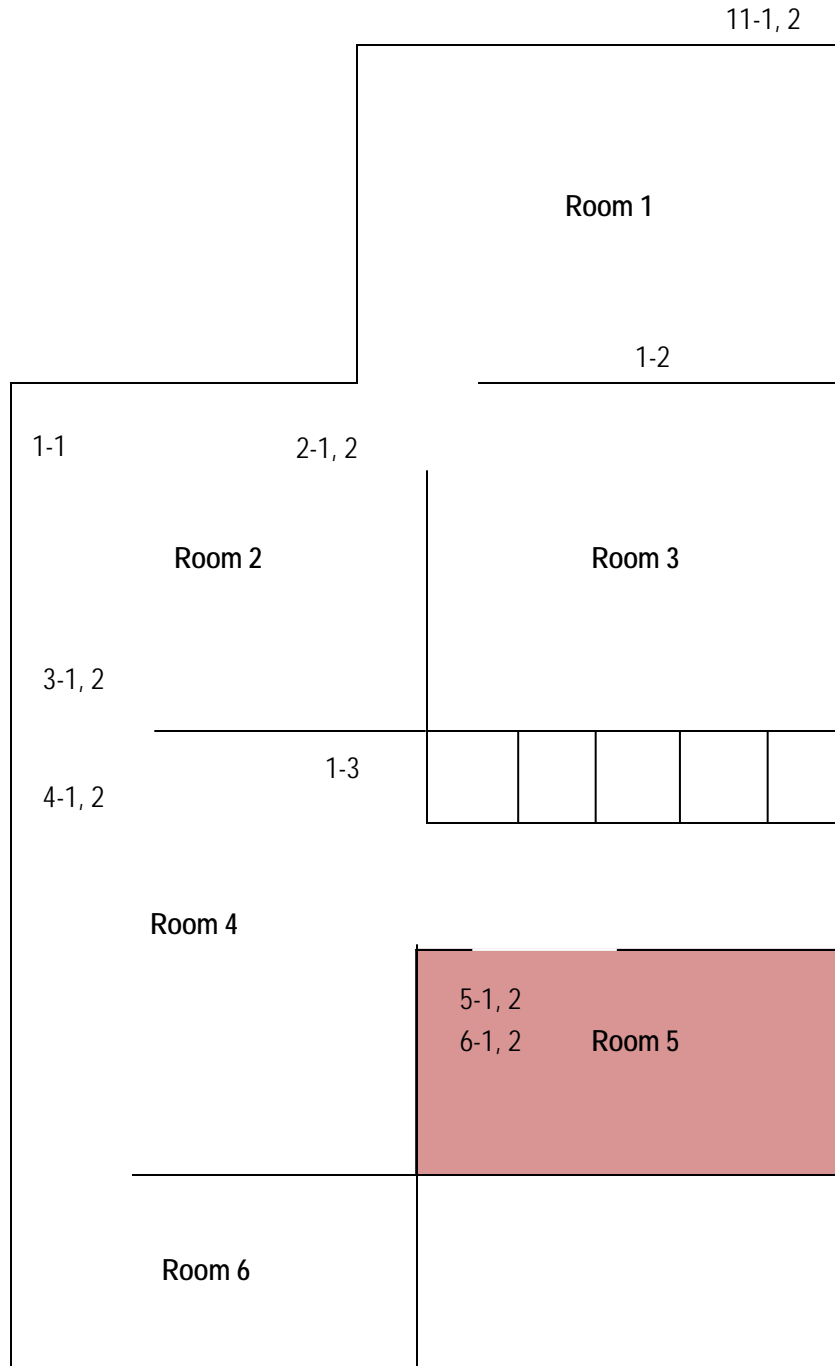
1st Floor

Red Linoleum (80 SF)

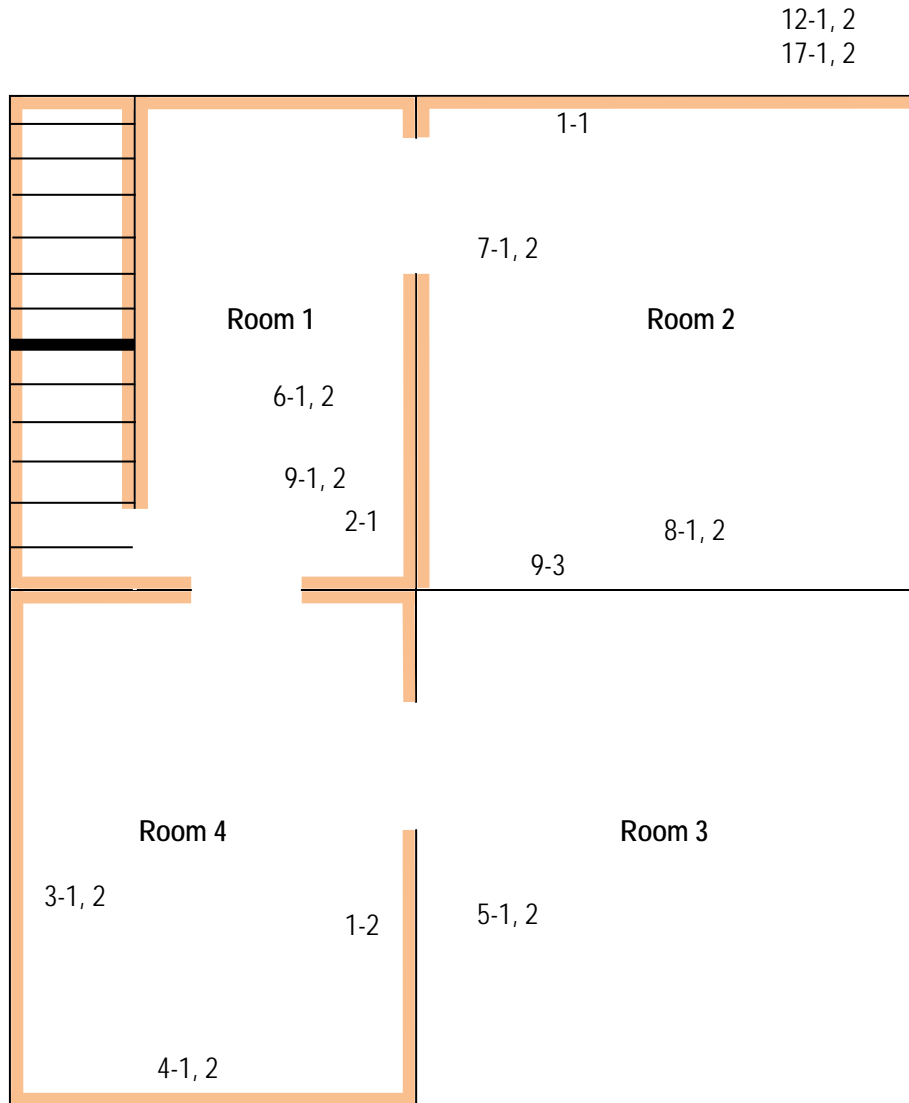
1st Floor

Plaster Walls and Ceilings (2,850 SF)

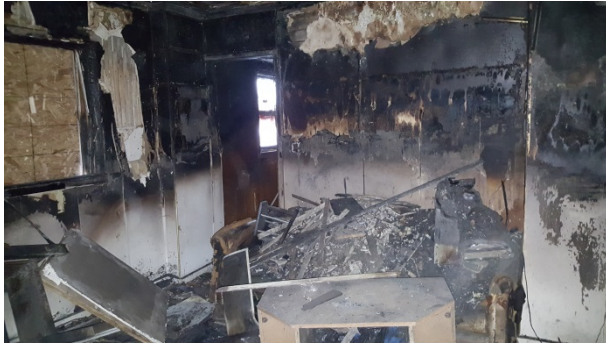
View of burned kitchen

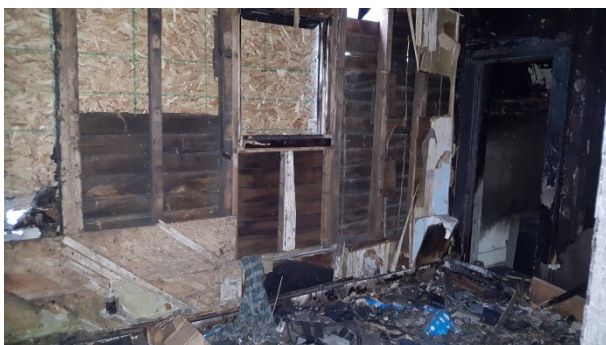
View of burned southwestern room

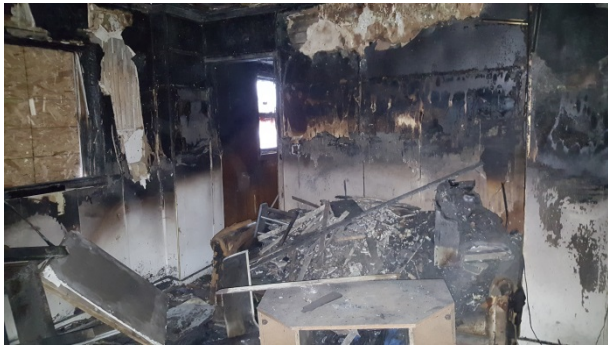
View of burned kitchen

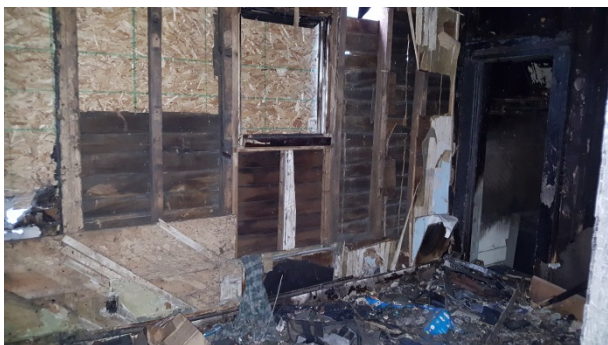
View of burned southwestern room

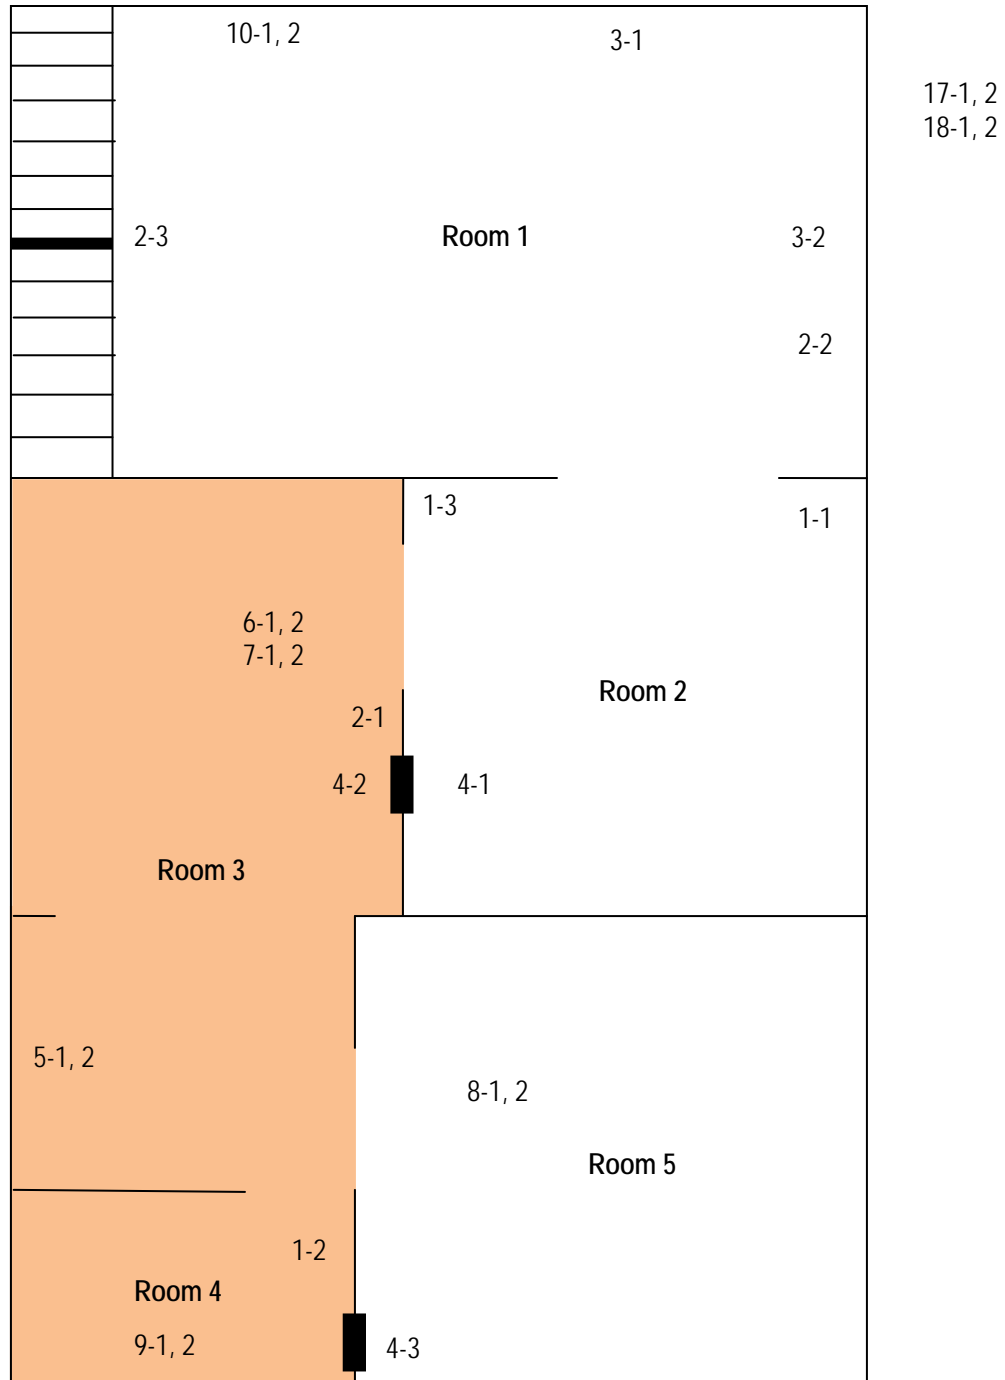
1st Floor

= Flooring Sandwich (240 SF)
