December 29, 2017

Re: Pre-Demolition Regulated Materials Survey  
 1000 W Saginaw St, Lansing, Ingham County, MI

The Mannik & Smith Group, Inc. (MSG) is pleased to present Ingham County with the results of the limited pre-demolition regulated materials survey (RMS) performed at 1000 W Saginaw St, Lansing, Ingham County, Michigan (hereinafter referred to as the "Site") by Kory McKay (Accreditation Number A47903).

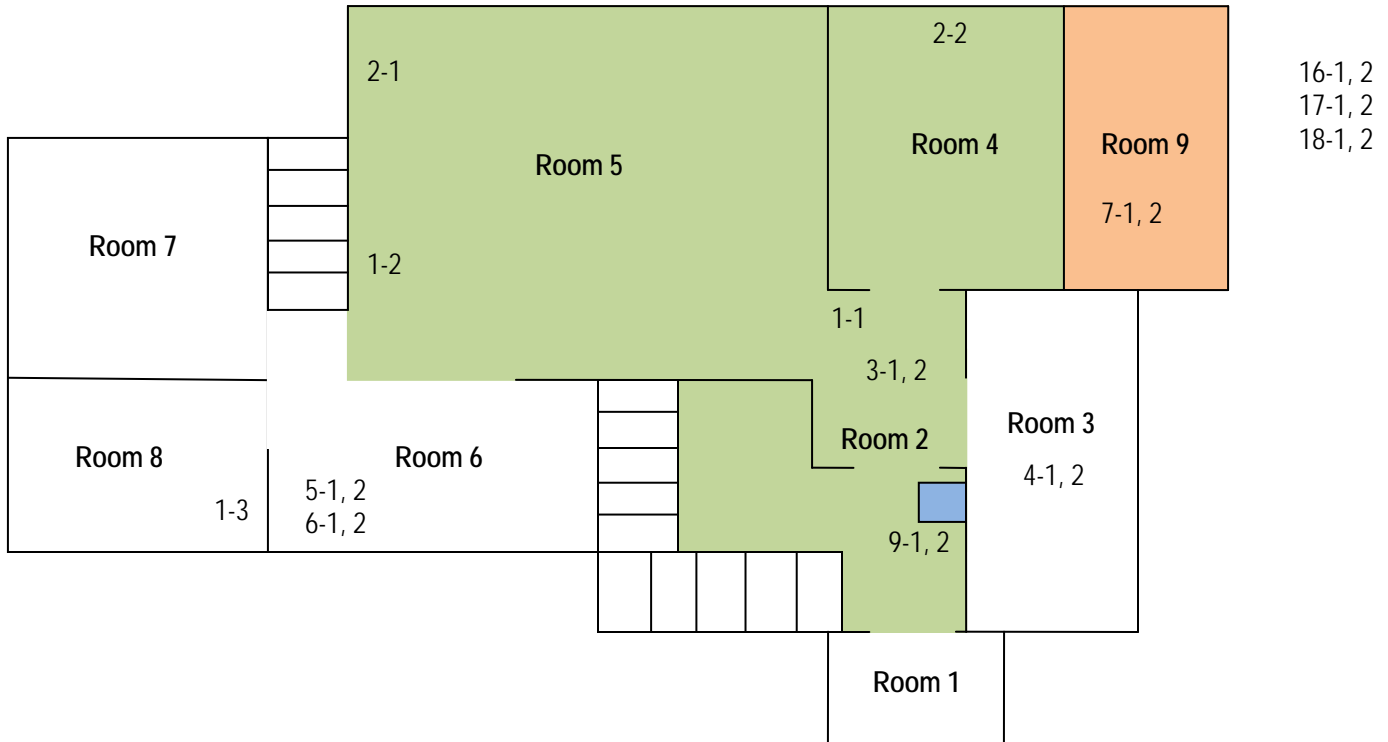
1<sup>st</sup> Floor

Sink Under Coating (3 SF)

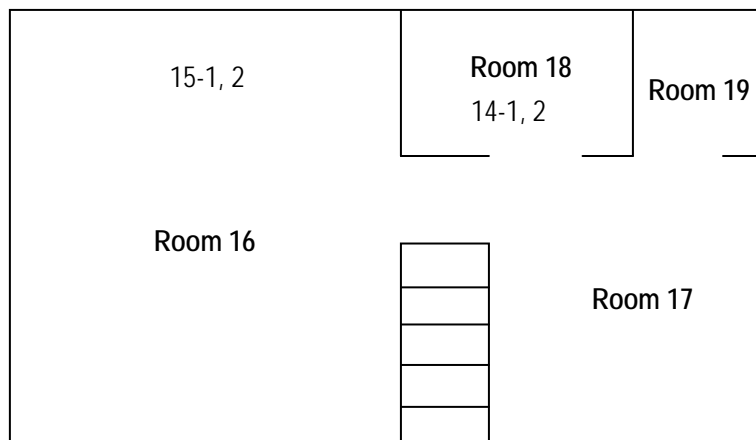
3<sup>rd</sup> Floor

Green Tile (275 SF)

Roof Tar (275 SF)

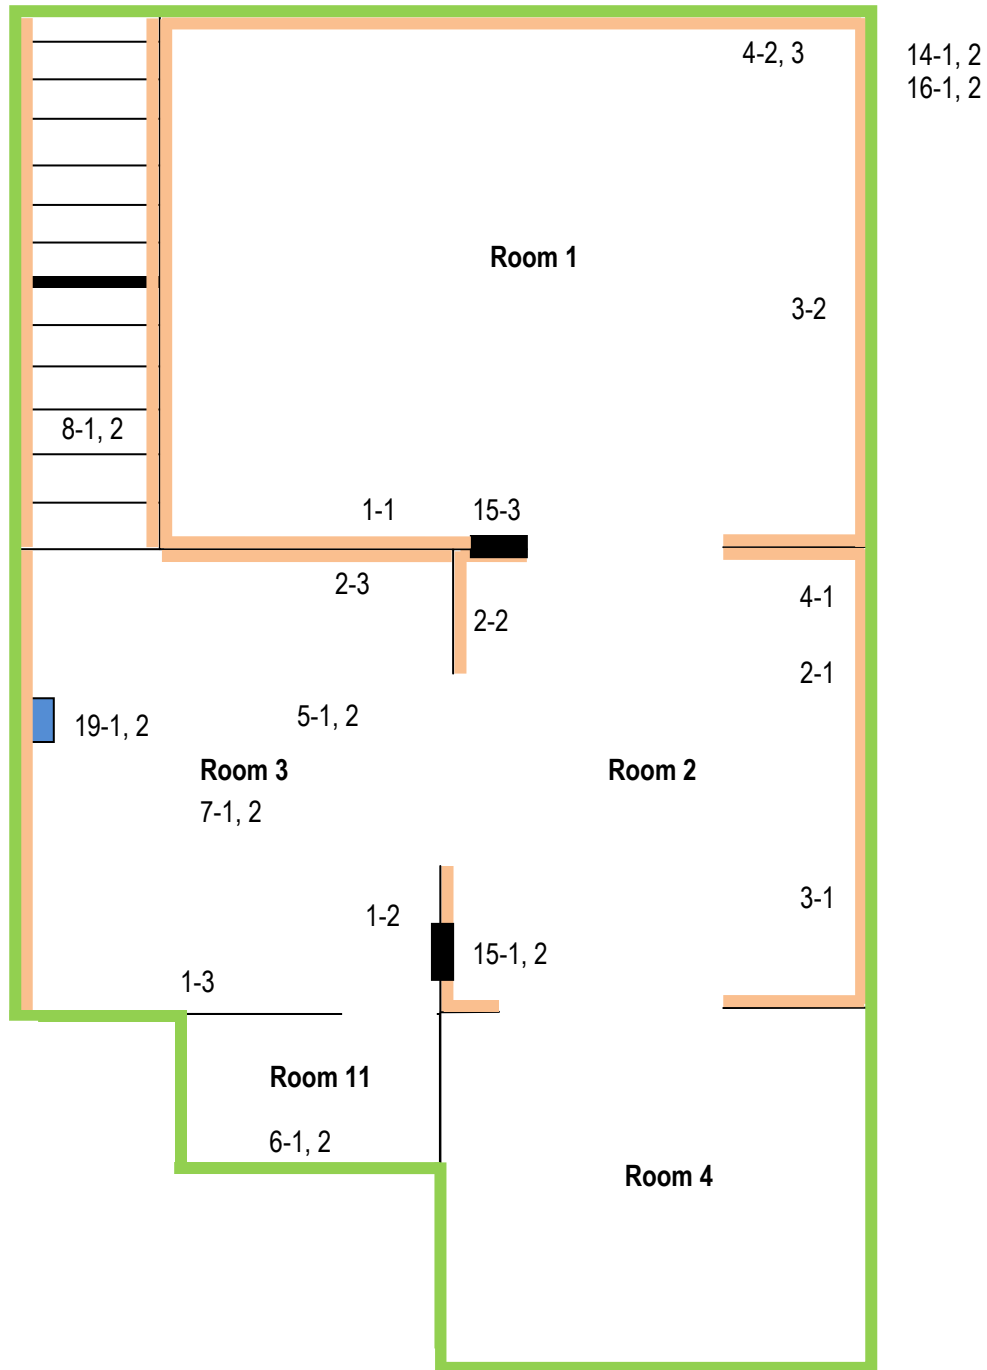
1<sup>st</sup> Floor

= Plaster Walls and Ceilings (4,250 SF)

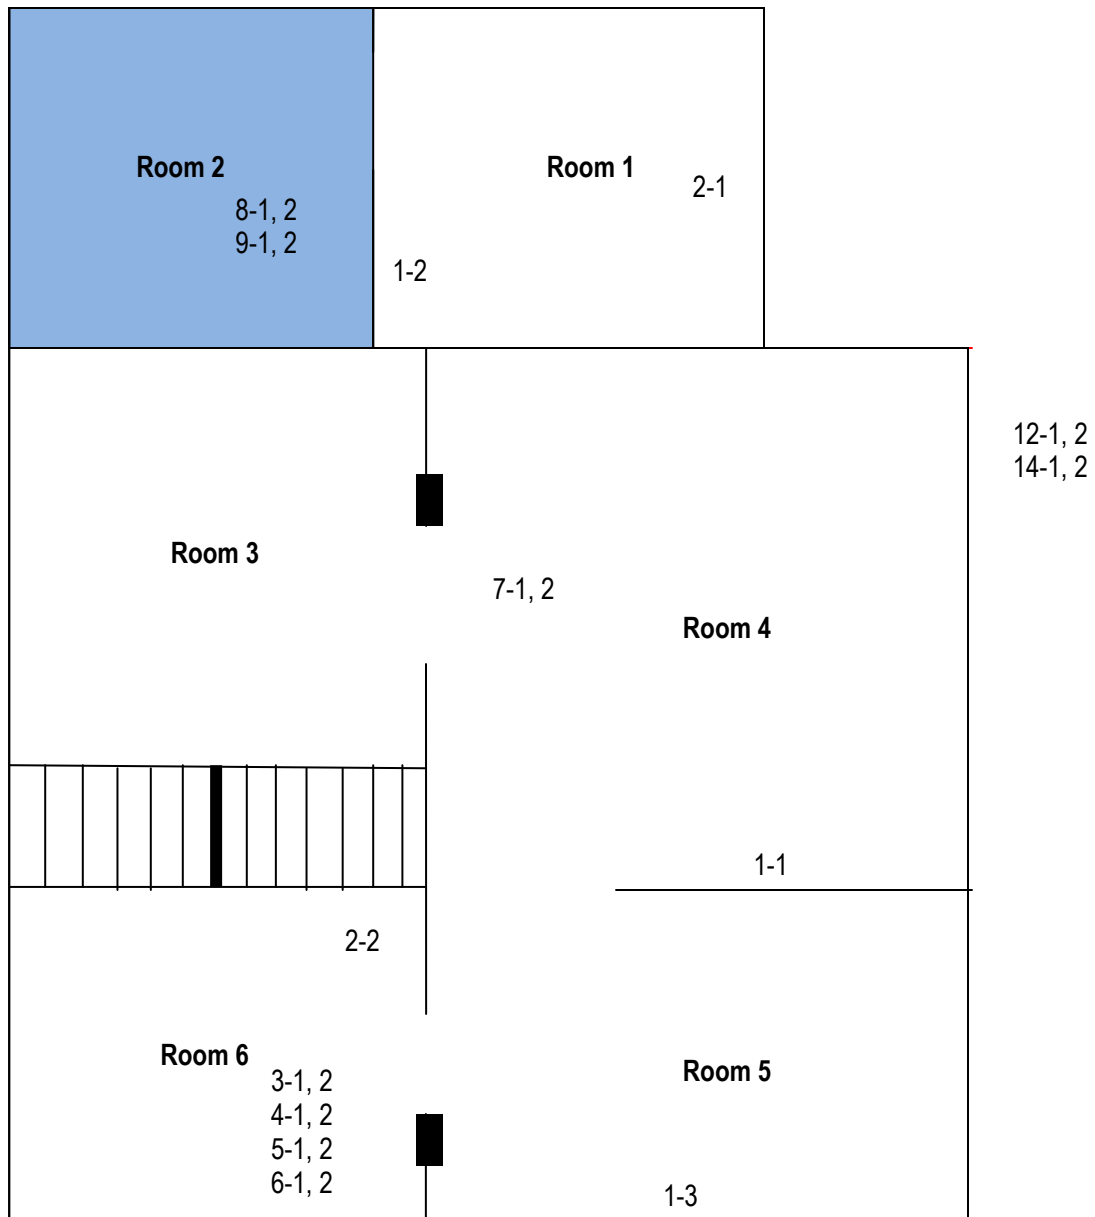
1<sup>st</sup> Floor

Multicolored Linoleum (100 SF)

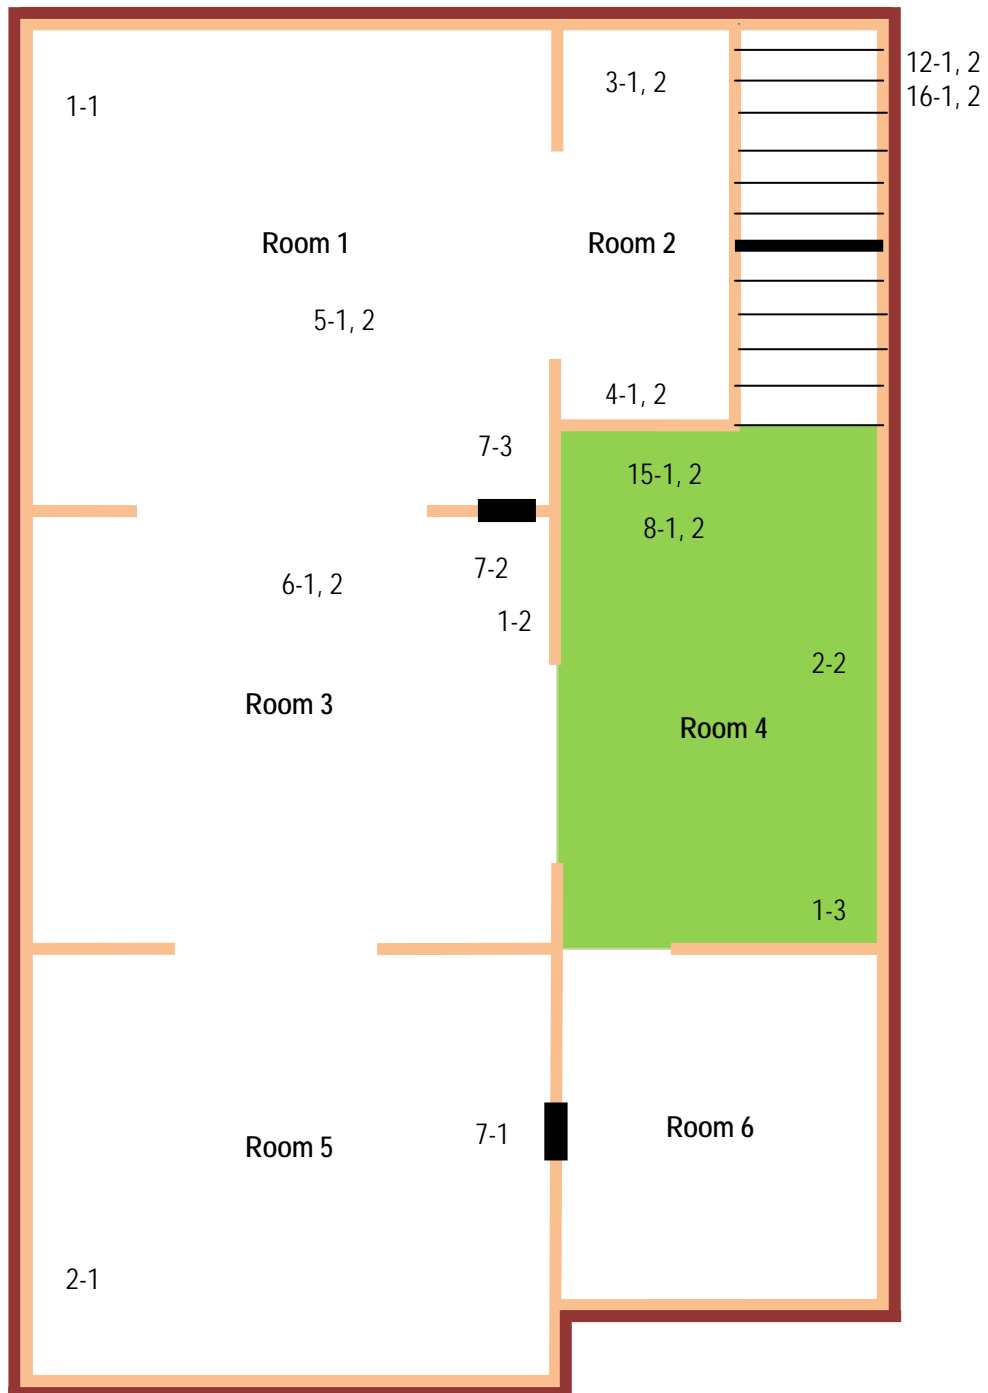
1<sup>st</sup> Floor

= Plaster (3,100 SF)

= Brown tile (120 SF)

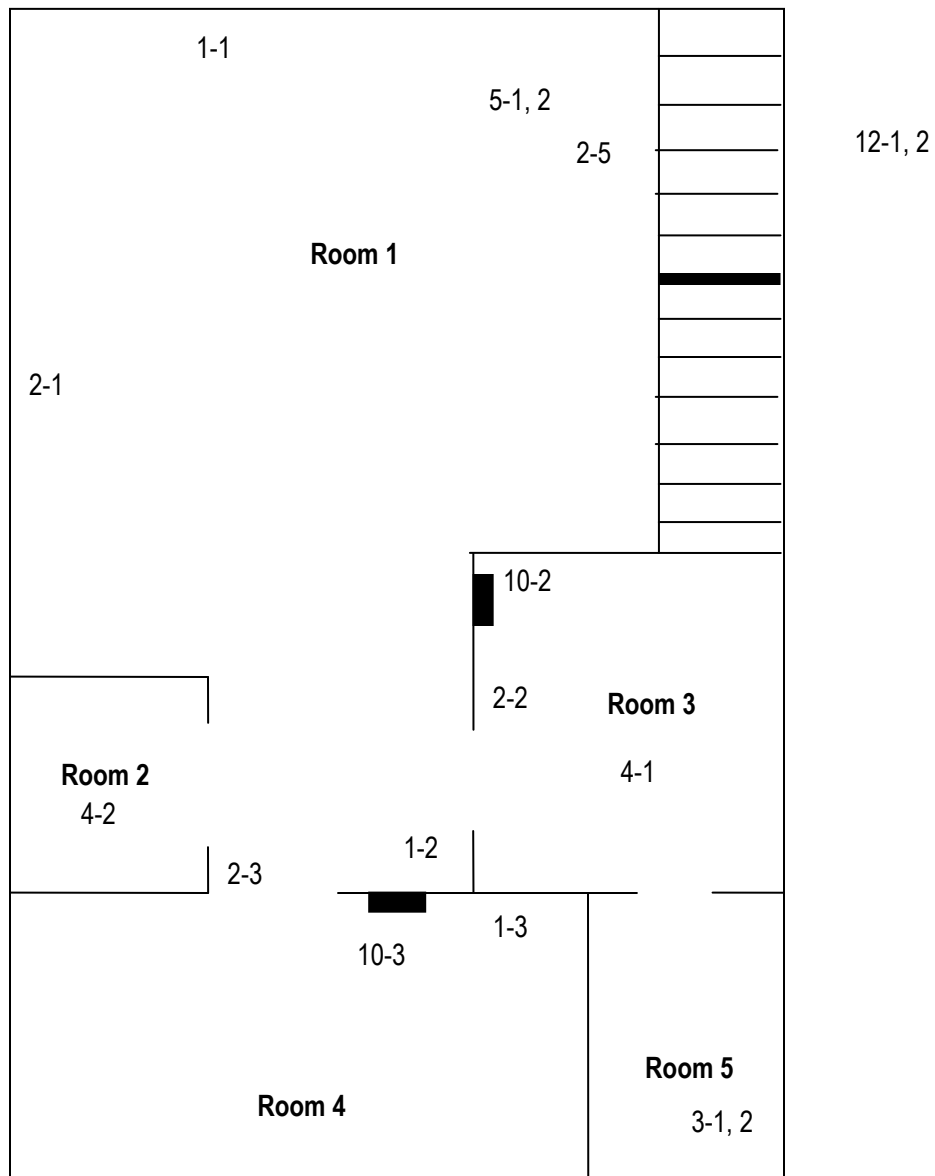
1st Floor

■ Vent with wrap (300 SF)

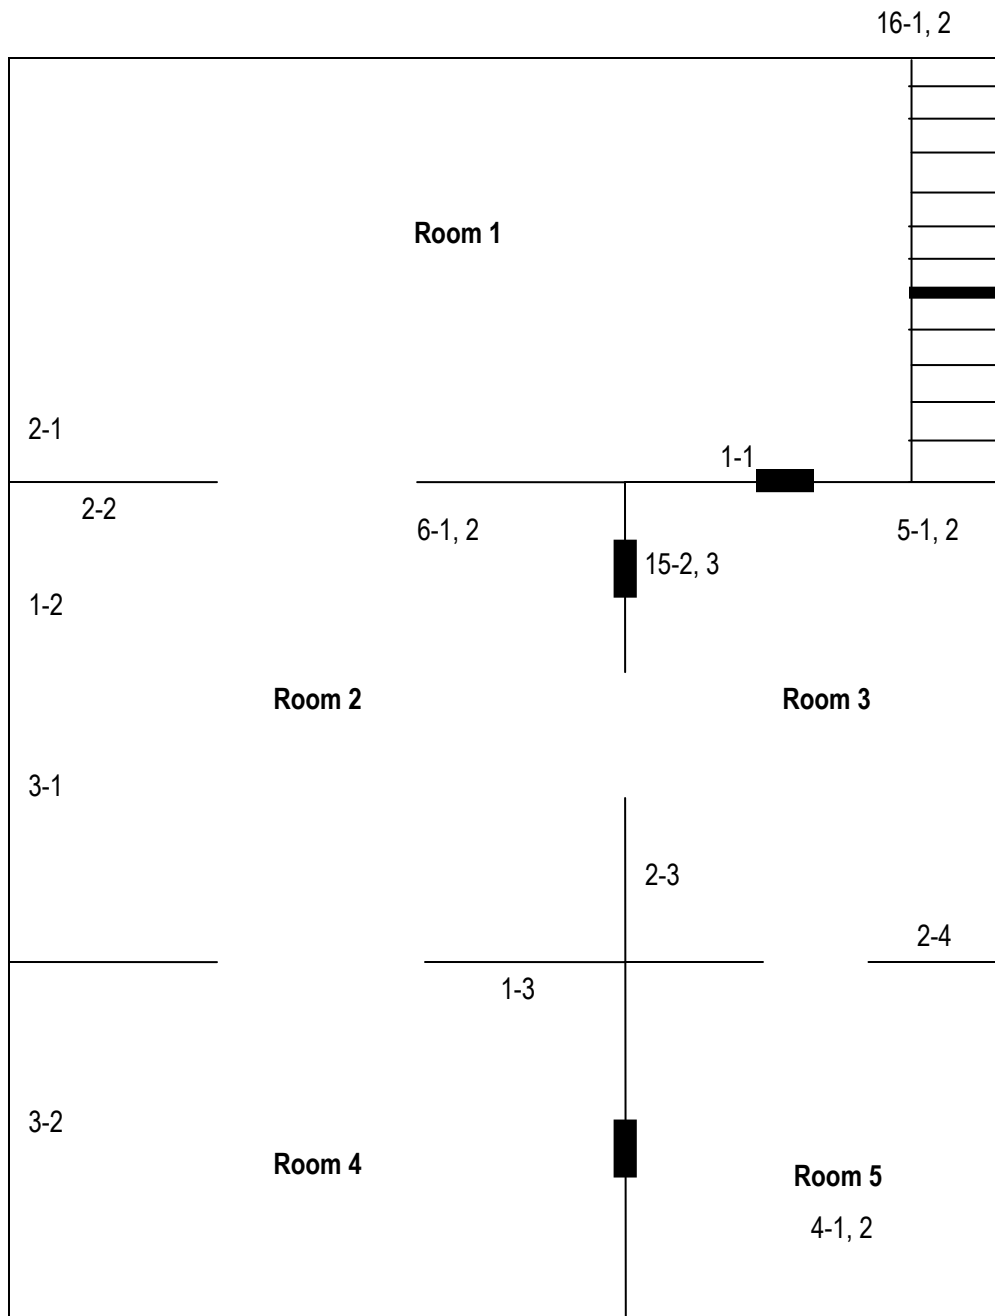
1<sup>st</sup> Floor

■ = Vent with wrap

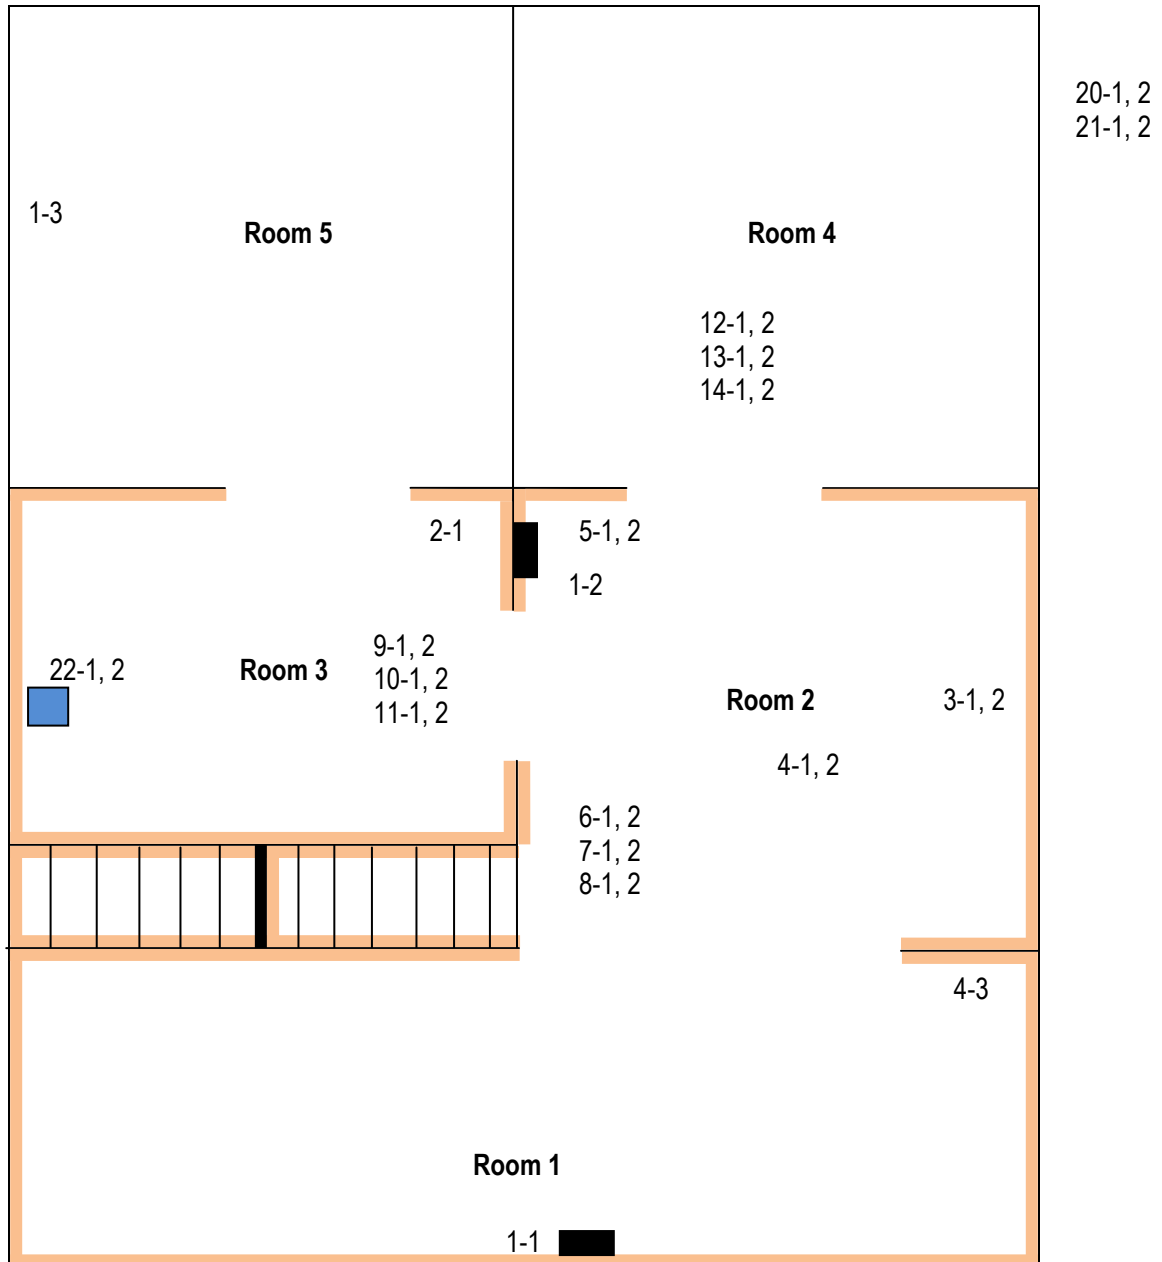
1<sup>st</sup> Floor

Plaster Walls and  
Ceilings (2,000 SF)

Sink Under Coating (4 SF)

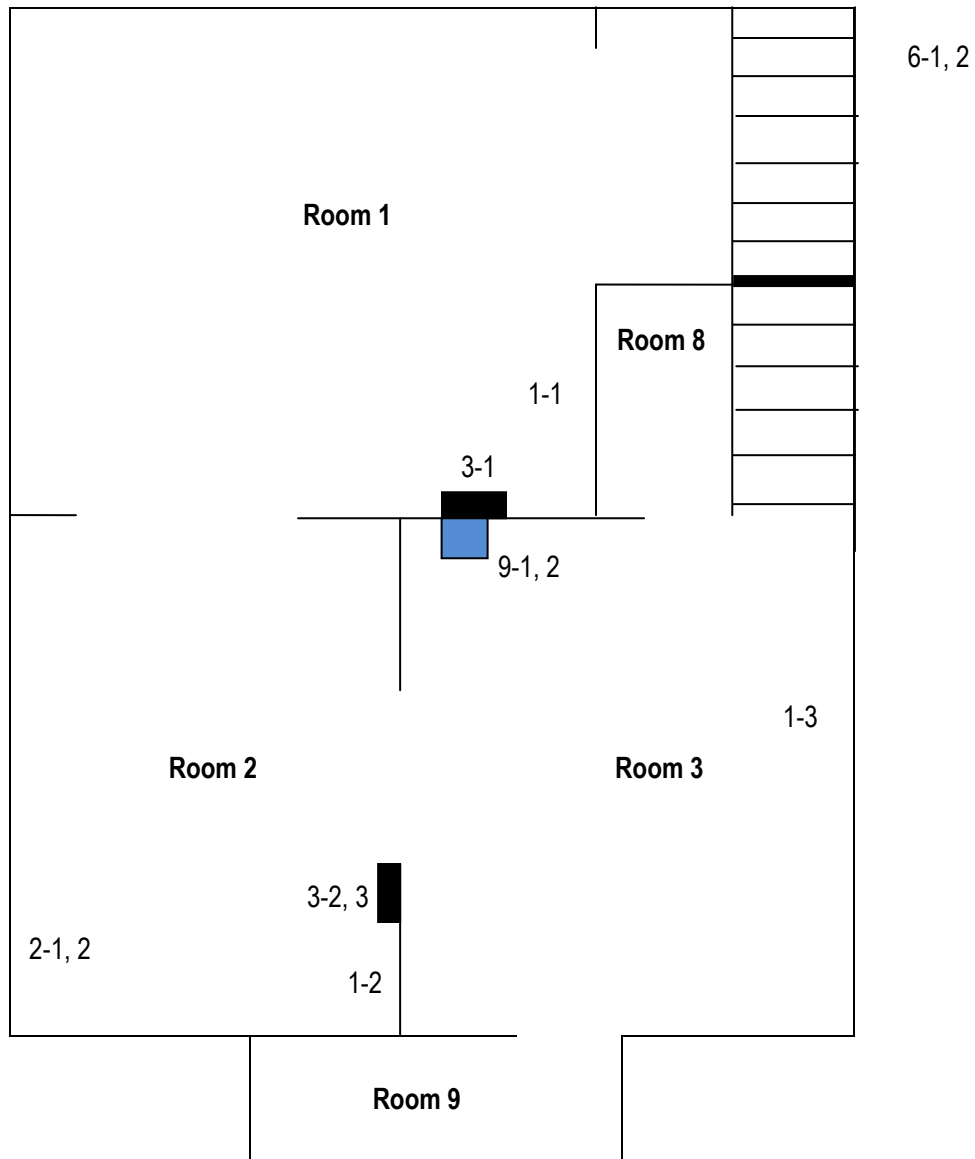
1<sup>st</sup> Floor

Sink Coating (3 SF)
