# PRE-DEMOLITION ENVIRONMENTAL INSPECTION SUMMARY REPORT

Ingham County Land Bank  
3024 Turner Street  
Lansing, MI 48906

Parcel:	33-01-01-15-154-091
House No:	917 Jerome St, Lansing, MI 48912
Date Inspected:	12/21/2017
Inspected By:	Wade Wiltse
Inspectors State Card #	A-51051

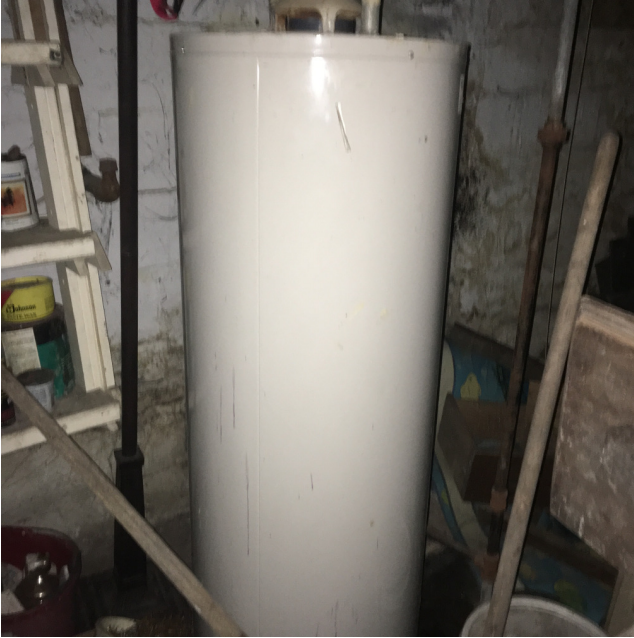
Hot Water Tank

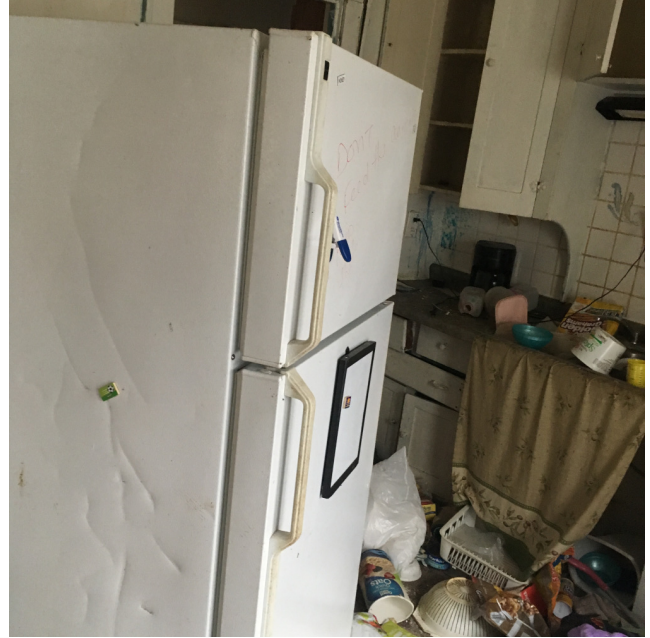
Refrigerators

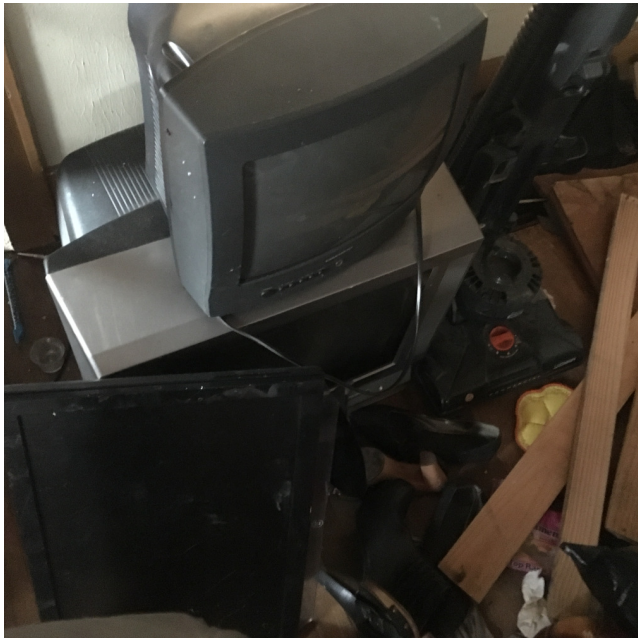
TV Screens/Electronics

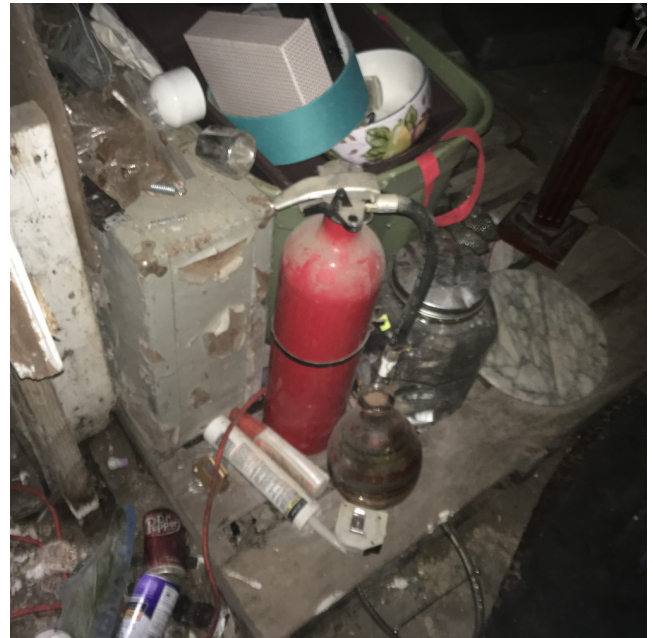
Fire Extinguishers

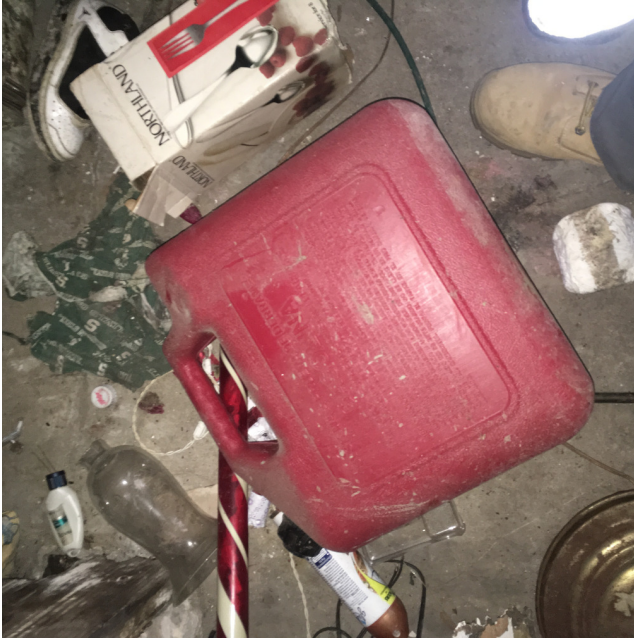
Misc. Items (solvents, cleaners)

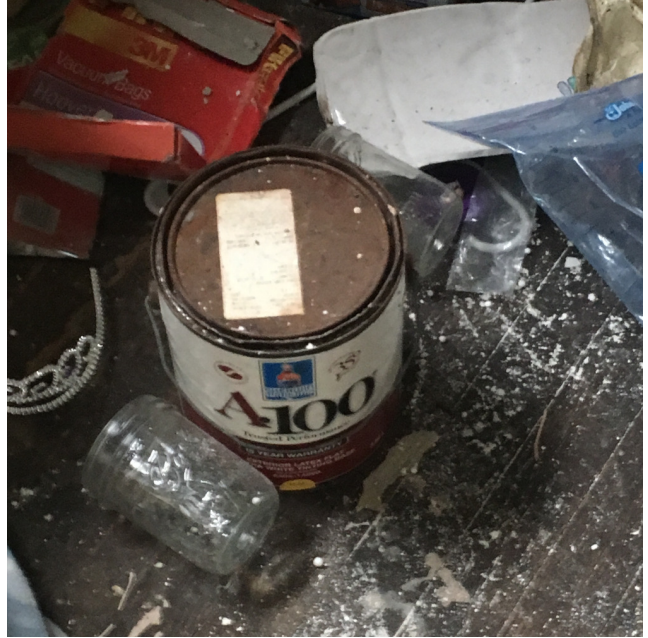
Paint Cans

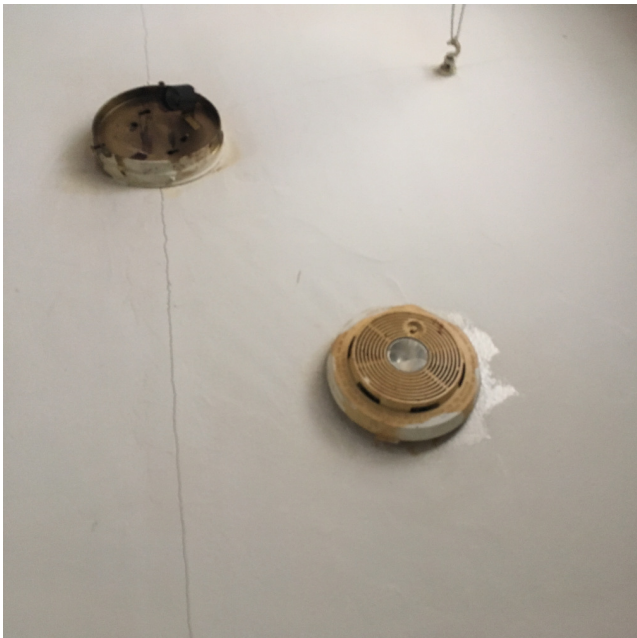
Smoke Detectors

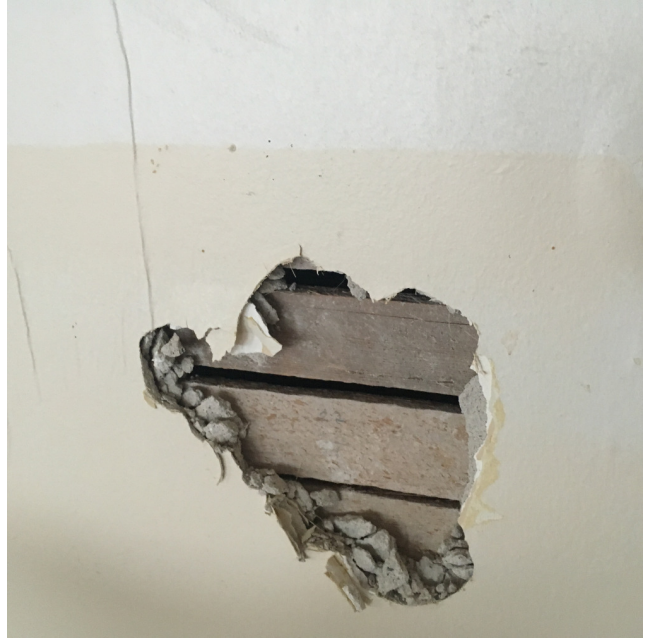
Plaster, grey

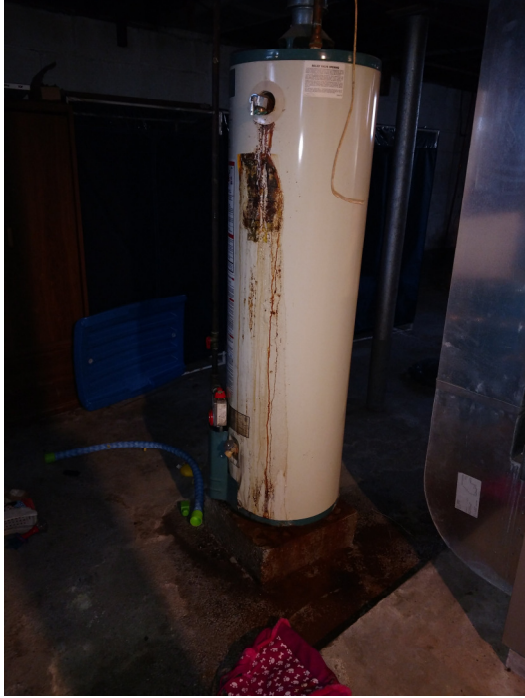
Hot Water Tank

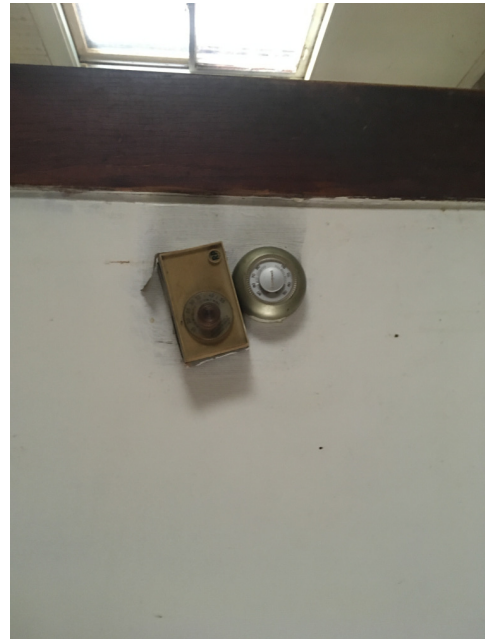
Thermostats

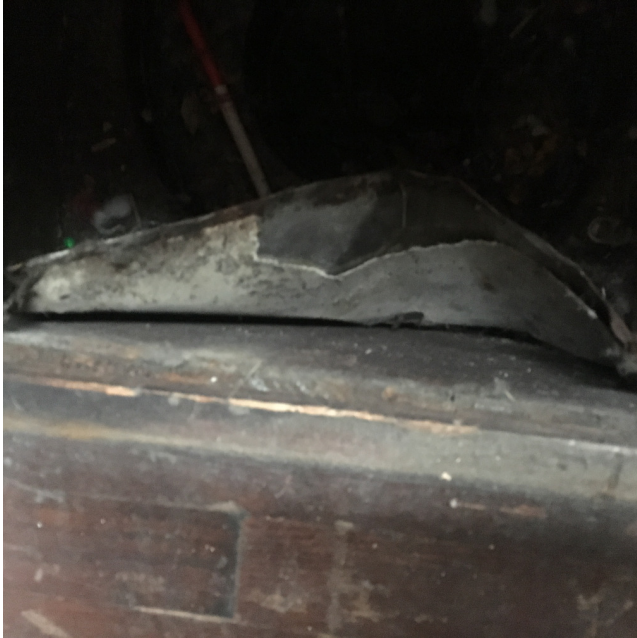
Duct Wrap

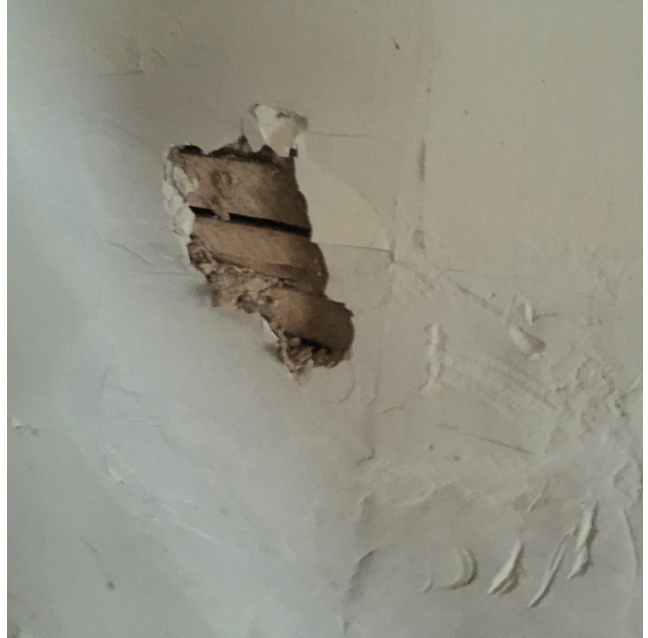
Plaster

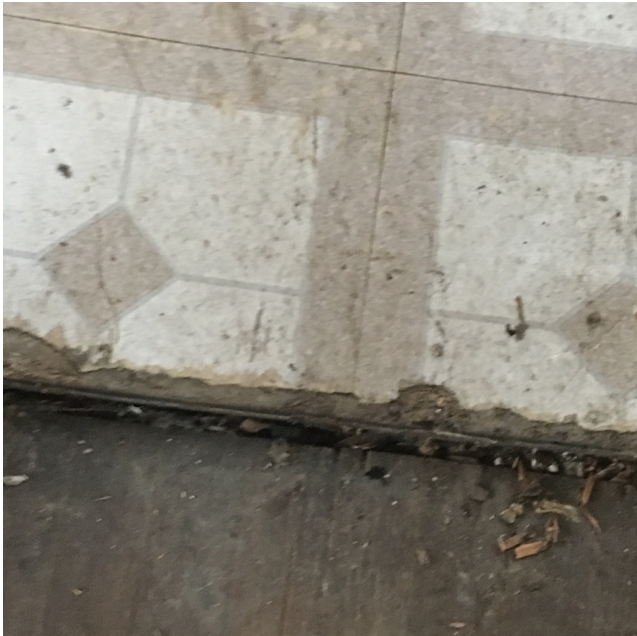
Linoleum, white; Mastic, brown

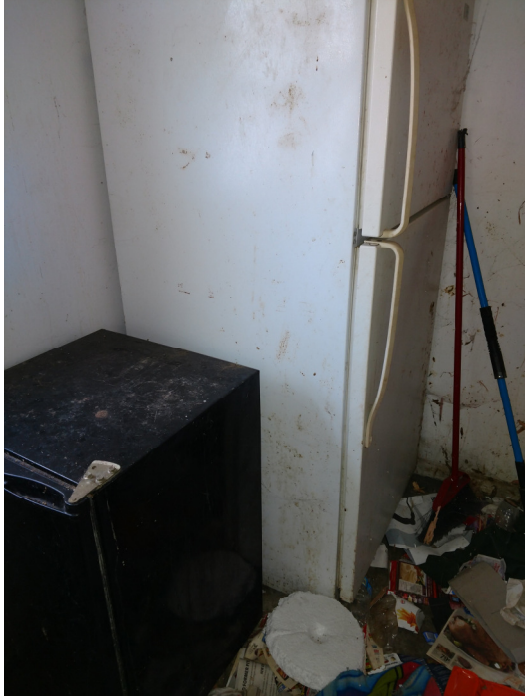
Refrigerator

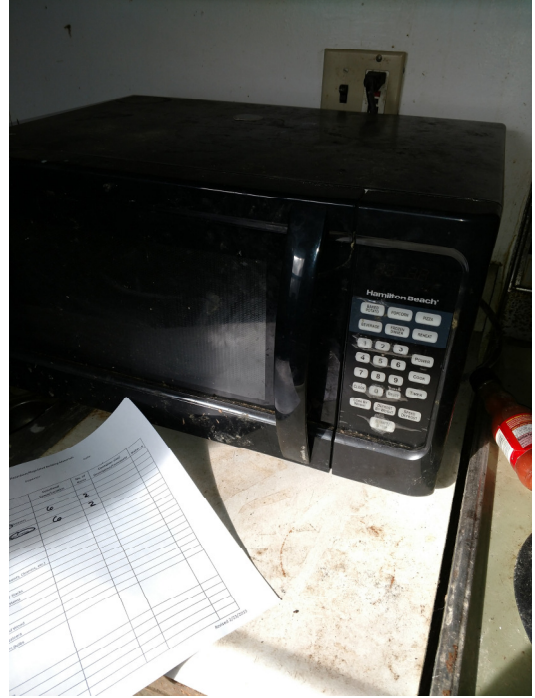
Electronics

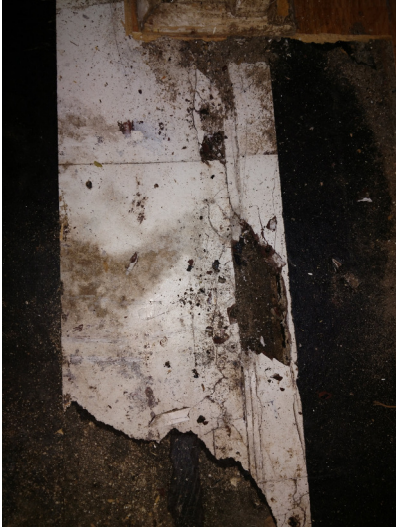
9x9 Floor tile, white

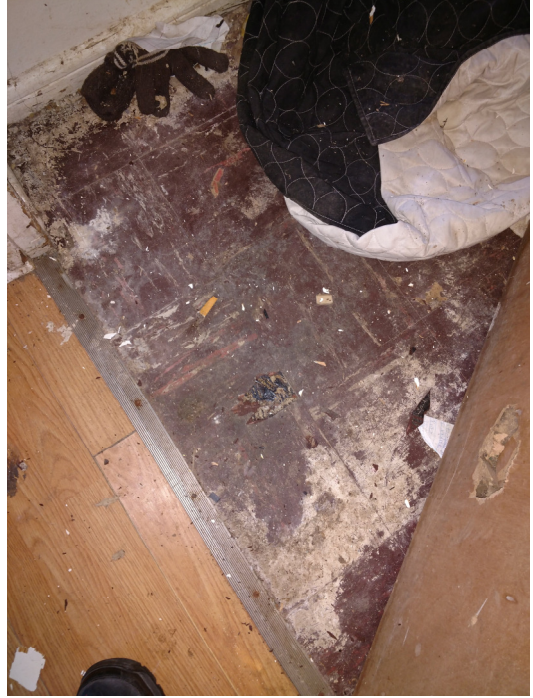
9x9 Floor tile, brown

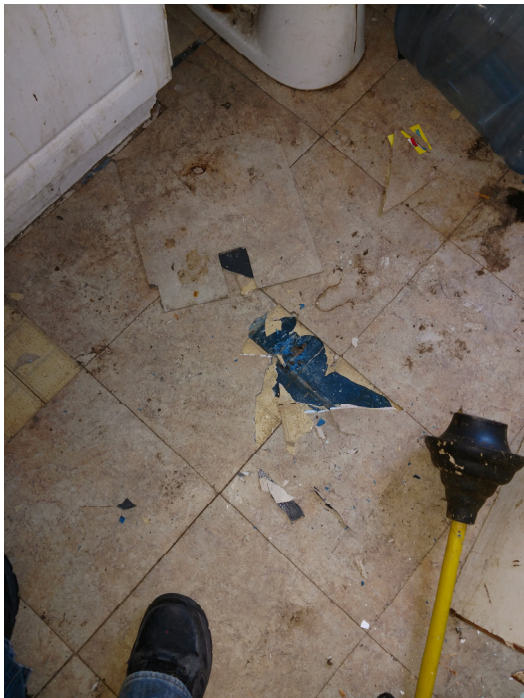
9x9 Floor tile, green

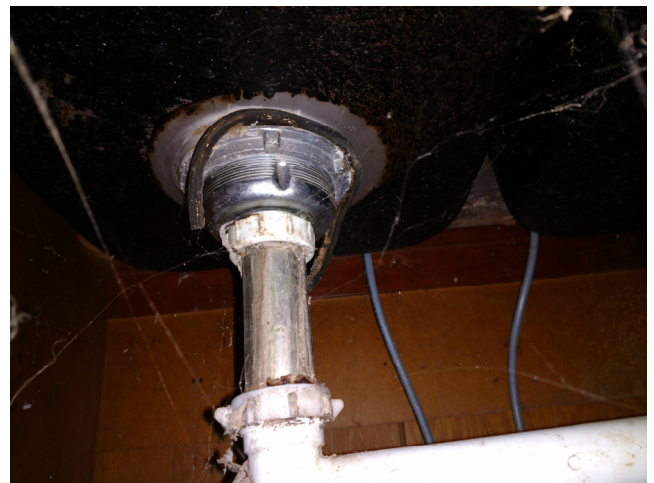
Sink undercoat

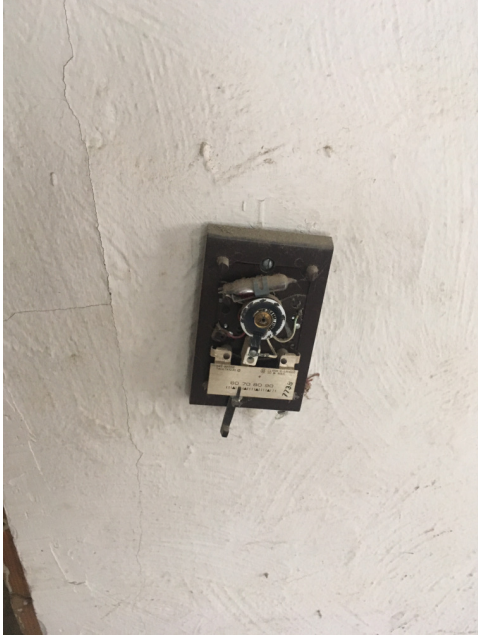
Thermostats

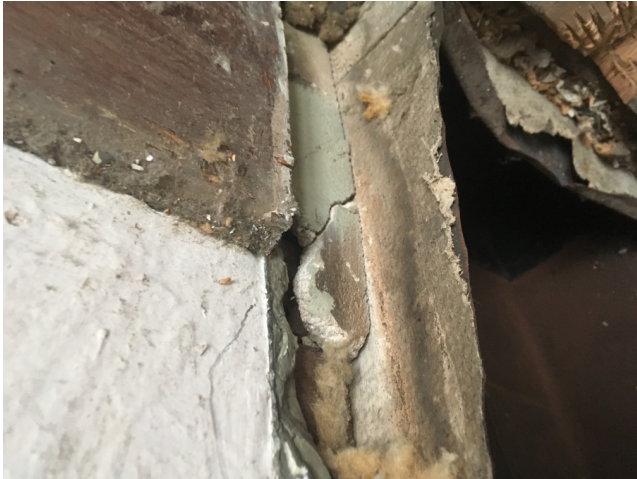
Duct Wrap

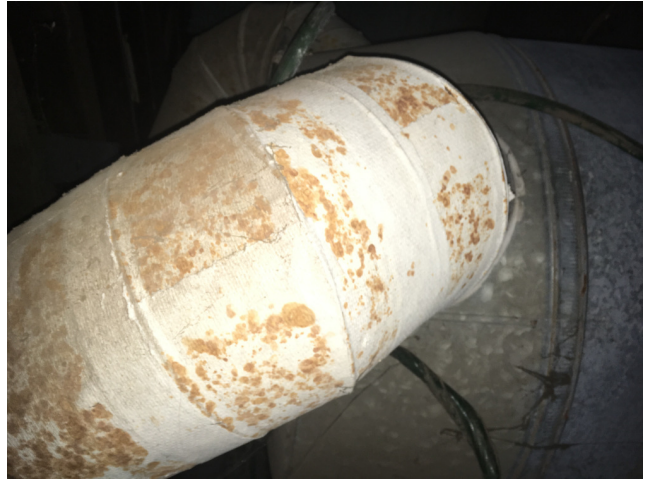
Elbow/Boot Wrap

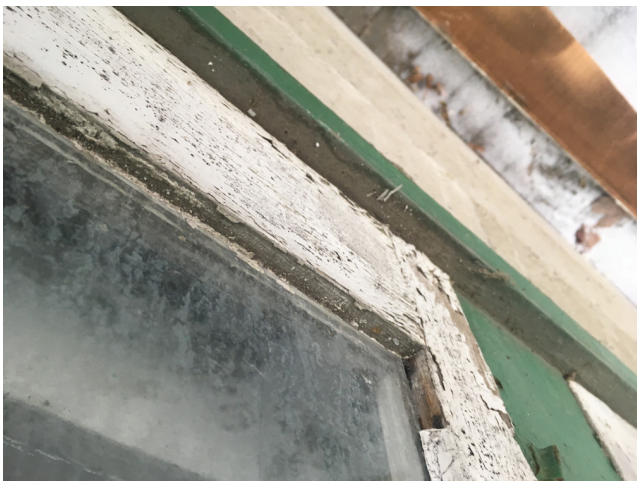
Window Glaze
