PRE-DEMOLITION ENVIRONMENTAL INSPECTION SUMMARY REPORT

Ingham County Land Bank
3024 Turner Street
Lansing, MI 48906

Parcel:	33-01-01-22-205-041
House No:	1017 S Holmes St, Lansing, MI 48912
Date Inspected:	12/18/2017
Inspected By:	Heather Davis
Inspectors State Card #	A-48908

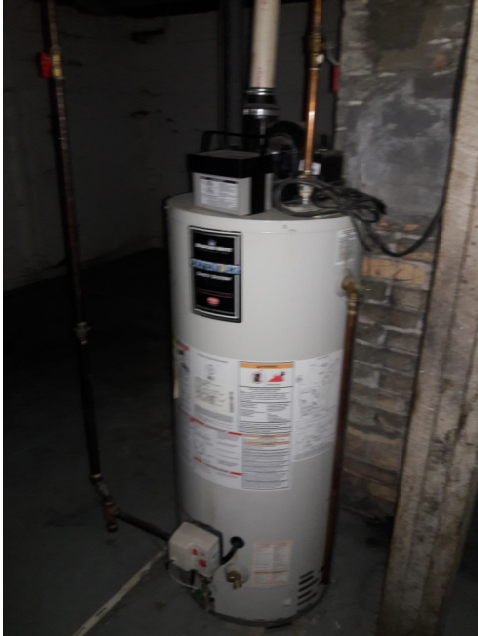
Material Description	Quantity & Units	Location
Hot Water Tank	1	Room 9
Battery	1	Room 9
Thermostats	1	Room 1

Hot Water Tank

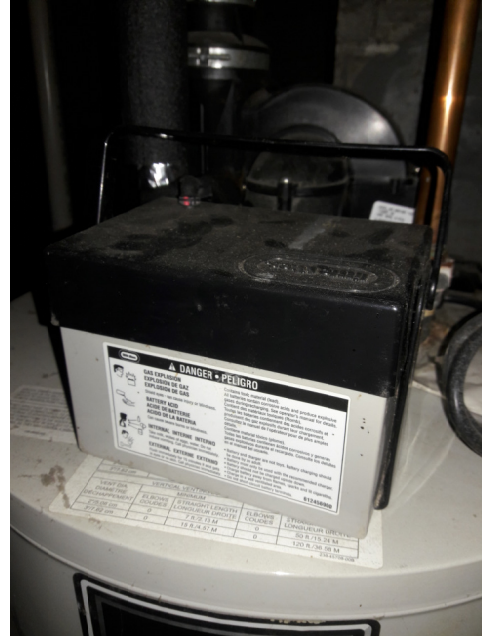
Battery

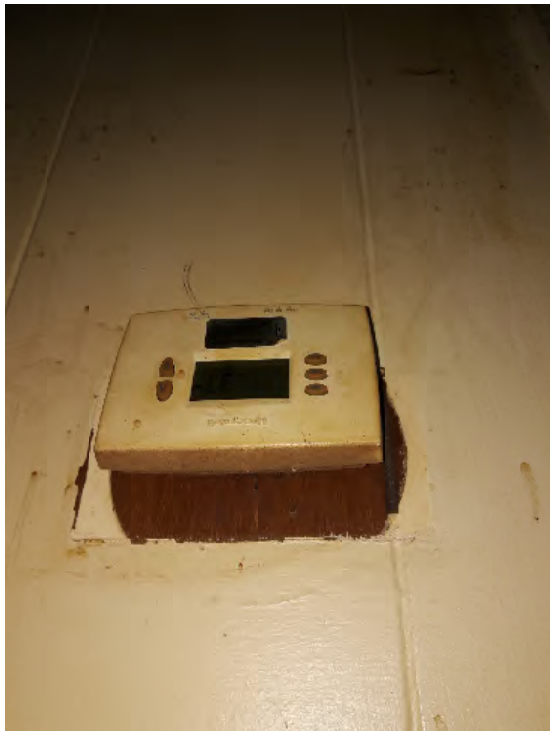
Thermostats

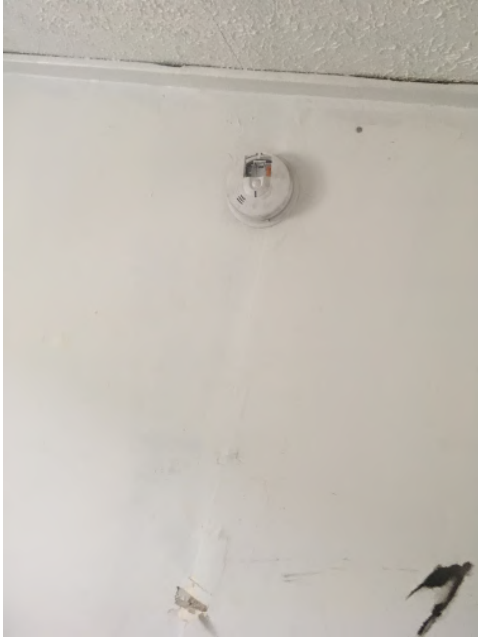
Smoke Detectors

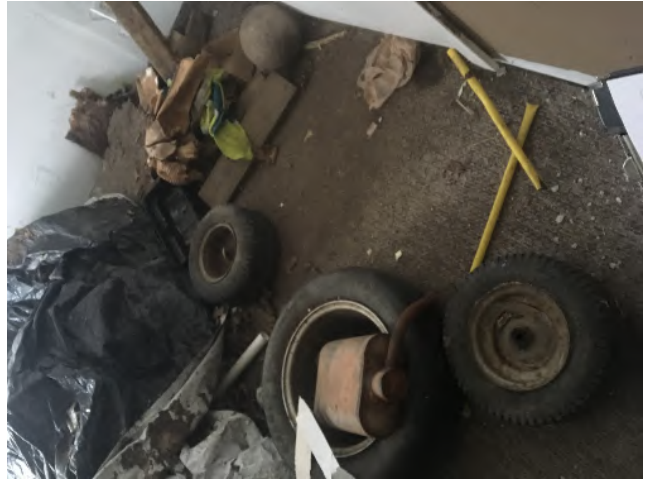
Tires

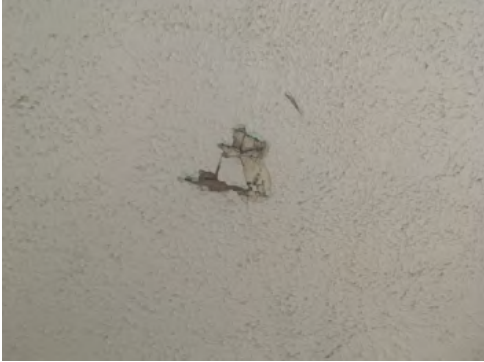
Wall Skim

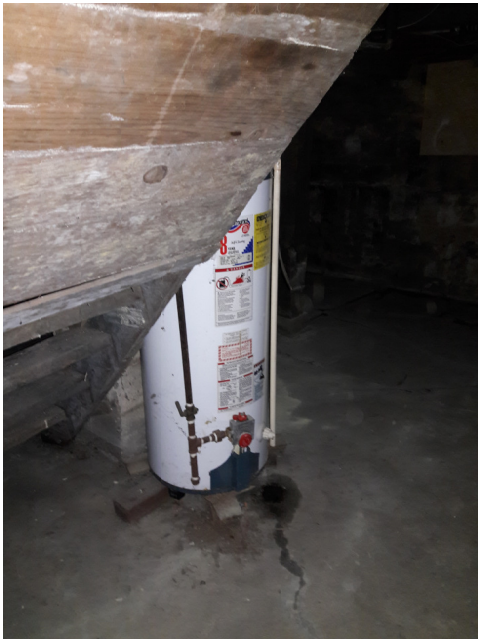
Hot Water Tank

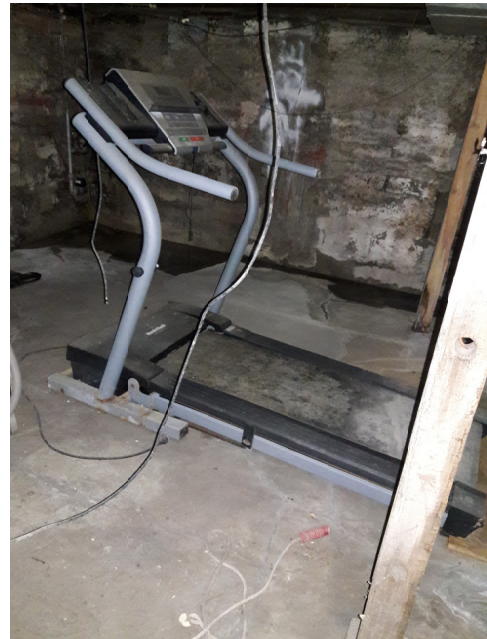
Electronics (treadmill)

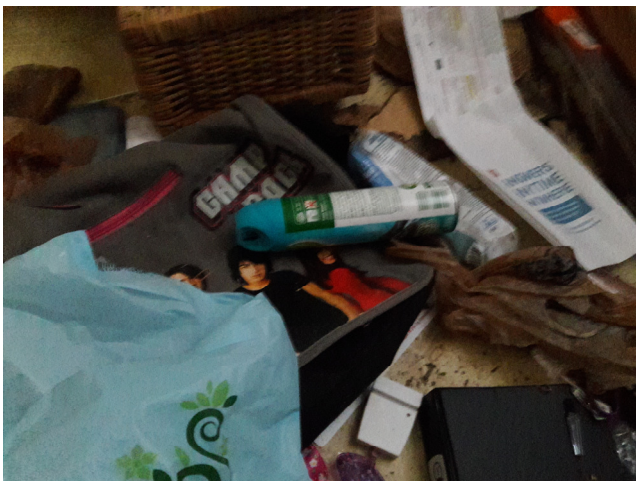
Misc. Items (solvents, cleaners)

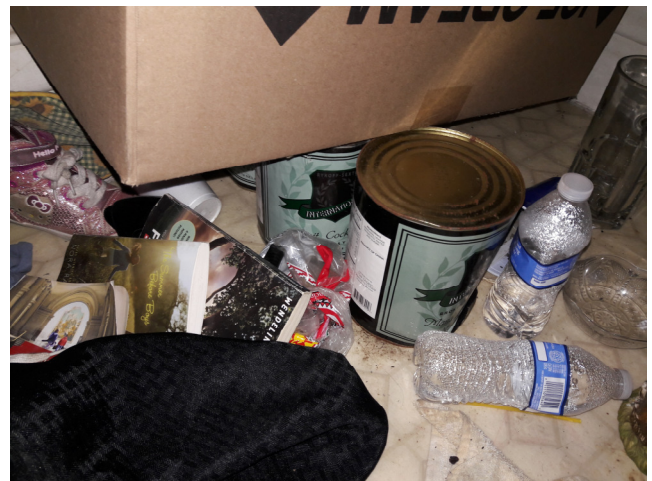
Paint Cans

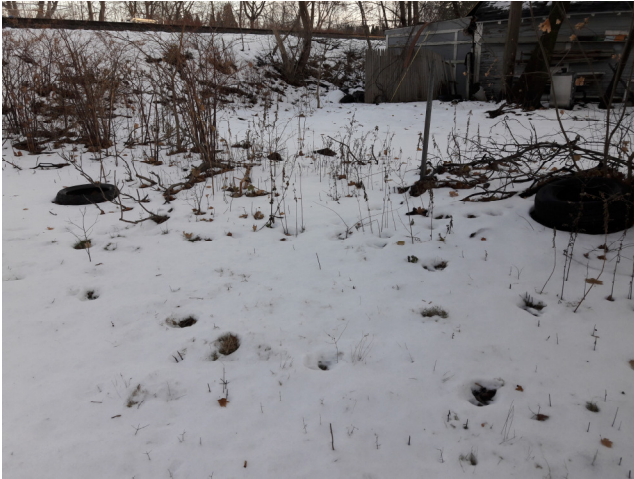
Tires

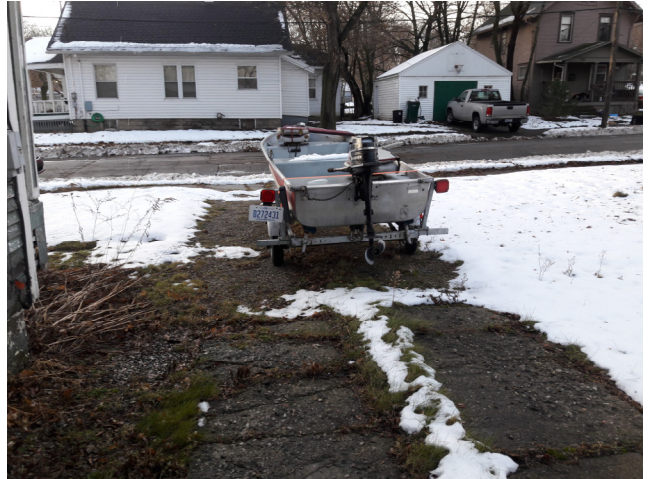
Boat

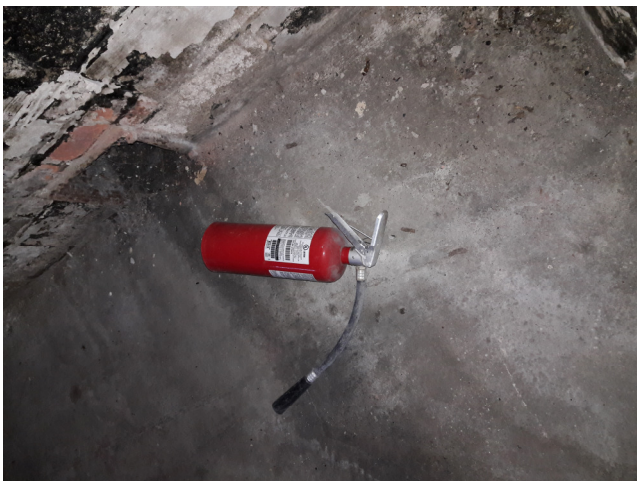
Fire Extinguishers

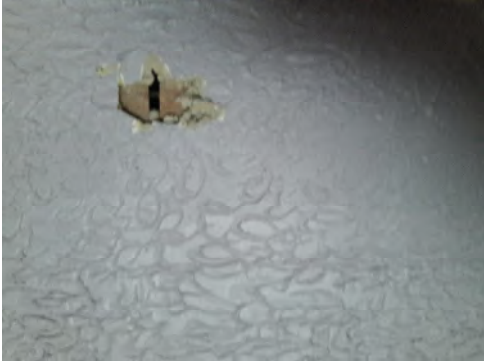
Texture, white

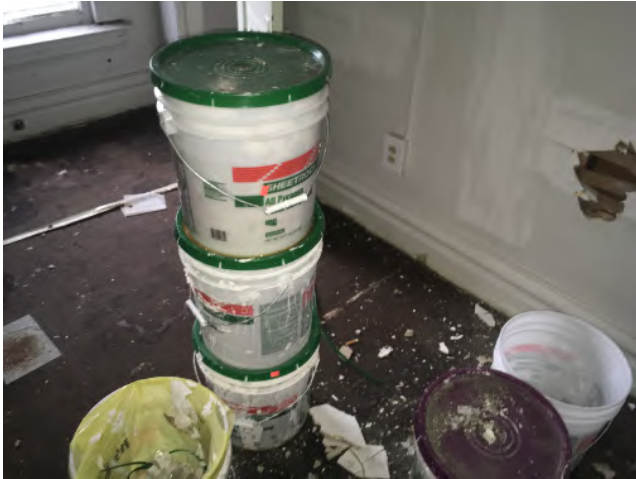
Misc. Items (joint compound)

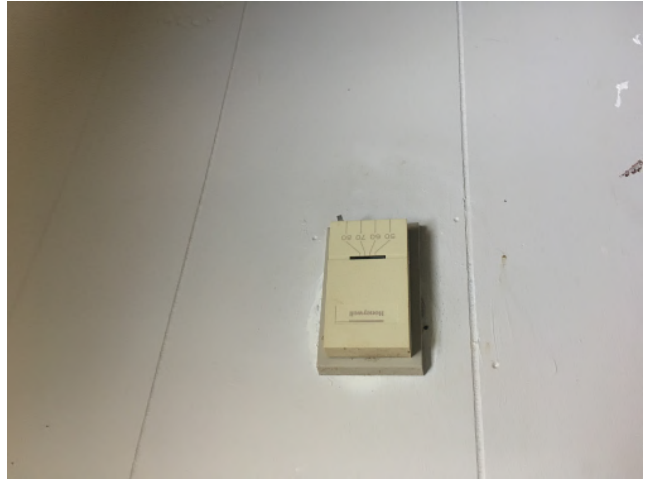
Thermostat

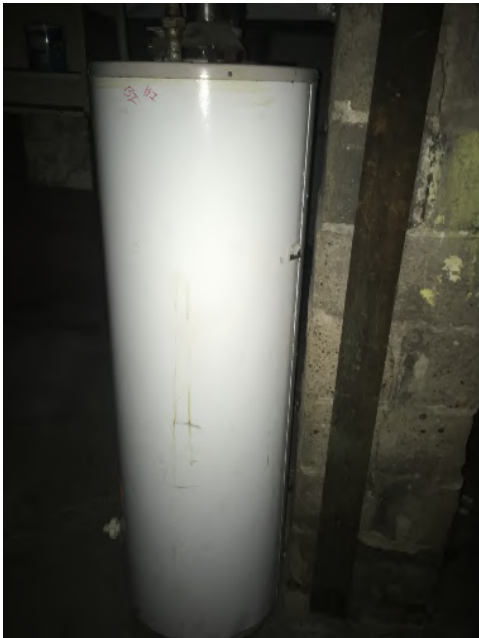
Water Heater

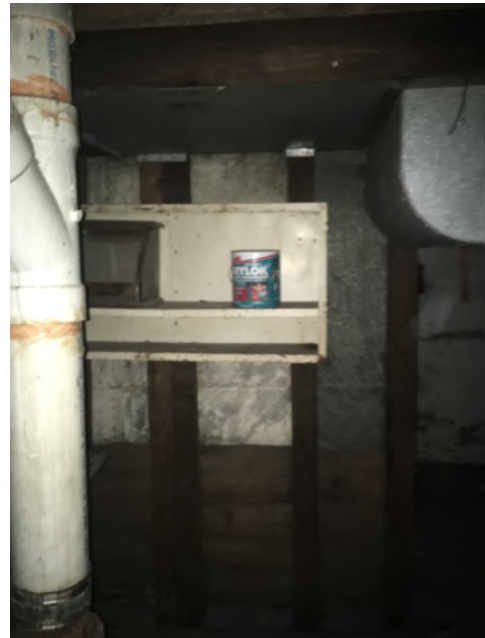
Paint Can

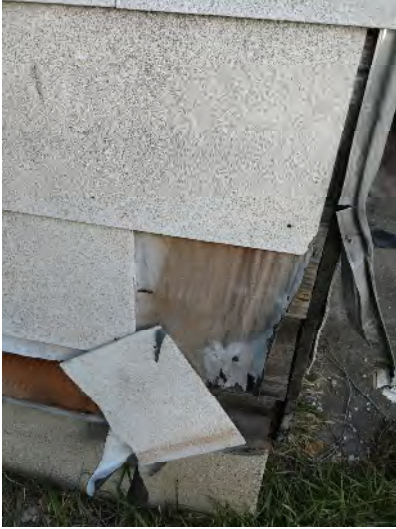
Transite, white/pink

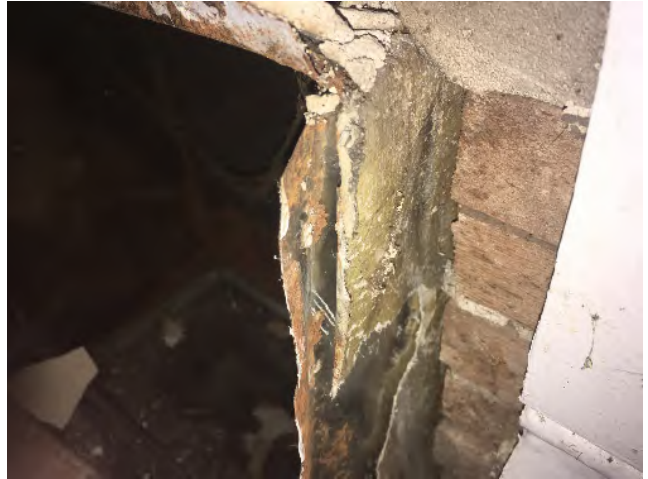
Duct wrap, grey

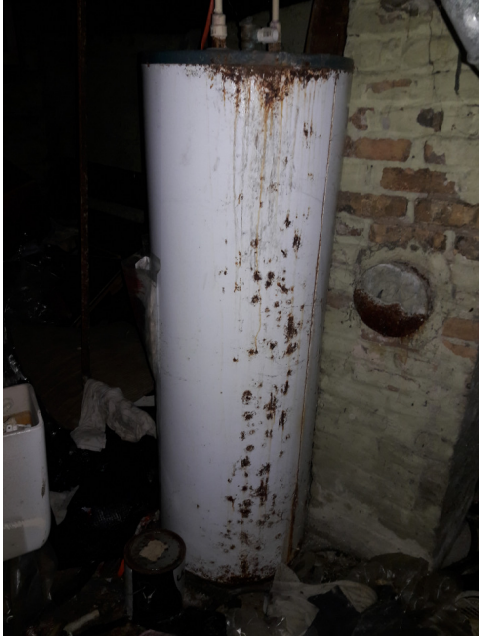
Hot Water Heater

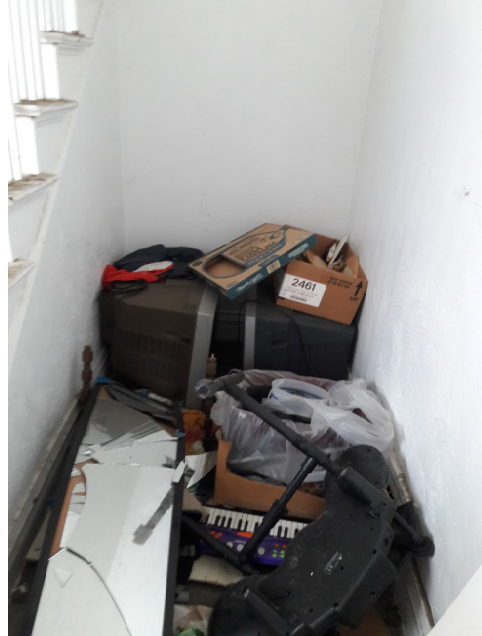
TV, Electronics

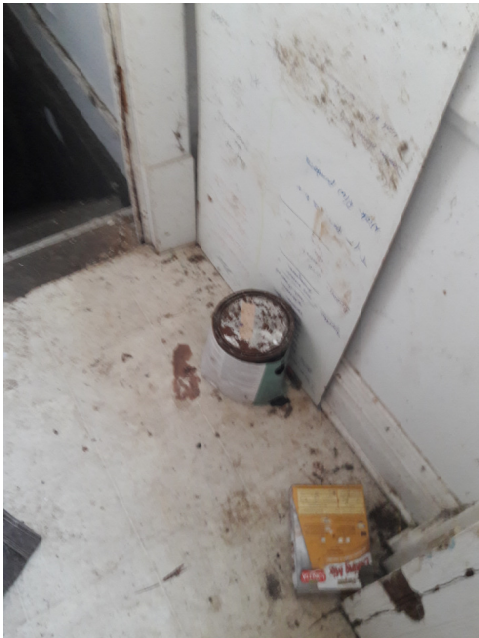
Paint Cans

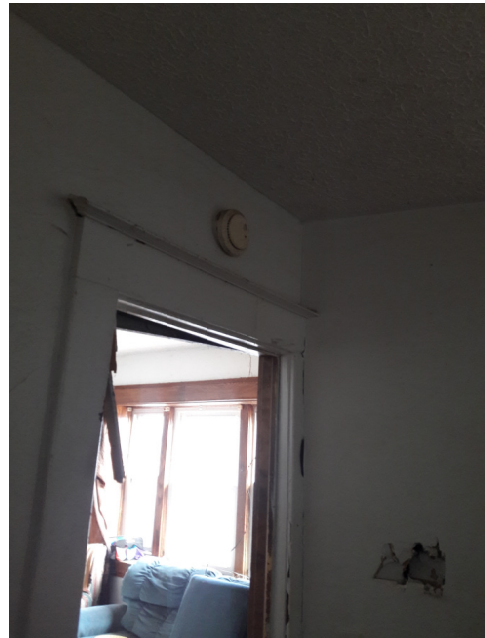
Smoke Detector

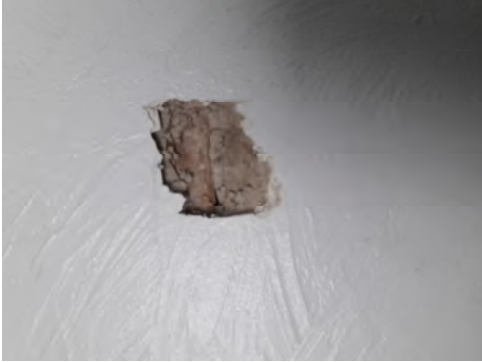
Plaster

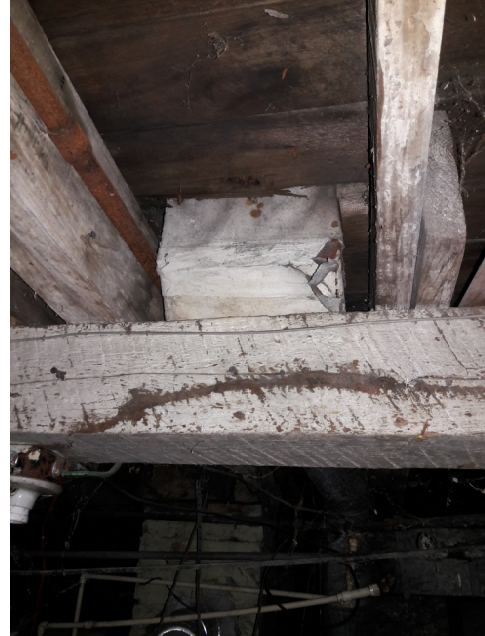
Duct Wrap

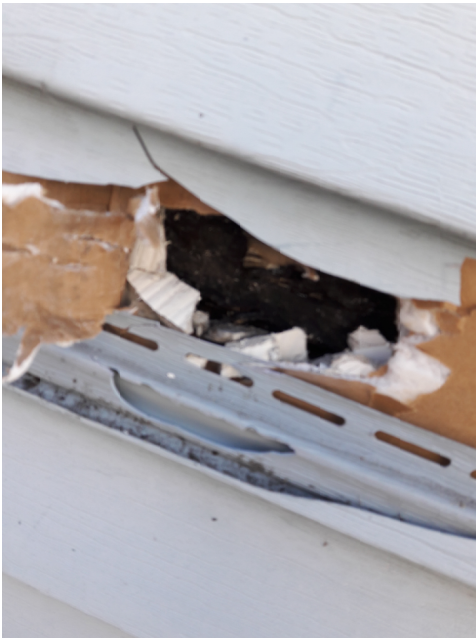
Transite
