# PRE-DEMOLITION ENVIRONMENTAL INSPECTION SUMMARY REPORT

Parcel:	33-01-01-21-428-045
House No:	1418 Bailey St, Lansing MI 48910
Date Inspected:	12/20/2017
Inspected By:	Wade Wiltse
Inspectors State Card #	A-51051

Parcel:	33-01-01-22-305-101
House No:	1441 Bailey St, Lansing, MI 48910
Date Inspected:	12/21/2017 & 2/27/2018
Inspected By:	Heather Davis
Inspectors State Card #	A-48908

Parcel:	33-01-01-22-351-061
House No:	1531 Bailey St, Lansing, MI 48910
Date Inspected:	1/2/2018
Inspected By:	Wade Wiltse
Inspectors State Card #	A-51051

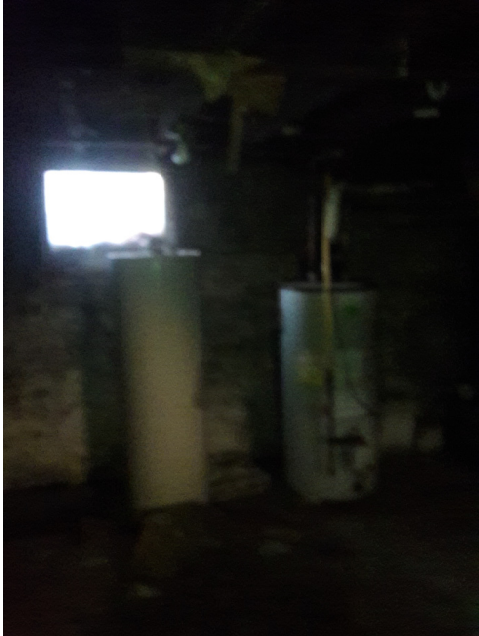
Hot Water Heater

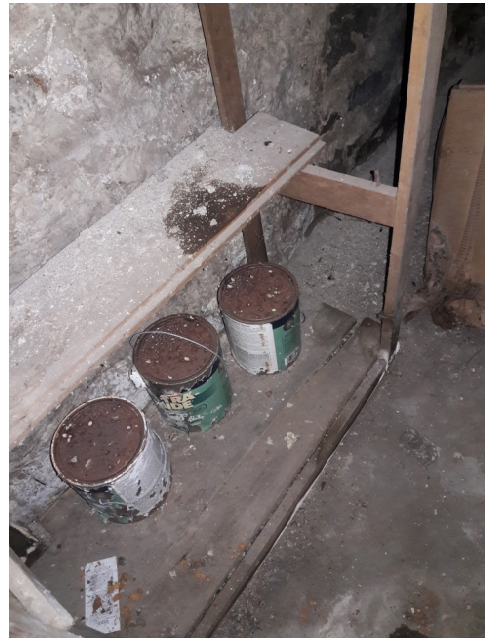
Paint Cans

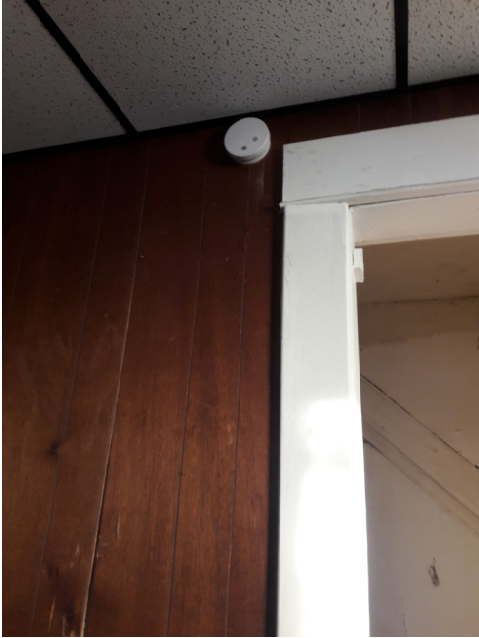
Smoke Detectors

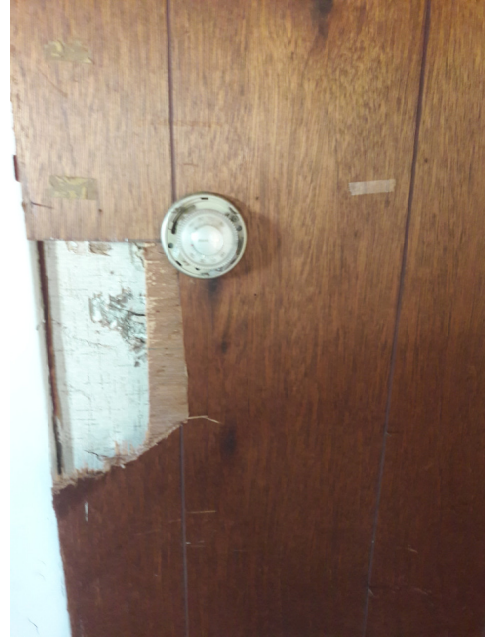
Thermostat

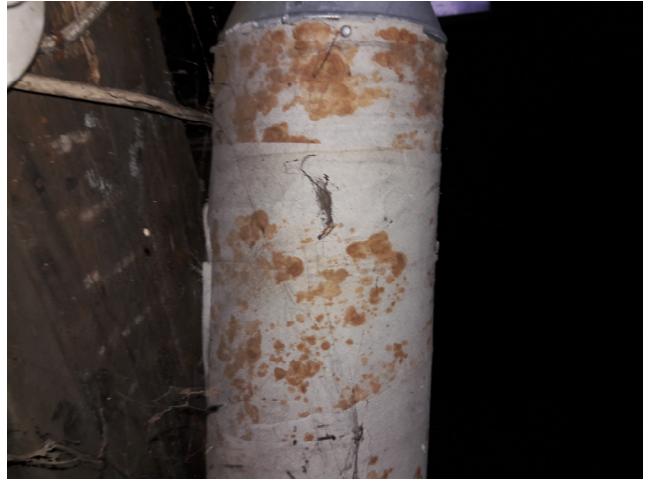
Duct Wrap

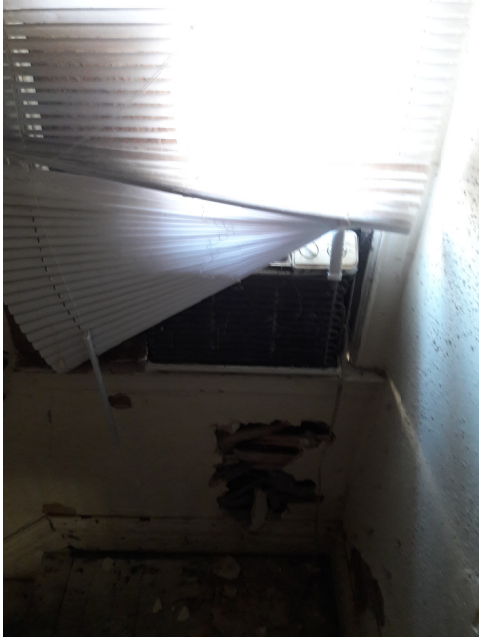
Air Conditioner

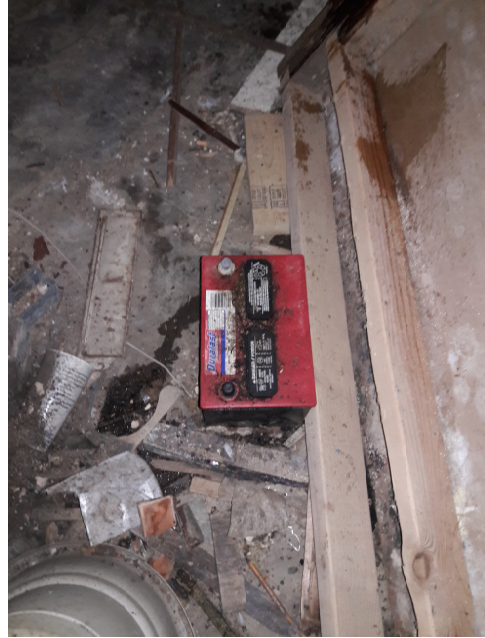
Car Battery

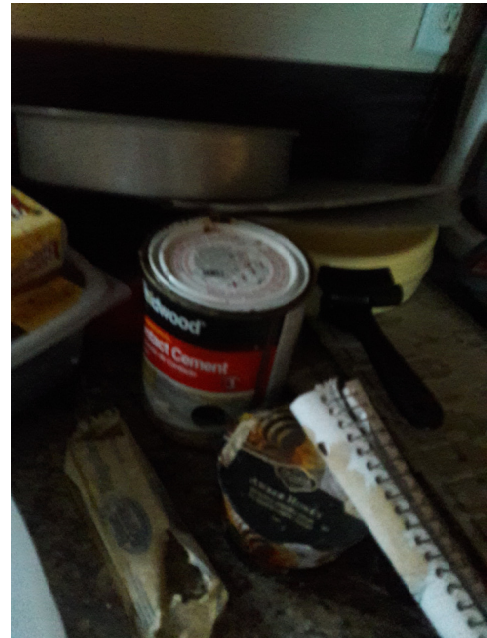
Misc. Items (solvent, cleaner)

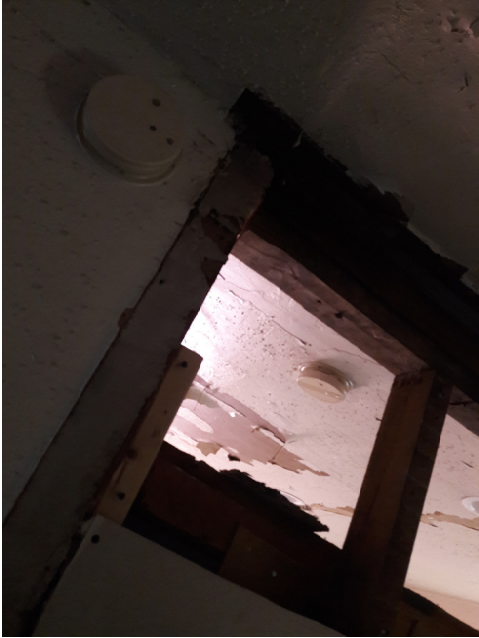
Smoke Detectors

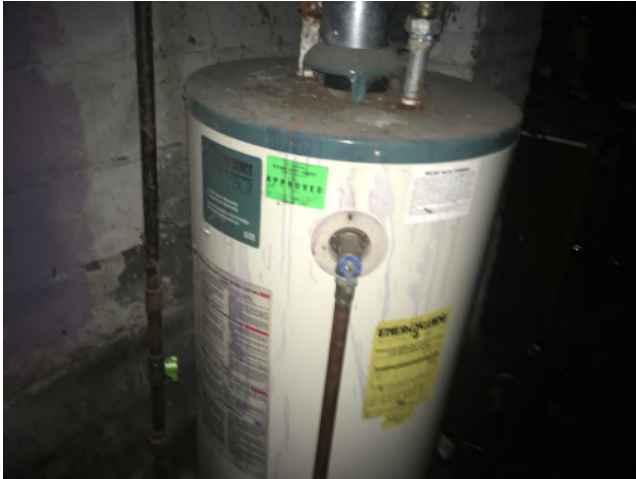
Hot Water Tank

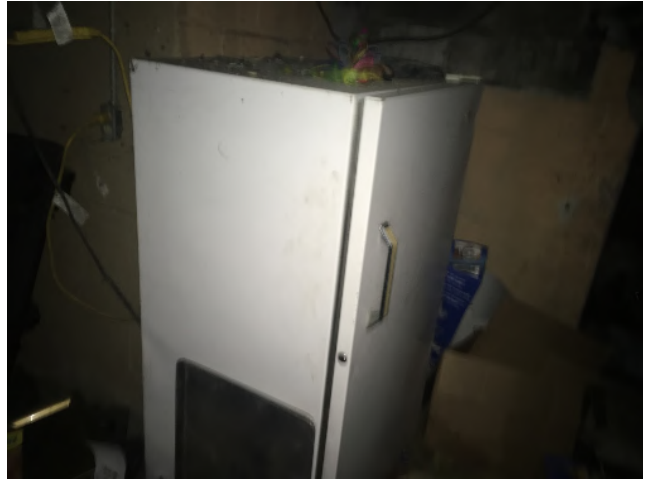
Air Conditioners/refrigerators

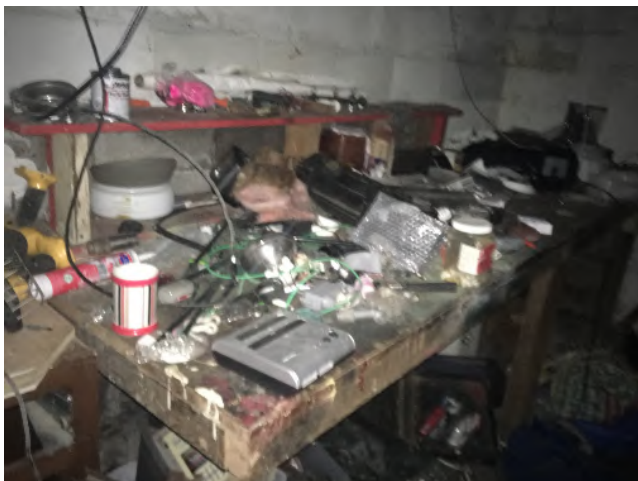
TV Screens/Monitors/Electronics

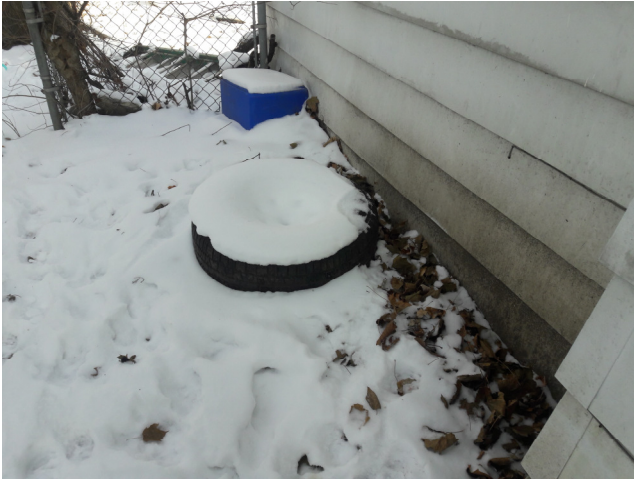
Tires

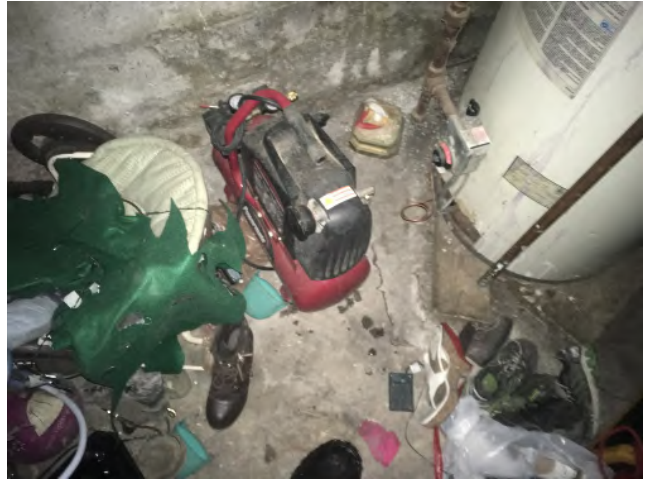
Air Compressor

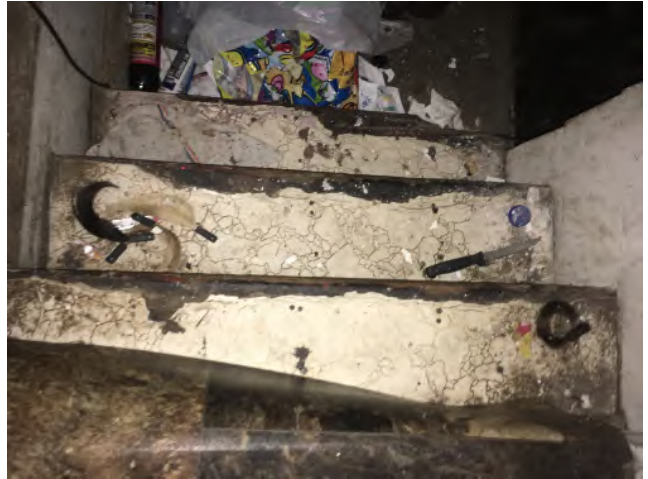
Linoleum, white/tan

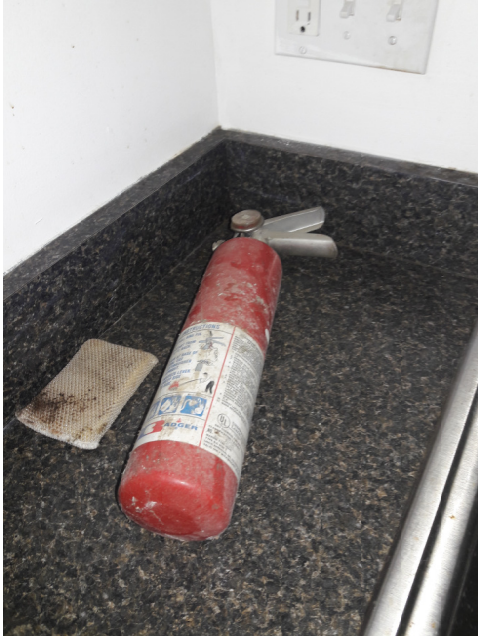
Fire Extinguishers

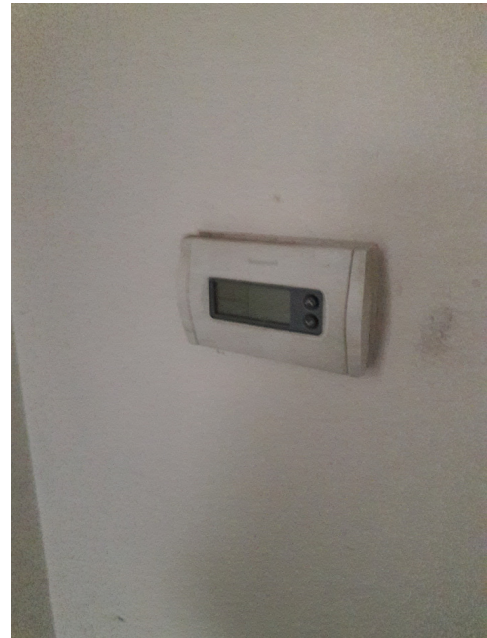
Thermostats

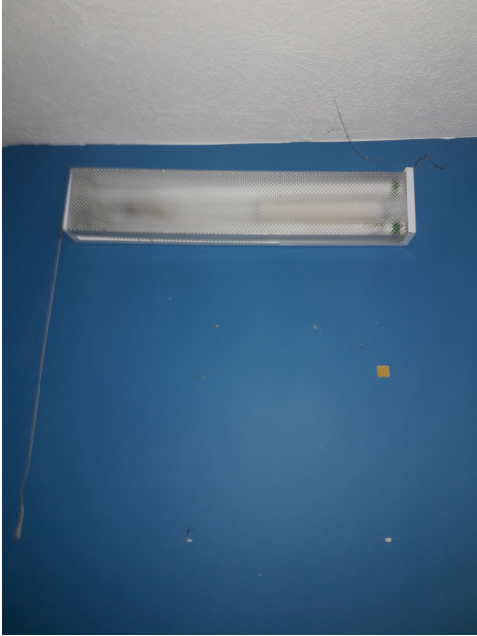
Florescent Light Bulbs

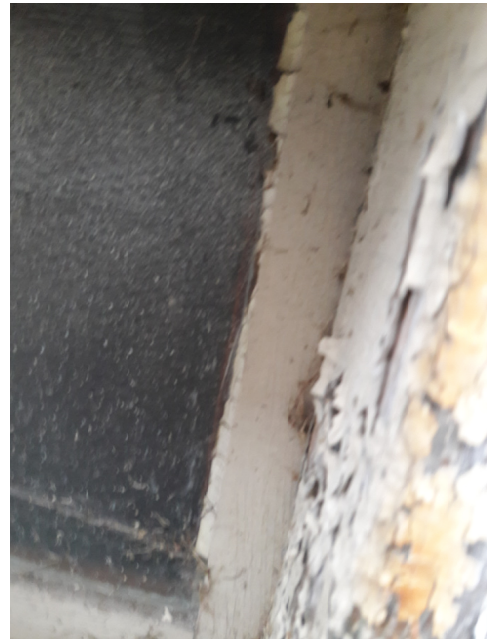
Window glaze, beige

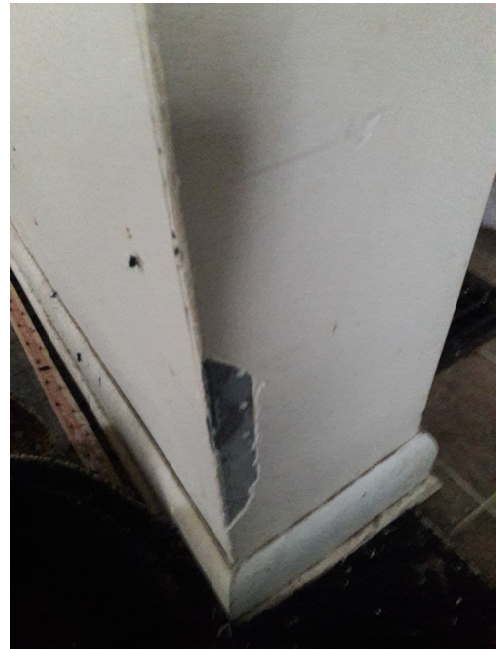
Mud, white

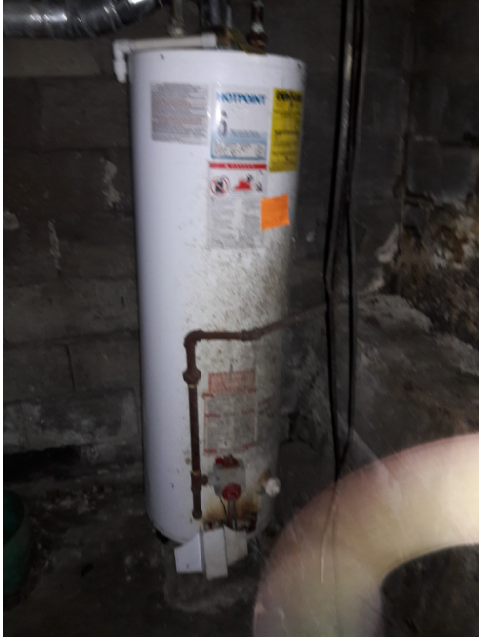
Hot Water Tank

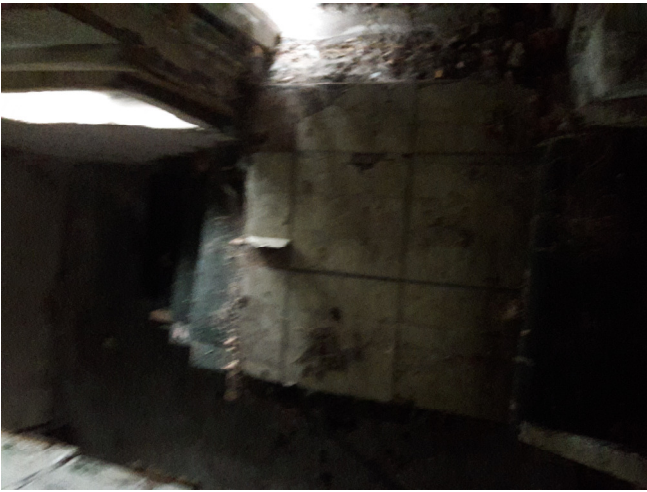
9x9 Floor tile, tan with stripes

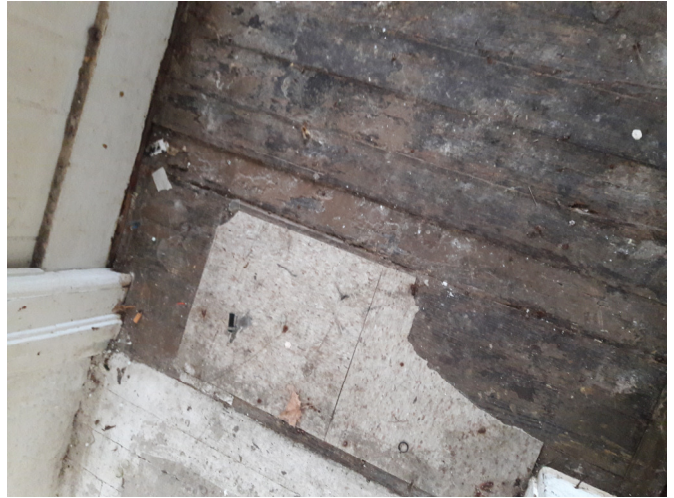
12x12 Peel and Stick, white with specs

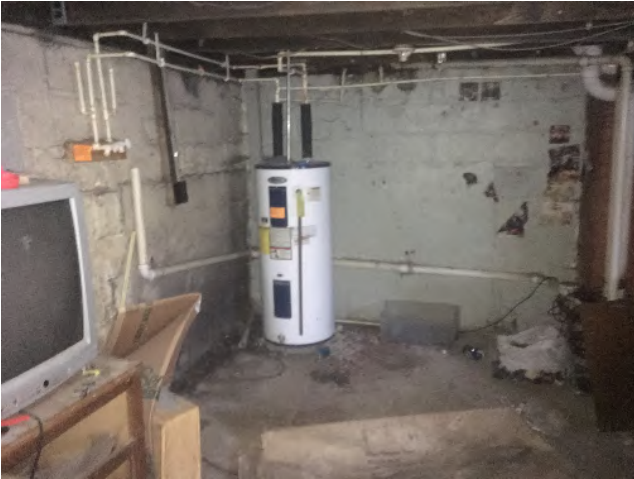
Hot Water Tank, TV Screen

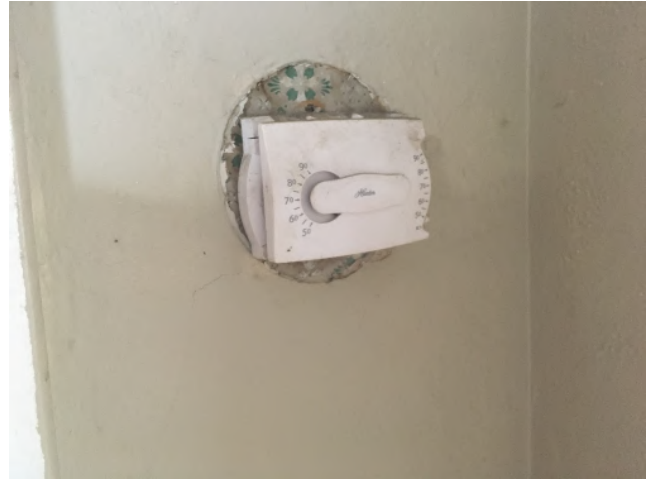
Thermostats

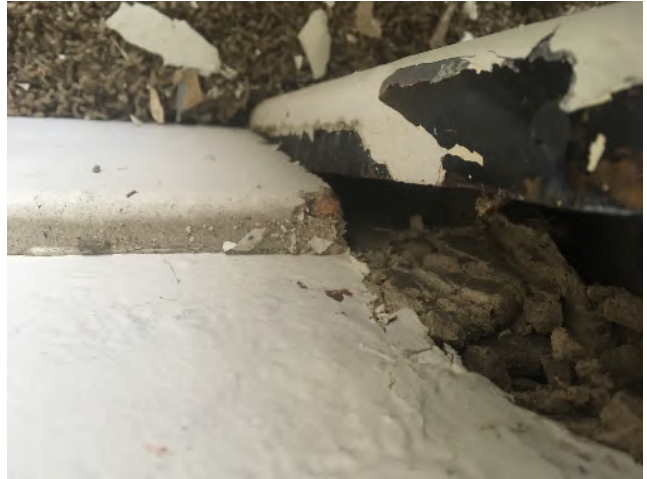
Duct wrap, grey
