PRE-DEMOLITION ENVIRONMENTAL INSPECTION SUMMARY REPORT

Ingham County Land Bank
3024 Turner Street
Lansing, MI 48906

Parcel:	33-01-01-21-253-020
House No:	1017 S Grand Ave, Lansing, MI 48910
Date Inspected:	12/22/2017
Inspected By:	Heather Davis
Inspectors State Card #	A-48908

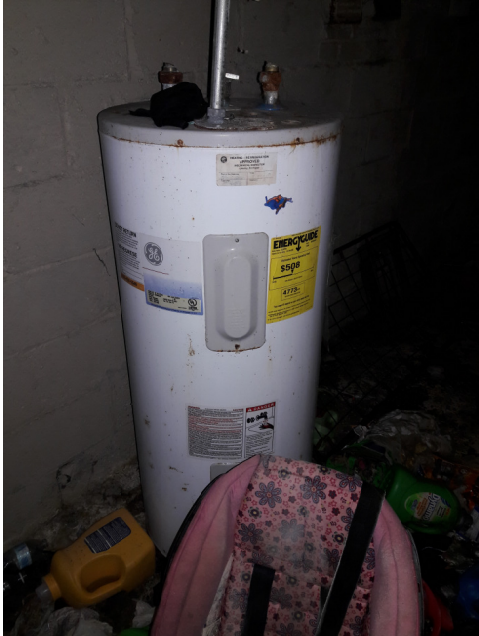
Hot Water Heater

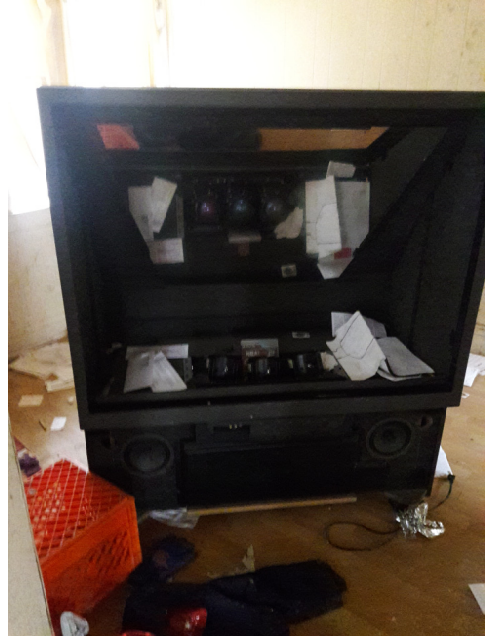
TV , Electronics

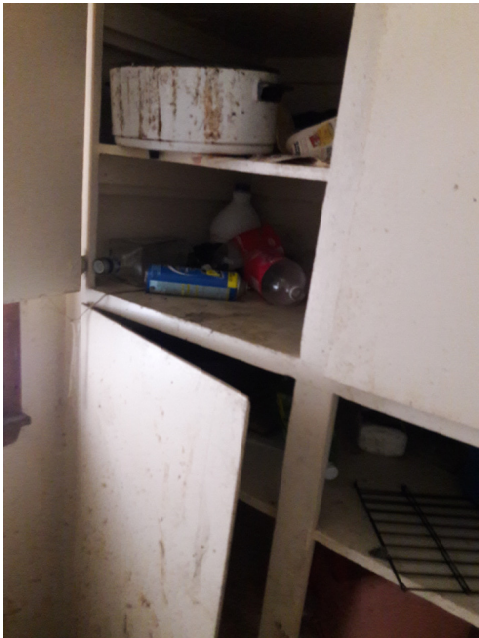
Misc. Items (solvents, cleaners)

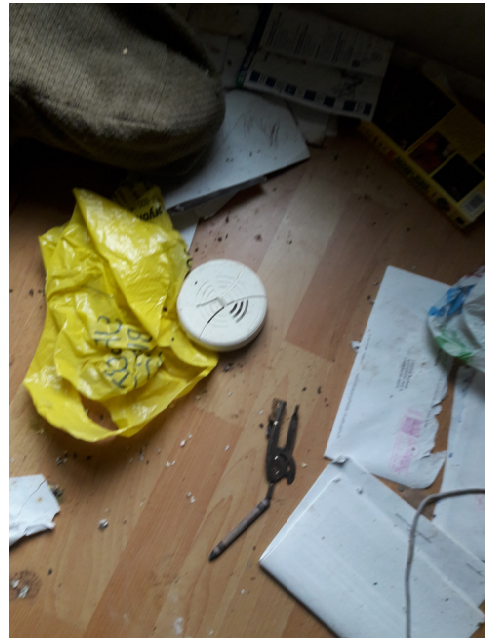
Smoke Detector

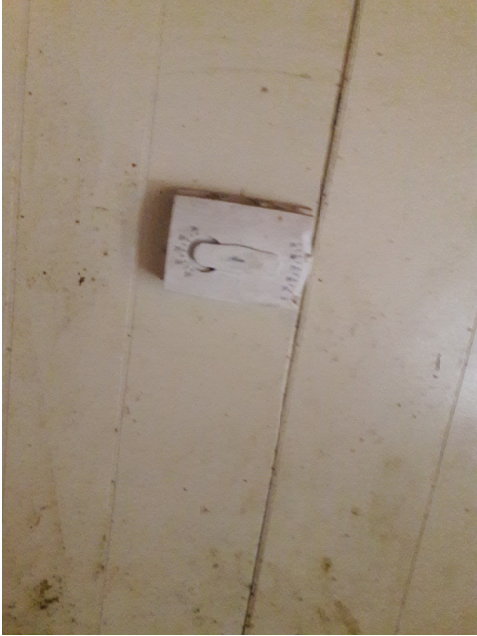
Thermostat

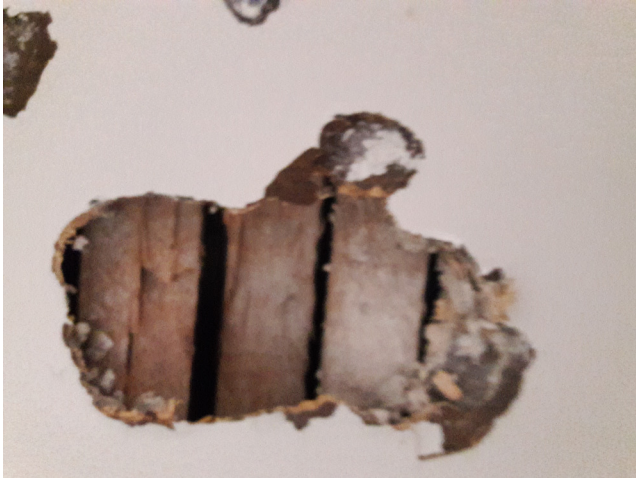
Plaster

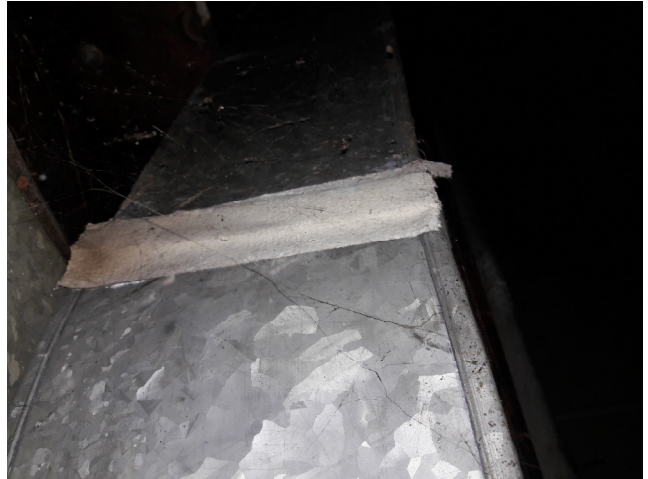
Duct Wrap

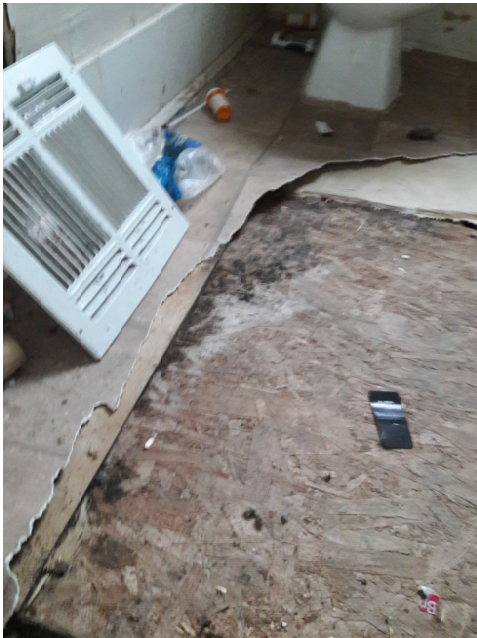
Floor Tile

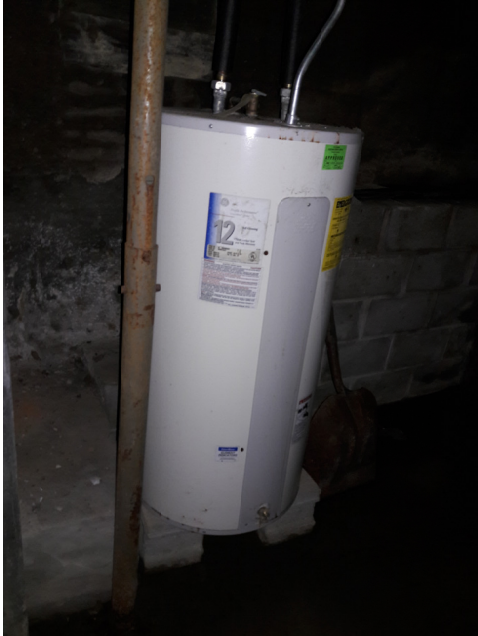
Hot Water Tank

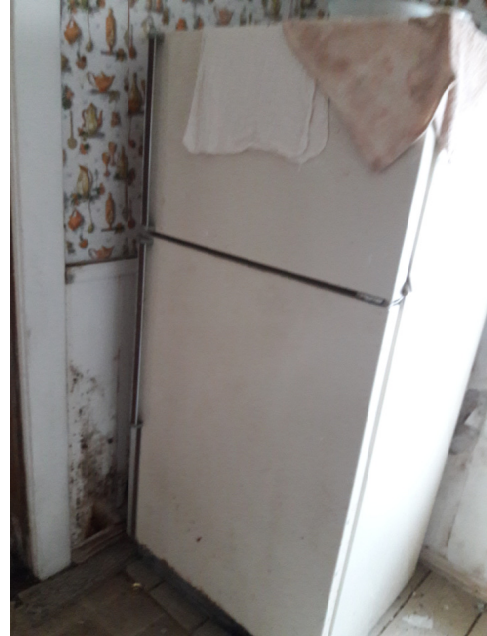
Refrigerators

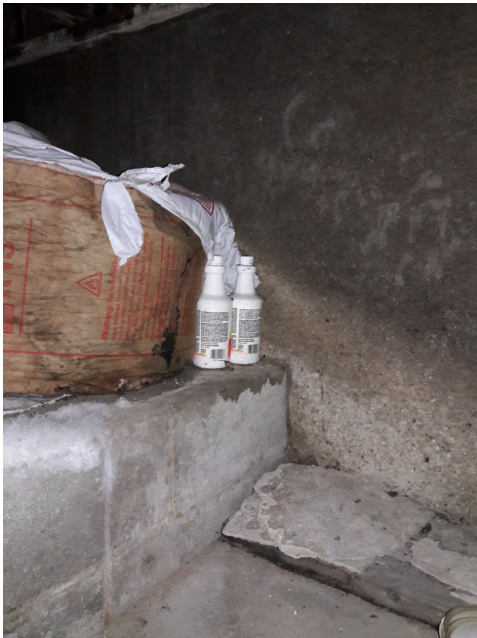
Misc. Items (solvents, cleaners)

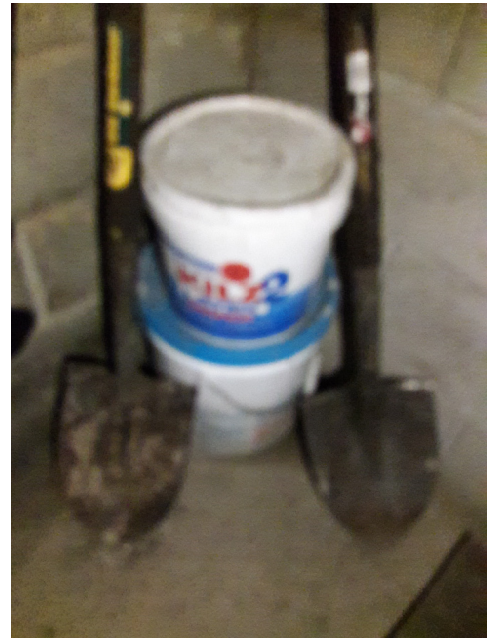
Paint Cans

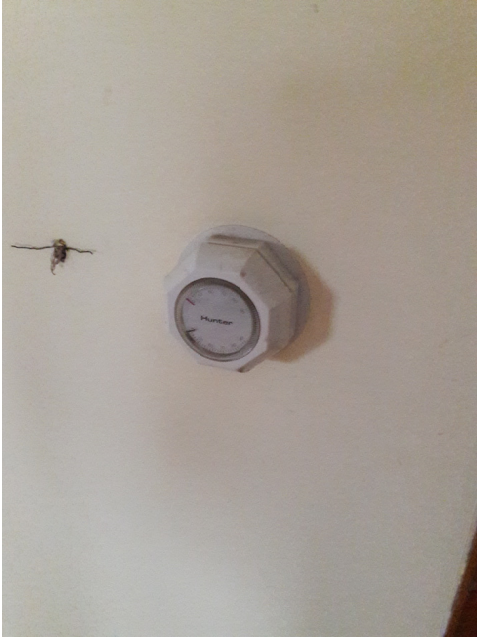
Thermostats

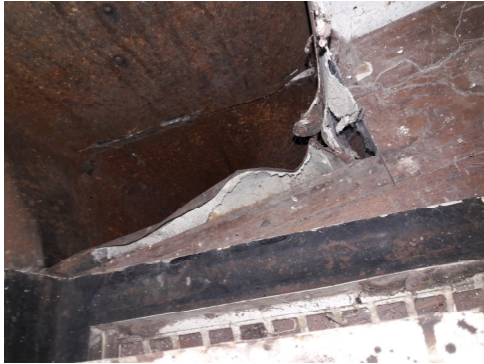
Duct wrap, grey

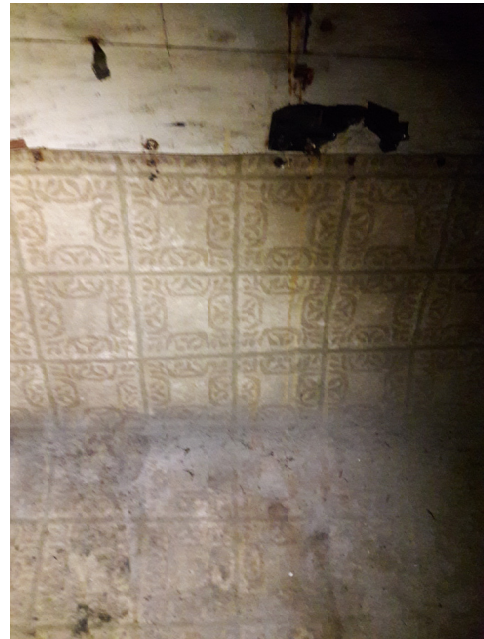
Wall linoleum, orange

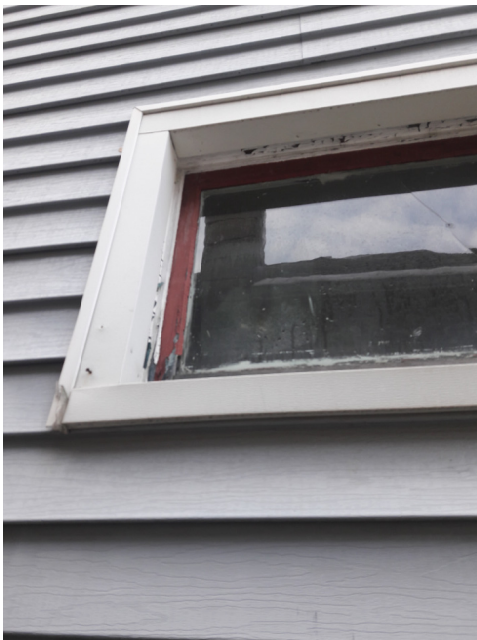
Window glaze, white

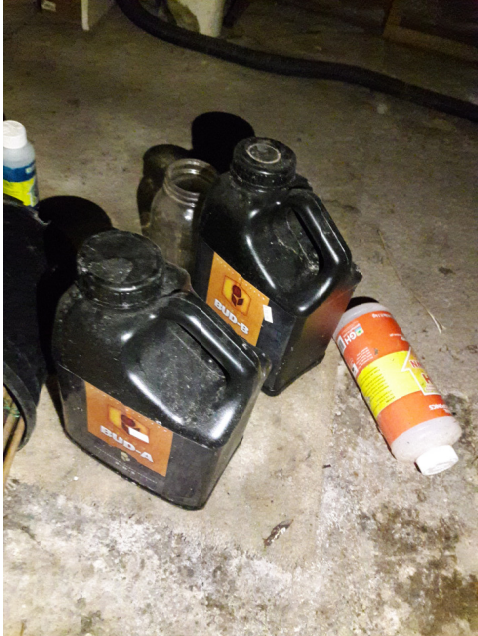
Misc. Items (solvents, cleaners)

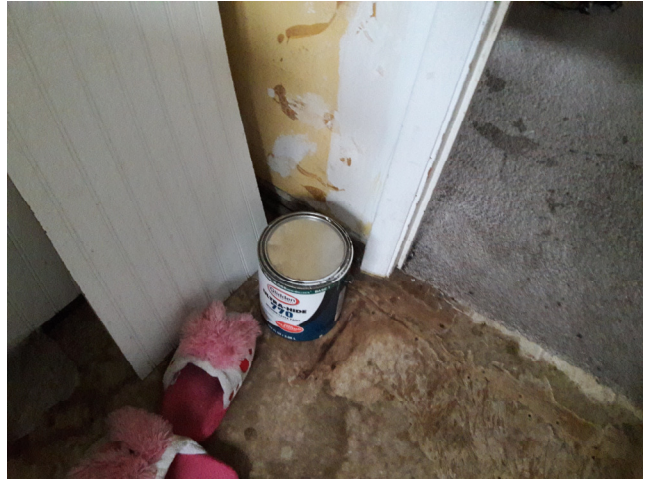
Paint Cans

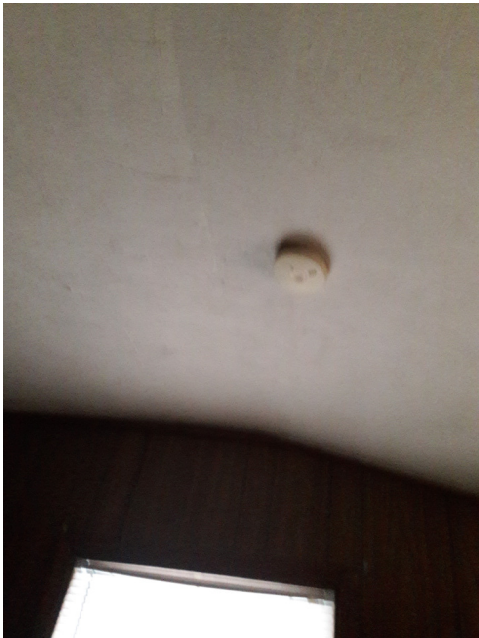
Smoke Detectors

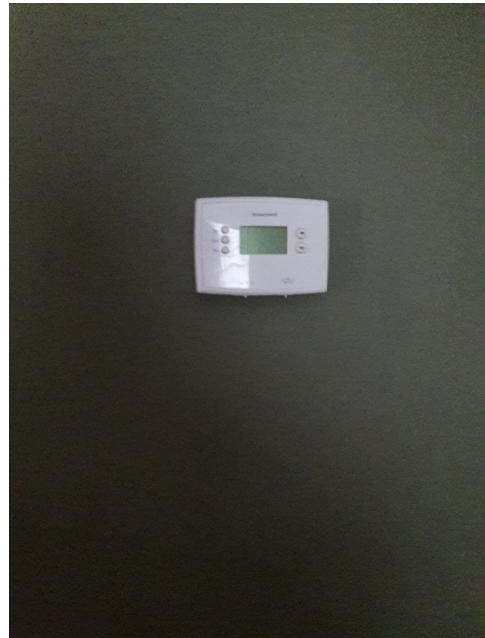
Thermostats

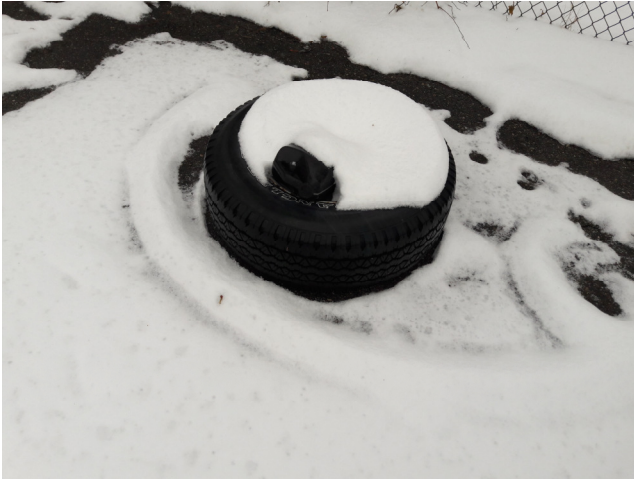
Tires

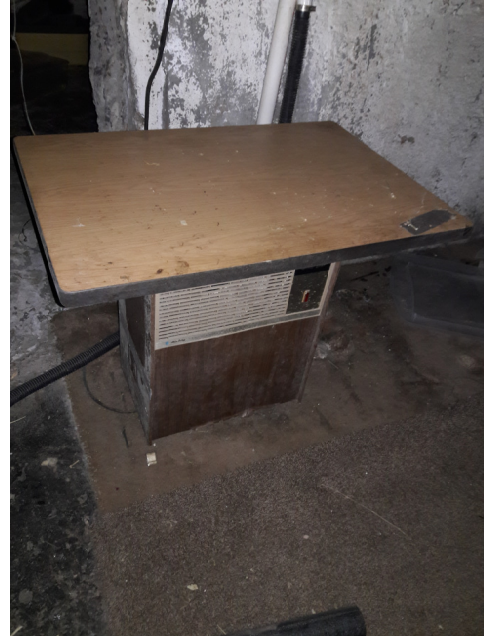
Space Heater

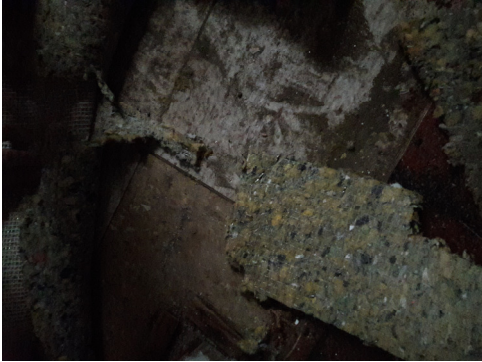
12x12 Tile, white

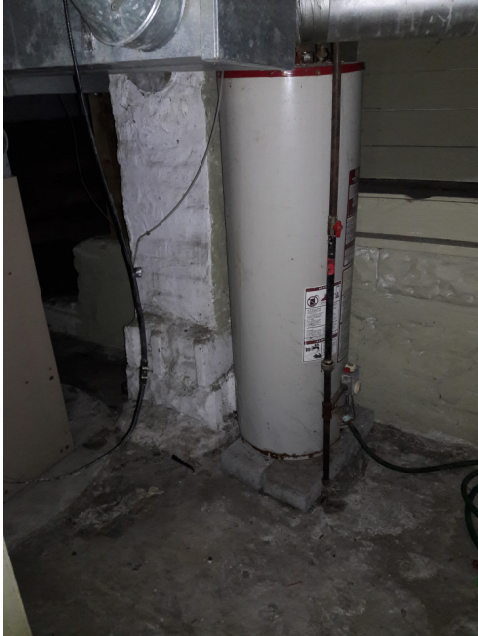
Hot Water Heater

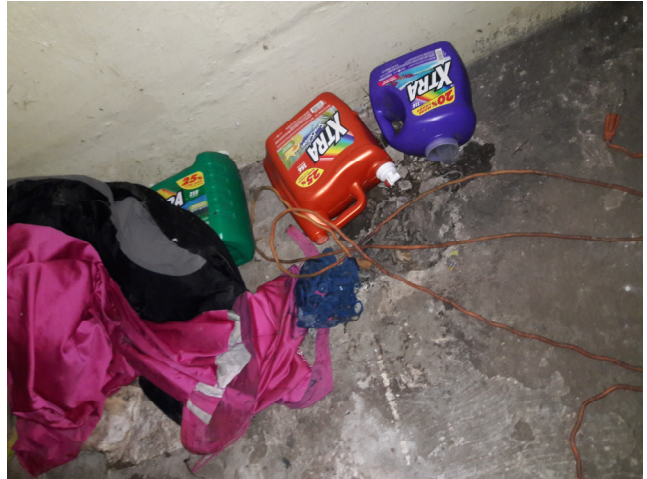
Misc. Items (solvents, cleaners)

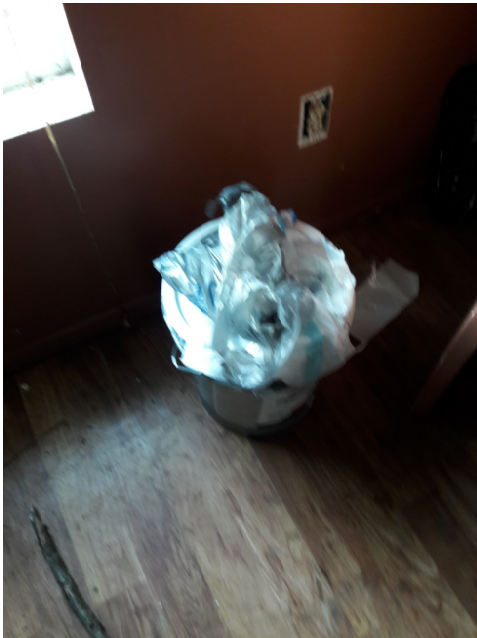
Paint Can

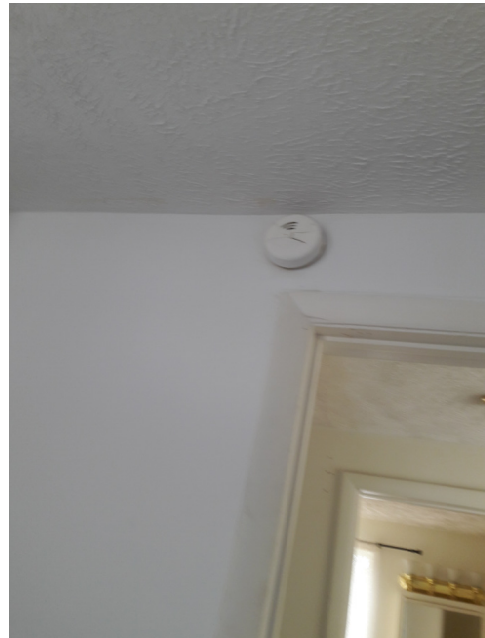
Smoke Detector

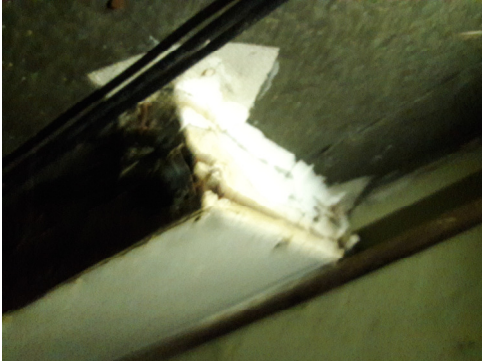
Duct Wrap

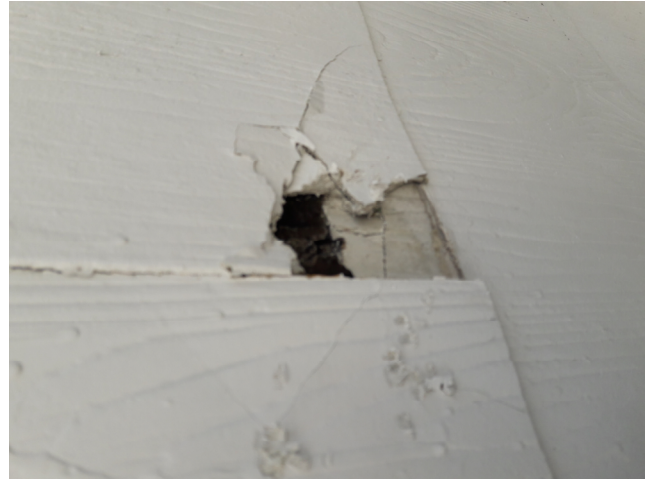
Transite
