RE: Letter of Finding for Dwellings Unfit to Enter (Asbestos/Hazardous Material Surveys)

Office of Building Safety
Unsafe Structures Notice

PRE-DEMOLITION ENVIRONMENTAL INSPECTION SUMMARY REPORT

Parcel:	33-01-01-14-380-171
House No:	630 S Francis Ave, Lansing, MI 48912
Date Inspected:	12/3/2017
Inspected By:	Jake Gleason
Inspectors State Card #	A-49991

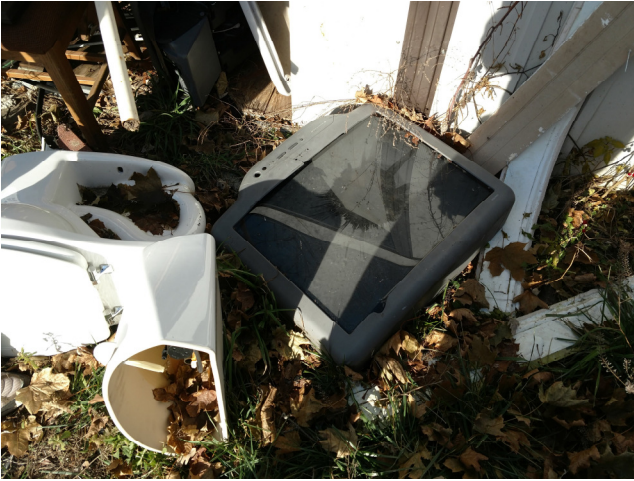
Material Description	Quantity & Units	Location
TV Screens, monitors	4	Shed

TV Screen, monitors

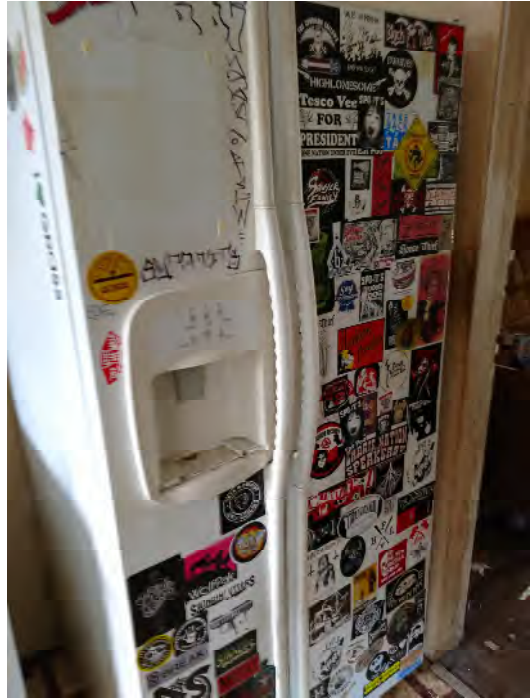
Refrigerator

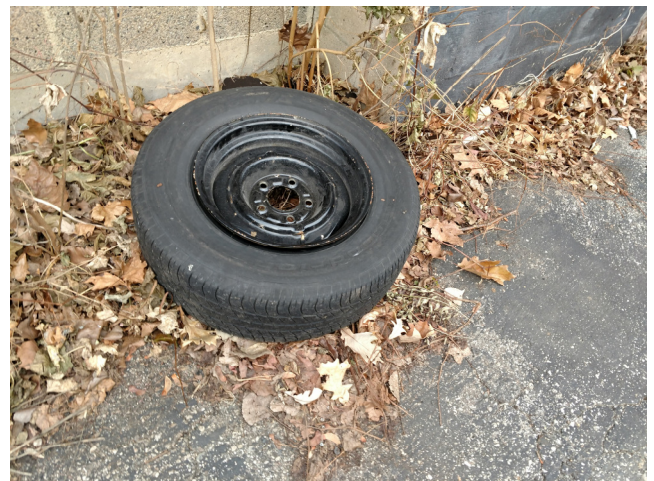
Tire

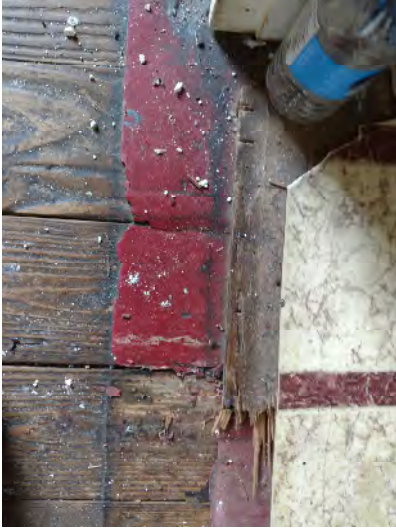
9x9 Floor Tile

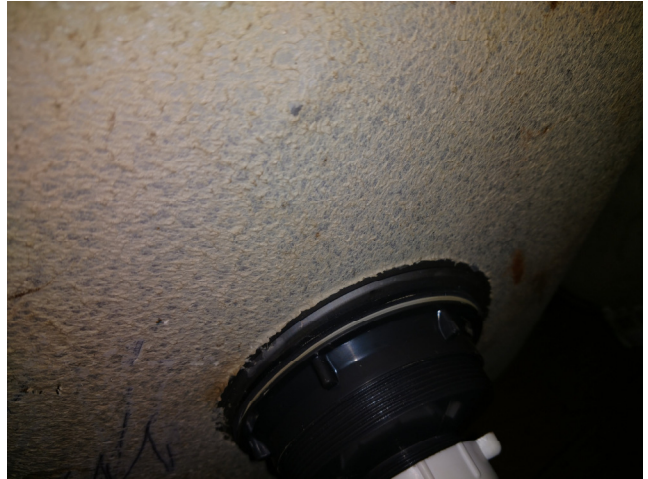
Sink Undercoat

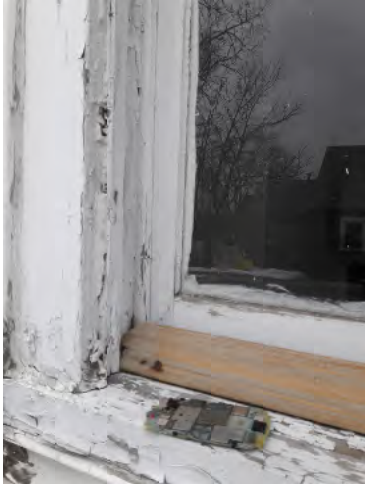
Window glaze, white

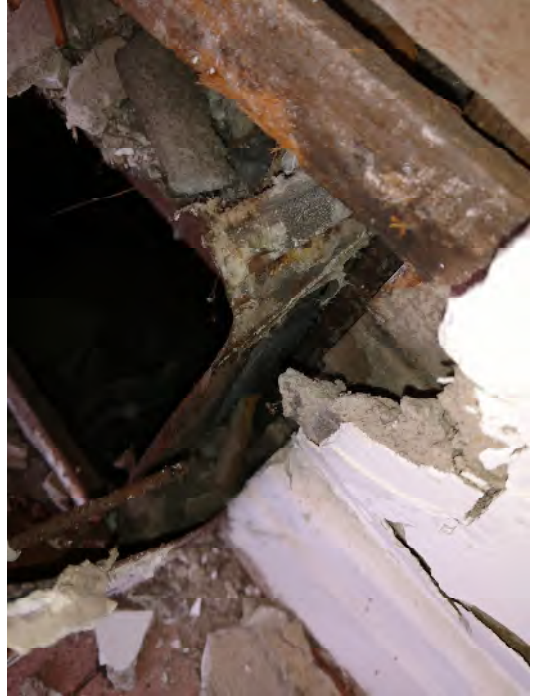
Duct wrap, brown

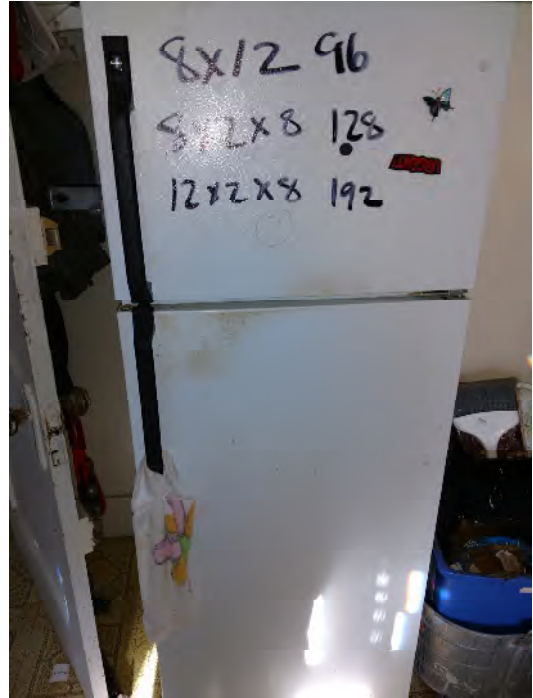
Refrigerator

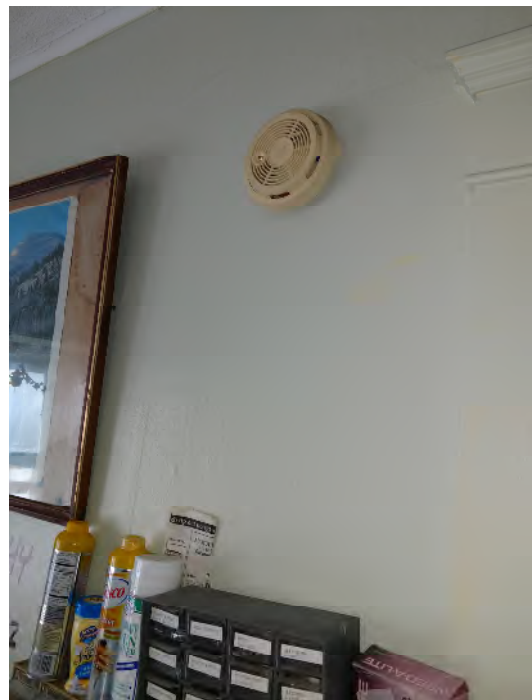
Smoke Detector

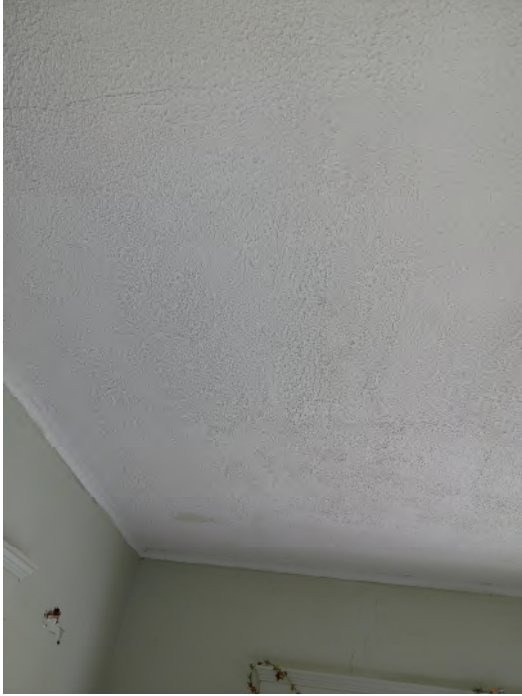
Plaster

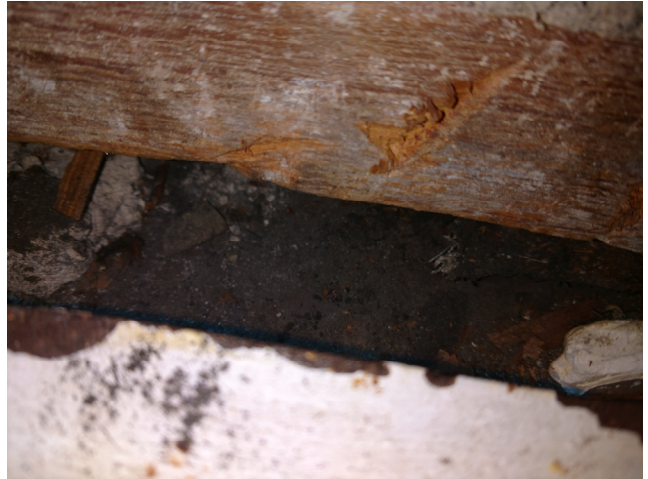
Duct wrap

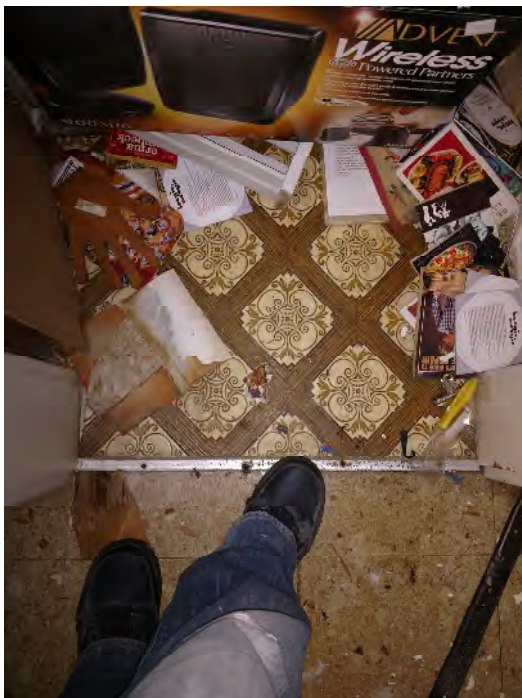
Linoleum, brown/yellow

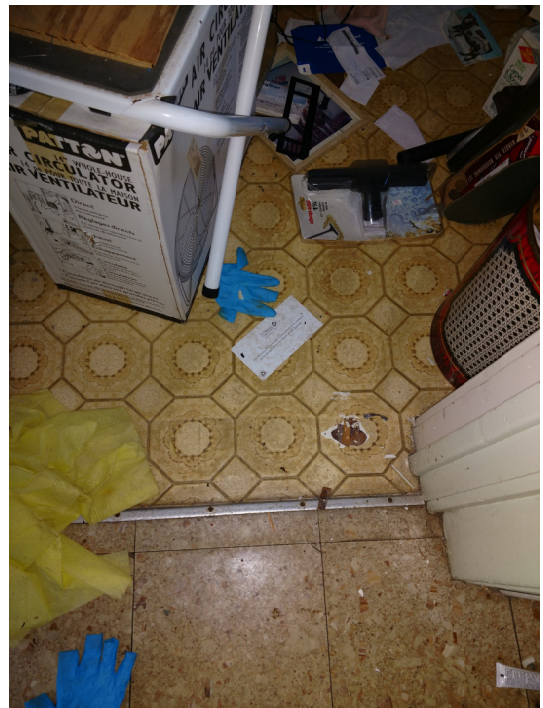
Linoleum, flower yellow

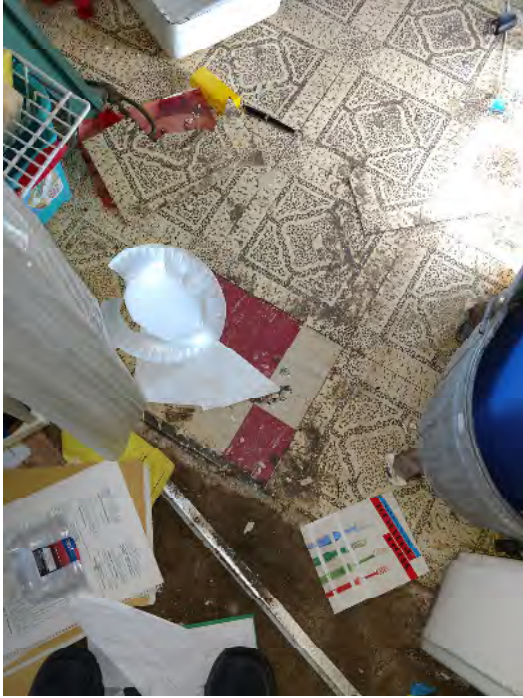
12x12 Peel and Stick, yellow; 9x9 Floor tile, red/tan

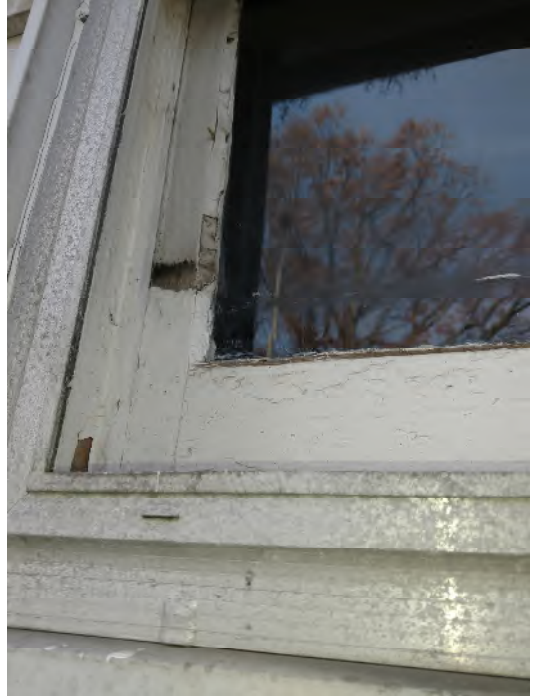
Window glaze

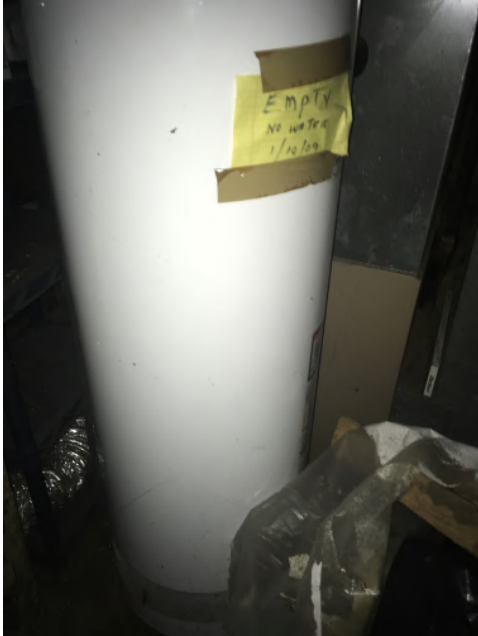
Hot Water Tank

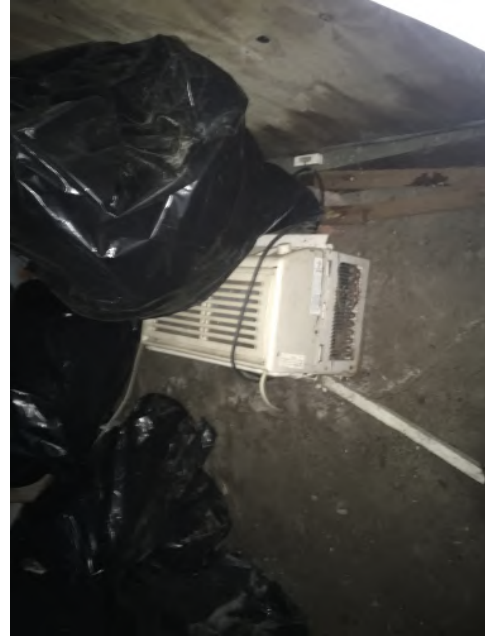
Air Conditioners/refrigerators/freezers

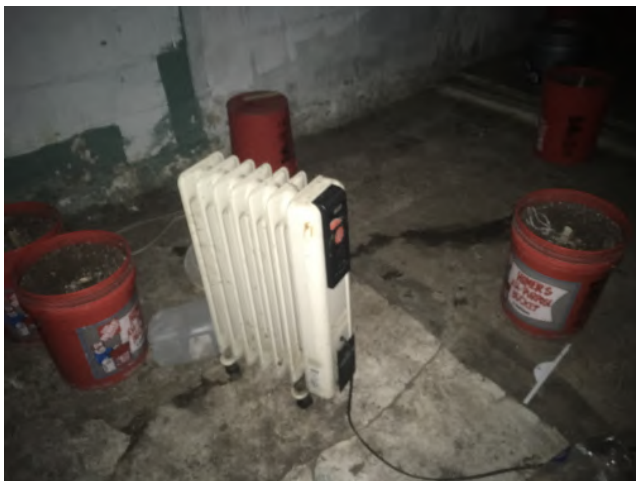
Electronics

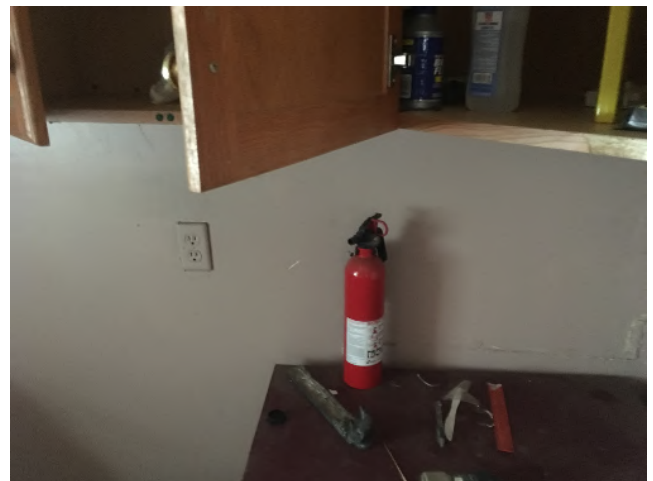
Fire Extinguishers

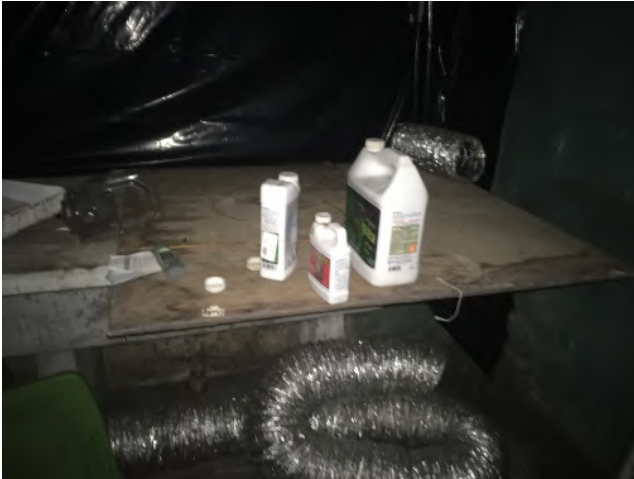
Misc. Items (solvents, cleaners)

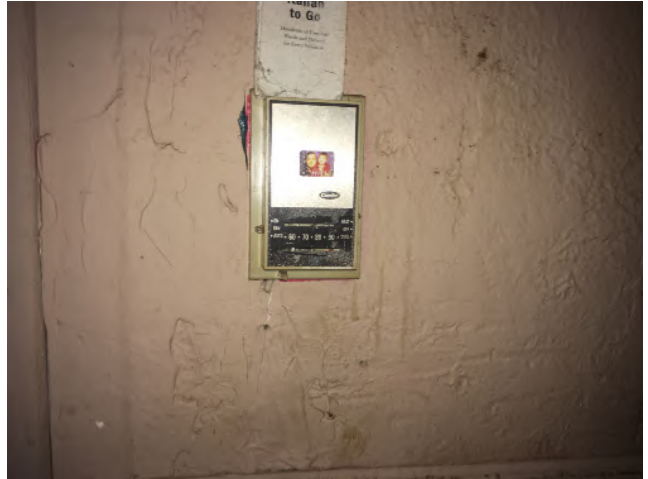
Thermostats

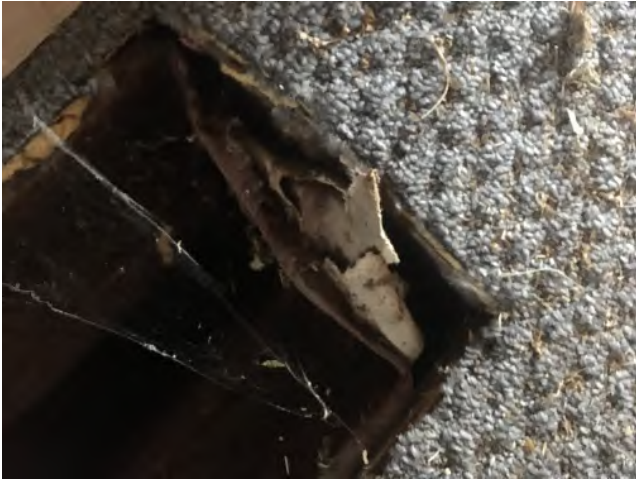
Duct Wrap
