# PRE-DEMOLITION ENVIRONMENTAL INSPECTION SUMMARY REPORT

**Ingham County Land Bank**  
 3024 Turner Street  
 Lansing, MI 48906

Parcel:	33-01-01-28-403-011
House No:	2609 Maplewood Ave, Lansing, MI 48910
Date Inspected:	11/28/2017
Inspected By:	Jake Gleason
Inspectors State Card #	A-49991

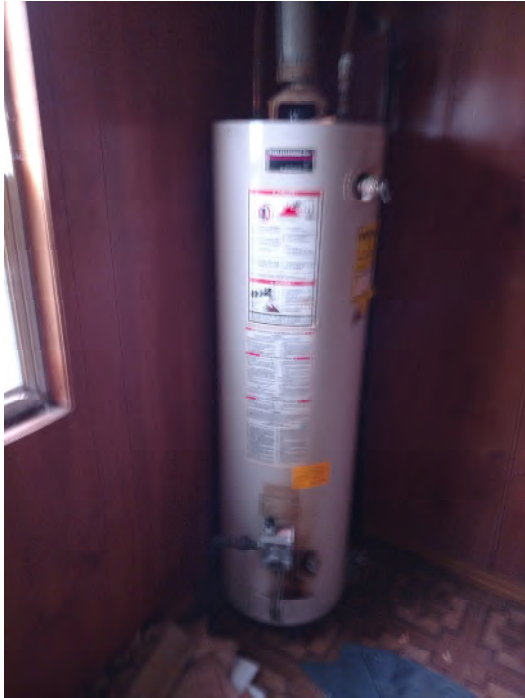
<b>Material Description</b>	<b>Quantity &amp; Units</b>	<b>Location</b>
Hot Water Heater	1	Room 8
AC, Refrigerator	3	Room 2, 4, 6

Hot Water Heater

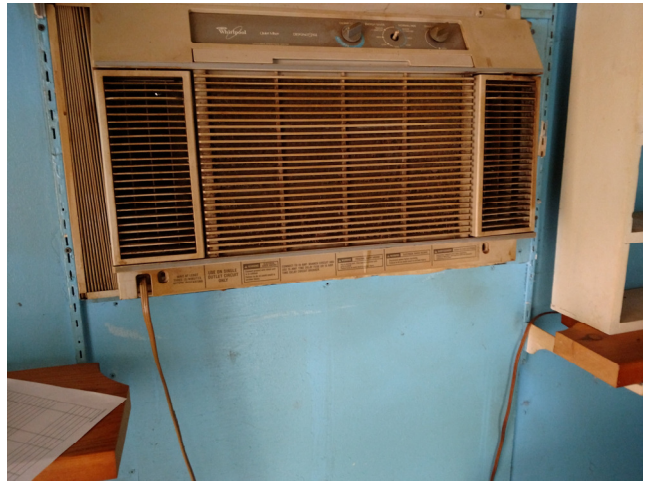
AC

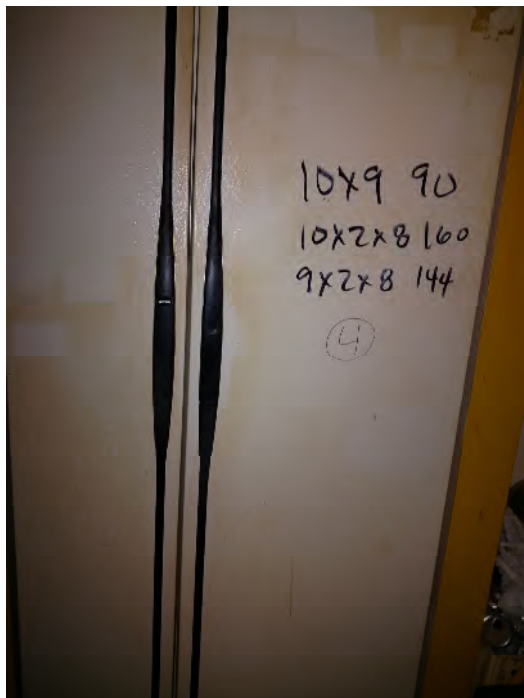
Refrigerator

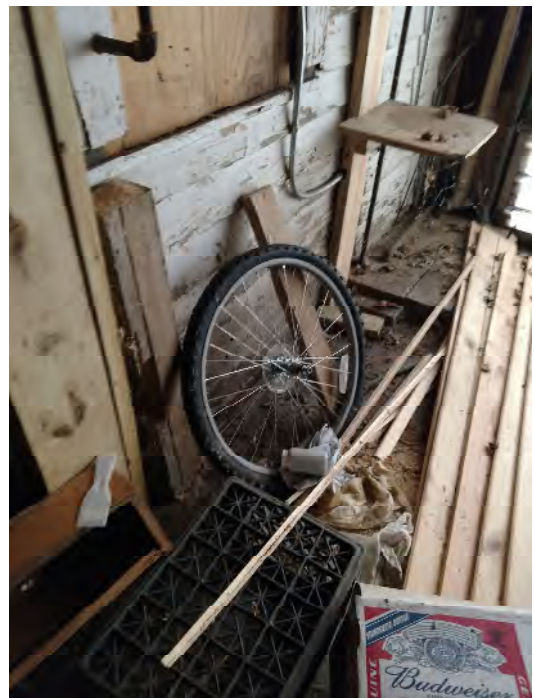
<b>Material</b>	<b>Quantity &amp; Units</b>	<b>Location</b>
Bike Tire	1	Room 9

Tire

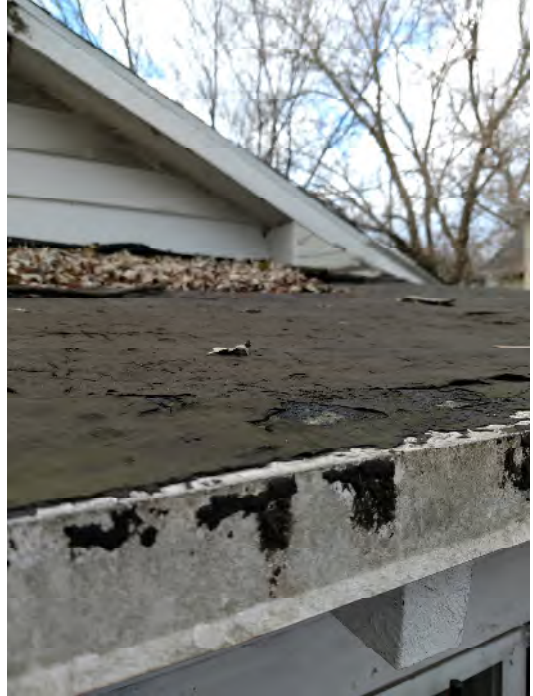
17	F	Asphalt shingle, black	Exterior (house)	2000 SF	No
<b>18</b>	<b>F</b>	<b>Rubber membrane, black</b>	<b>Exterior (garage)</b>	<b>300 SF</b>	<b>YES</b>

Rubber Membrane

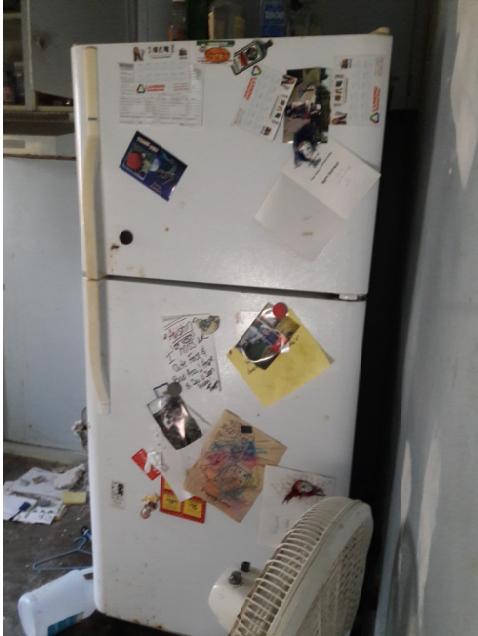
Refrigerators

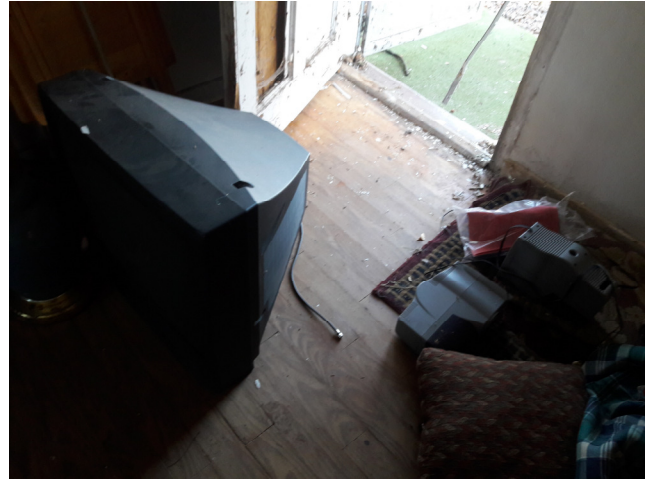
TV Screens/Electronics

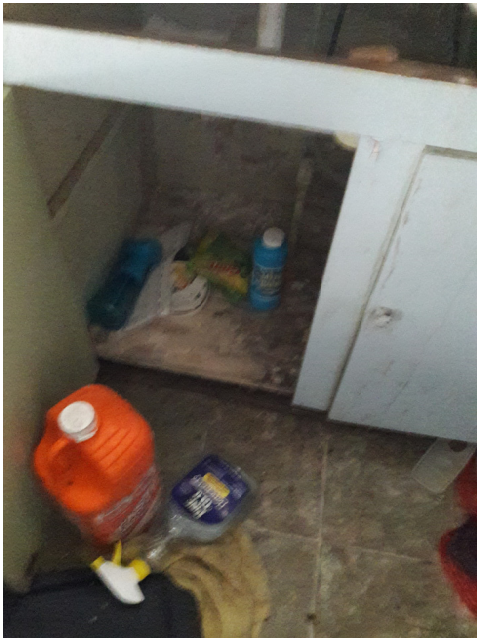
Misc. Items (solvents, cleaners)

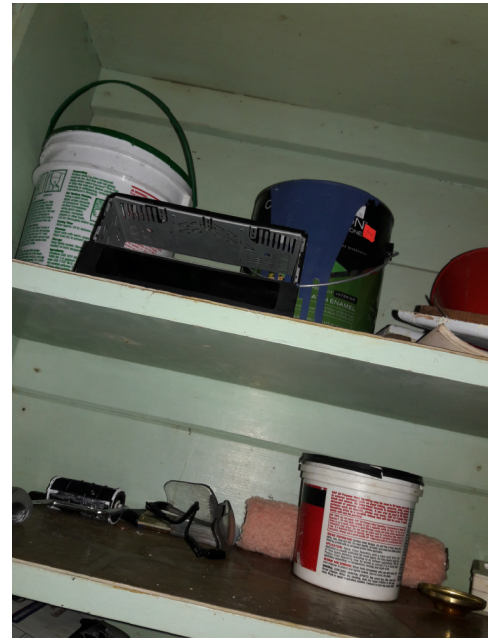
Paint Cans

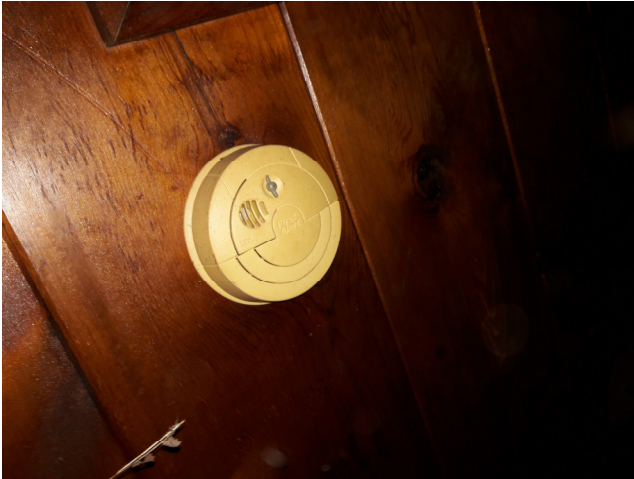
Smoke Detectors

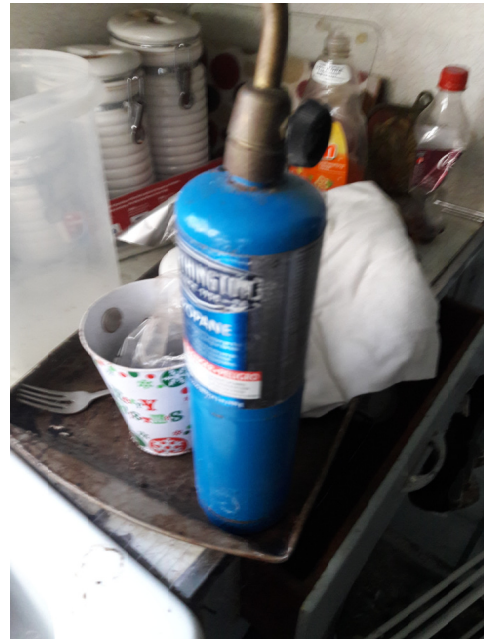
Propane

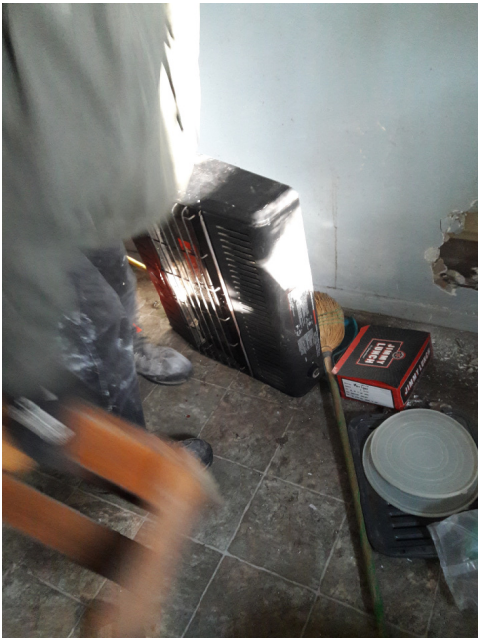
Portable Gas Heater

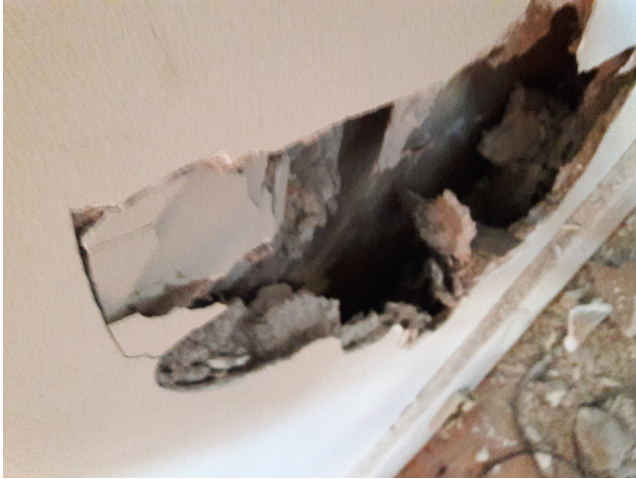
Plaster

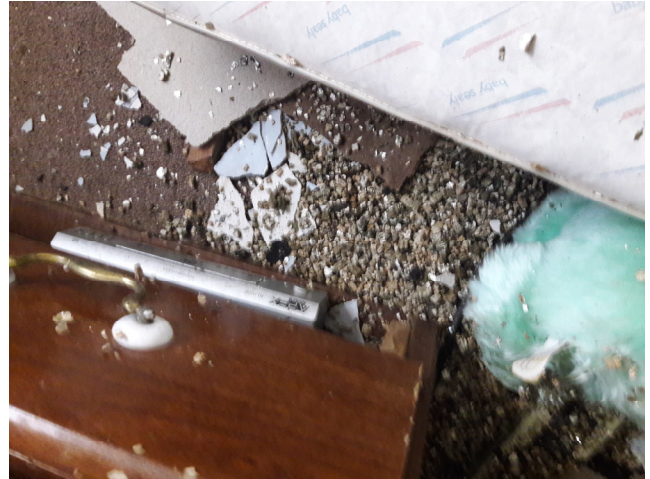
Vermiculite, tan

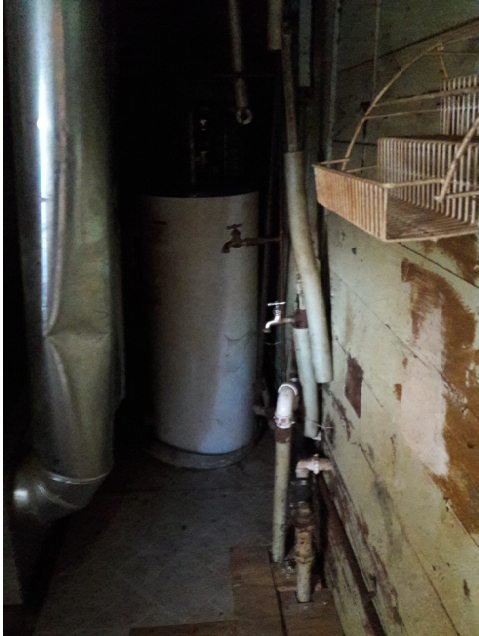
Hot Water Tank

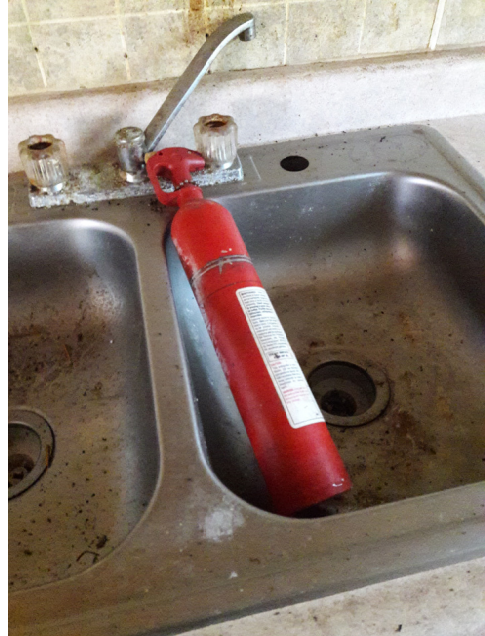
Fire Extinguishers

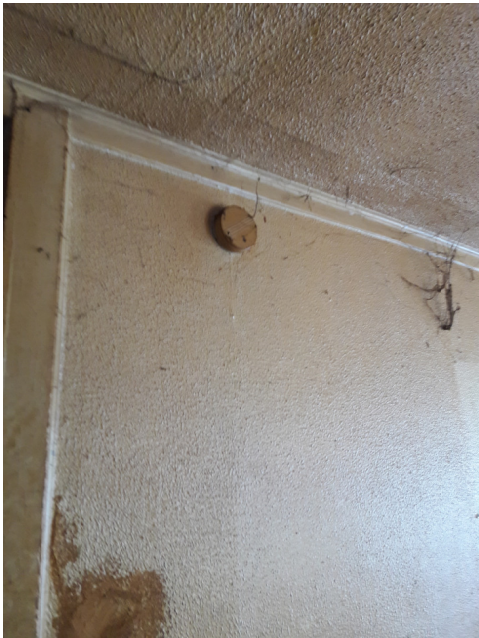
Smoke Detectors

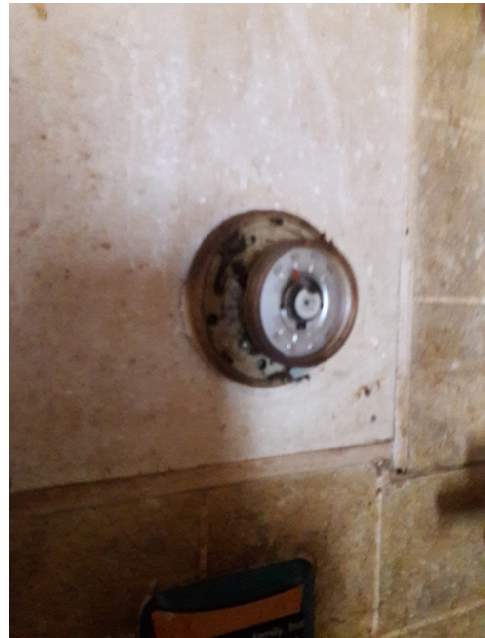
Thermostats

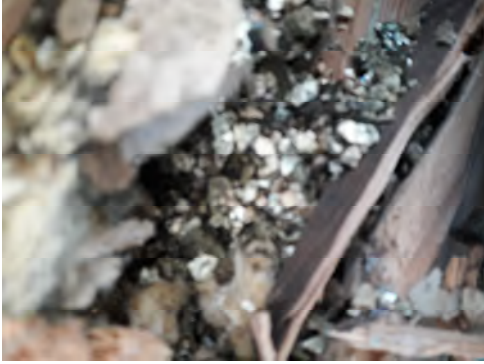
Vermiculite

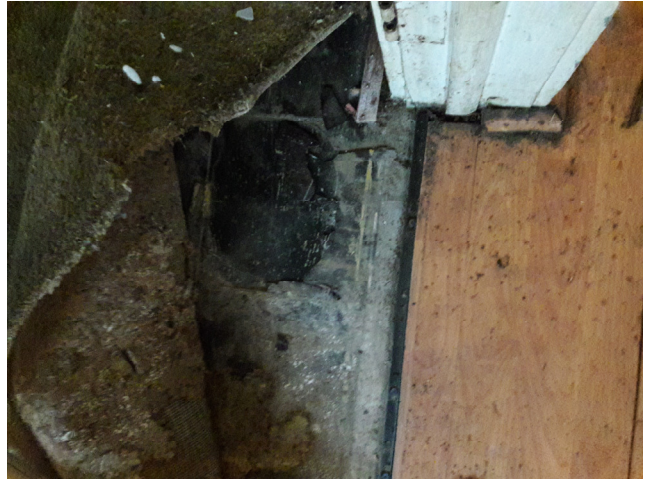
9x9 Floor tile, grey

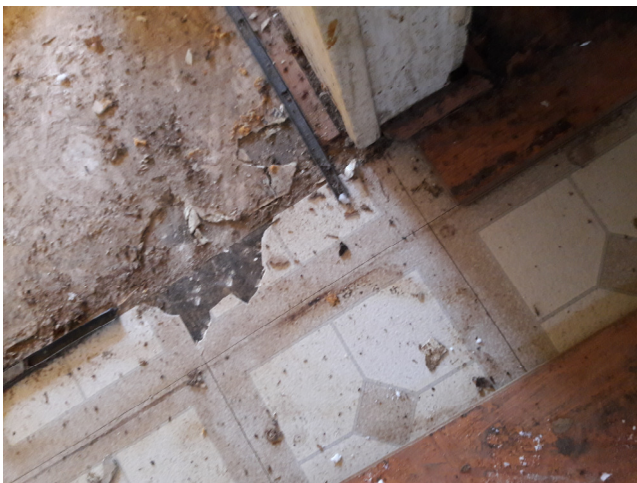
9x9 Floor tile, black

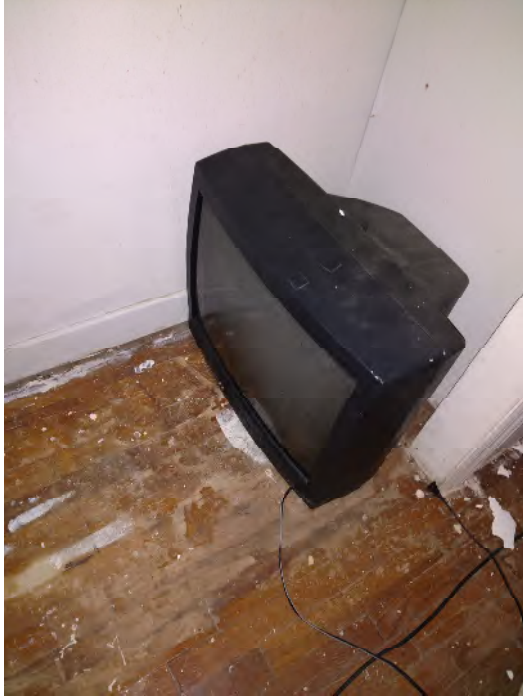
TV Screens

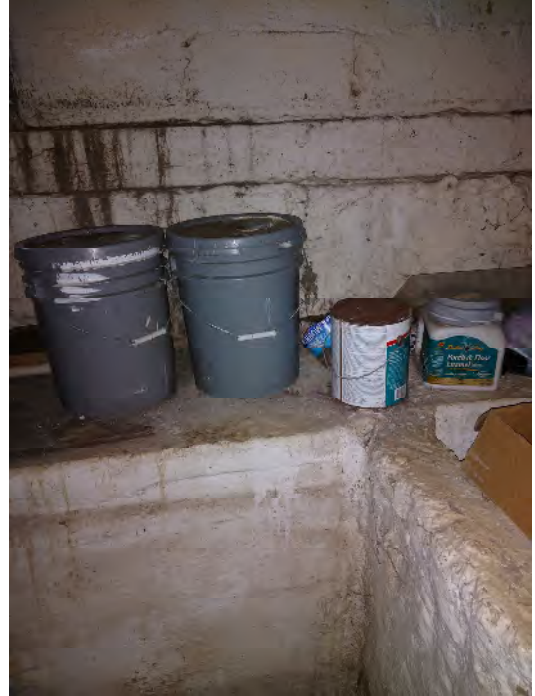
Paint Cans

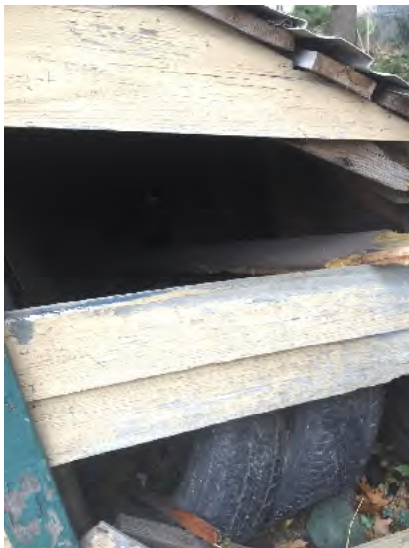
Tires

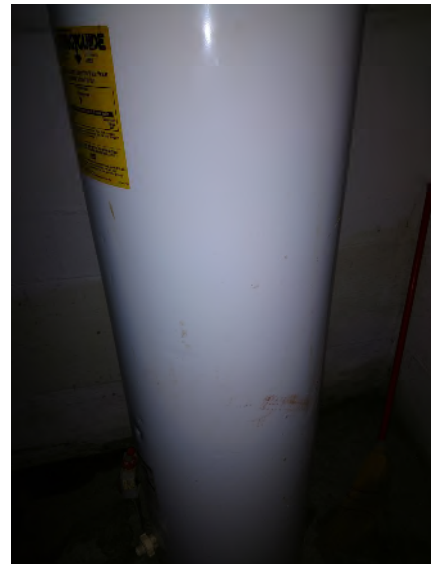
Hot Water Heater

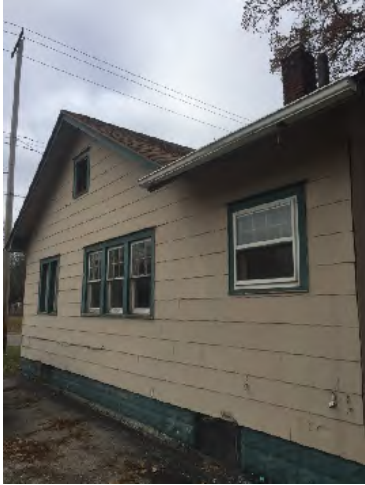
Transite, tan

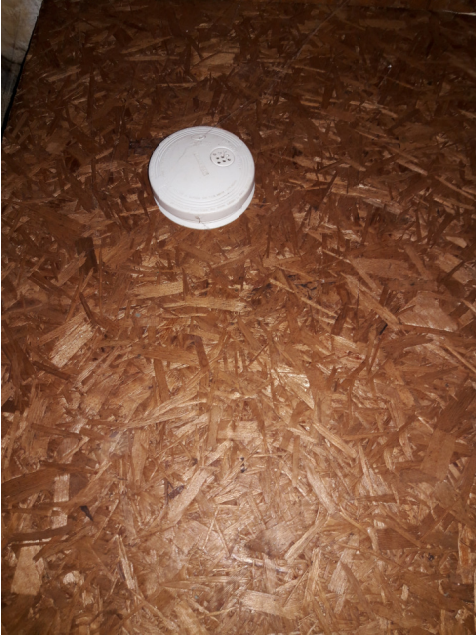
Smoke Detectors

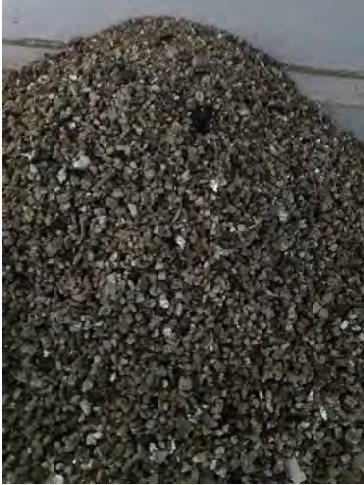
Vermiculite, tan

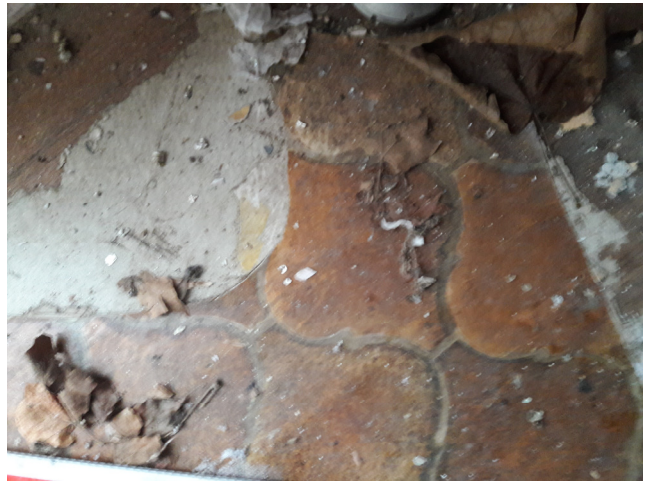
Linoleum, red
