PRE-DEMOLITION ENVIRONMENTAL INSPECTION SUMMARY REPORT

Ingham County Land Bank
3024 Turner Street
Lansing, MI 48906

Parcel:	33-01-01-32-126-152
House No:	1733 Holmes Rd, Lansing, MI 48910
Date Inspected:	12/22/2017
Inspected By:	Heather Davis
Inspectors State Card #	A-48908

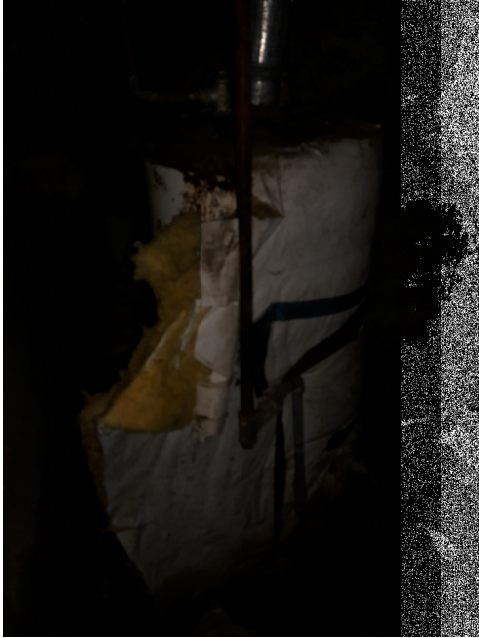
Hot Water Tank

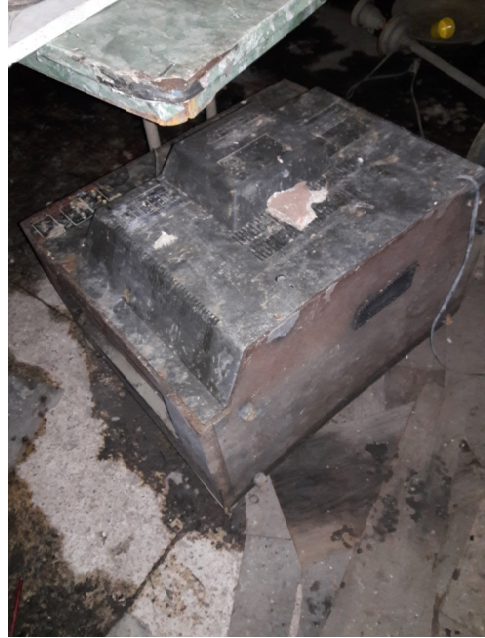
TV Screens

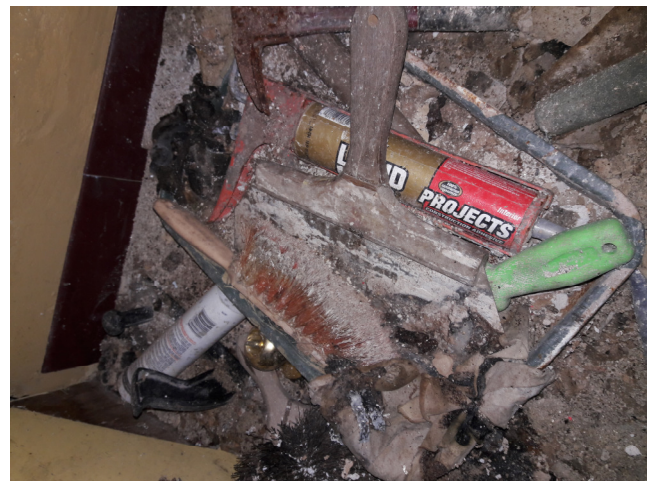
Misc. Items (solvents, cleaners)

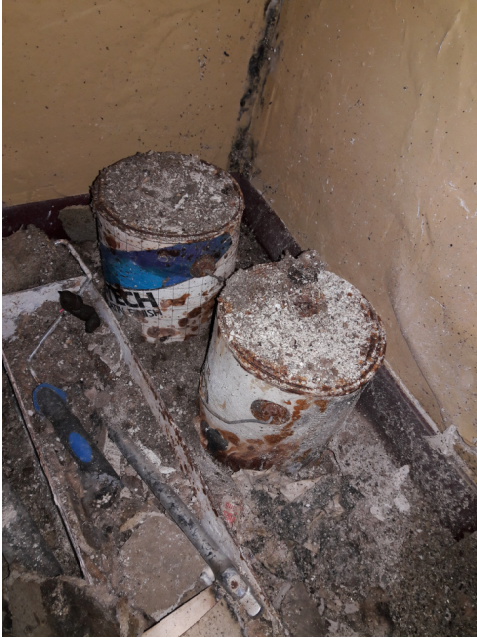
Paint Cans

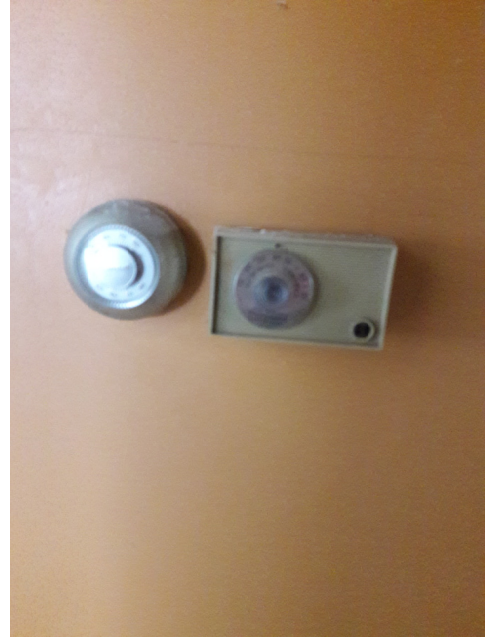
Thermostats

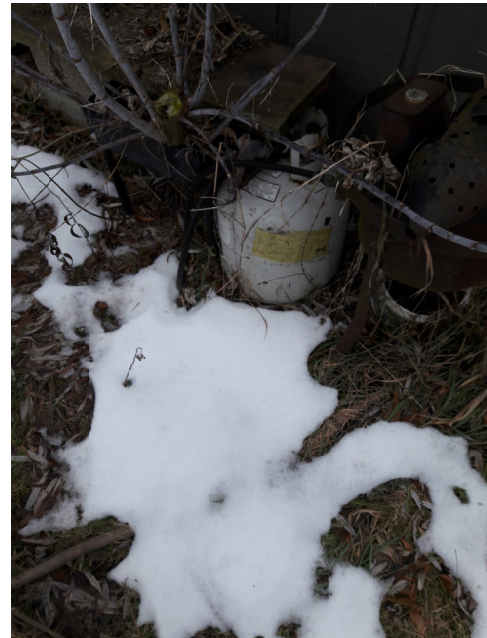
Propane Tanks

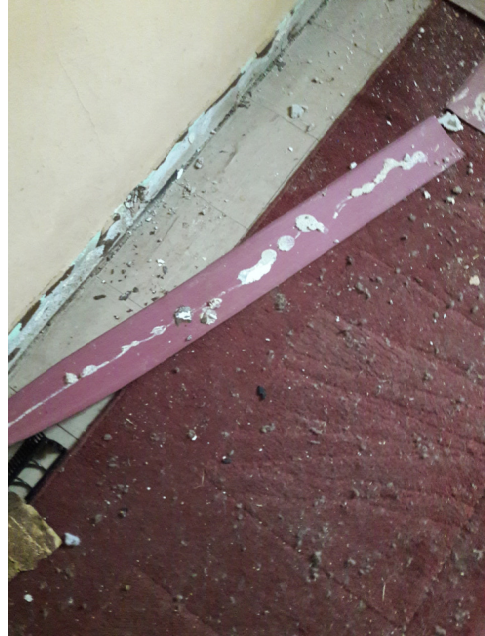
9x9 Tile, tan; Mastic, black

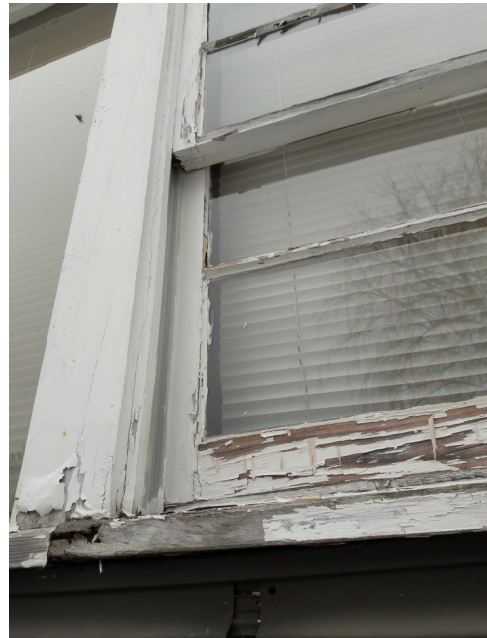
Window Glaze, white

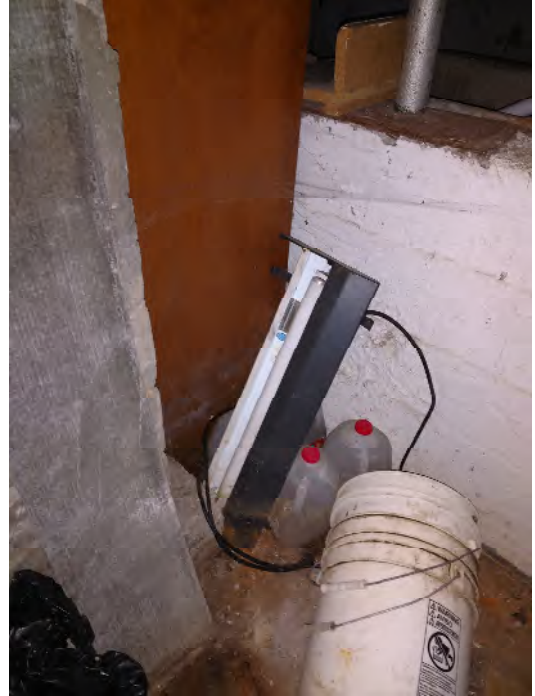
Light Ballasts

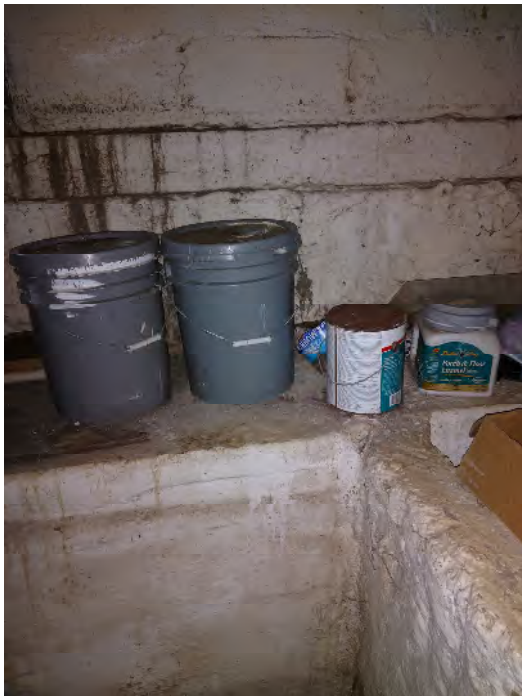
Paint Cans

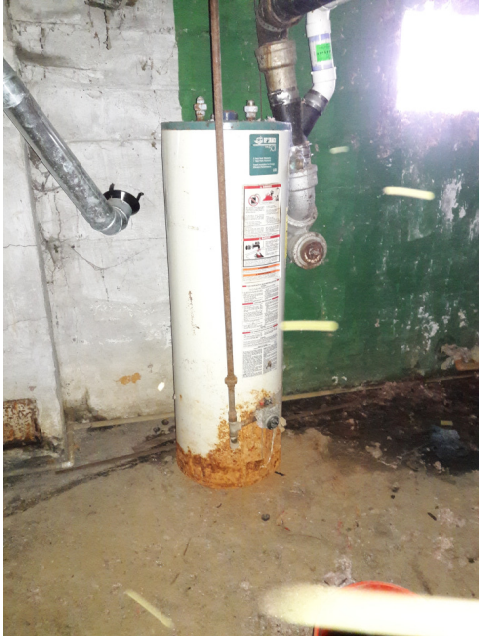
Hot Water Tank

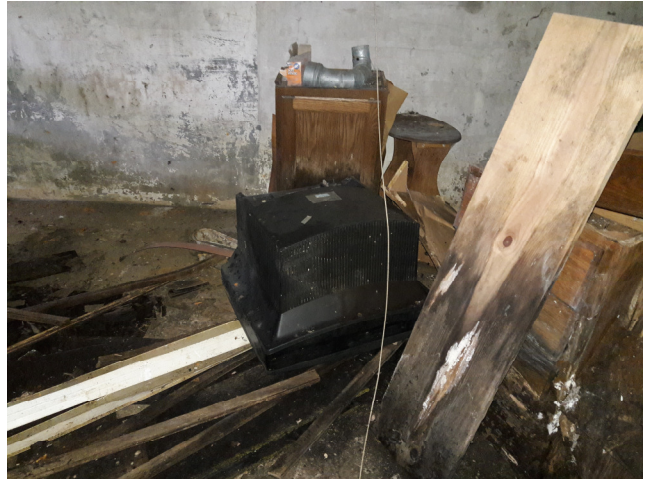
TV Screens/Electronics

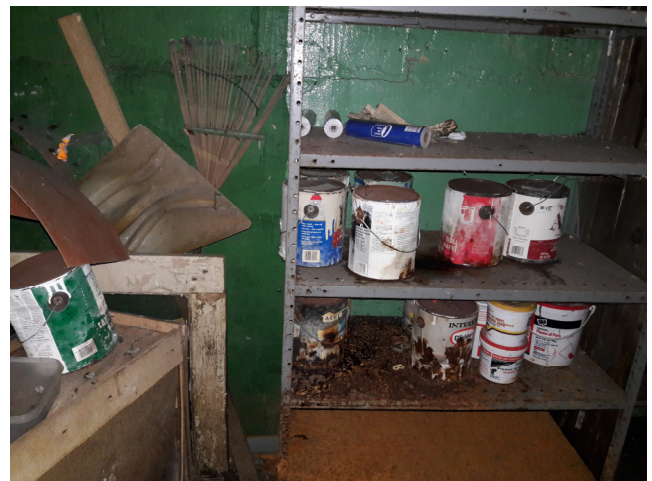
Paint Cans

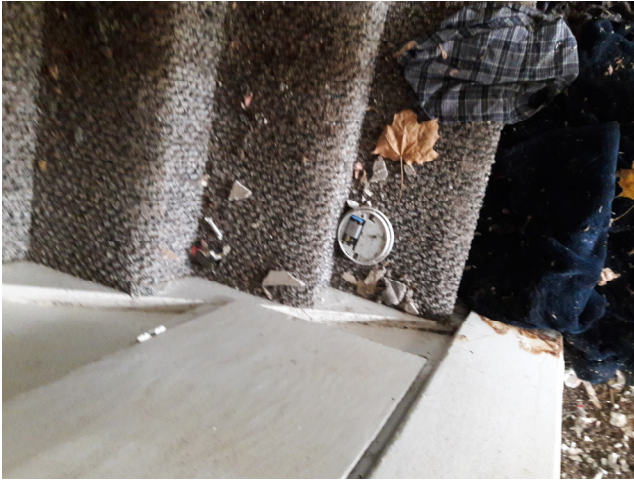
Smoke Detectors

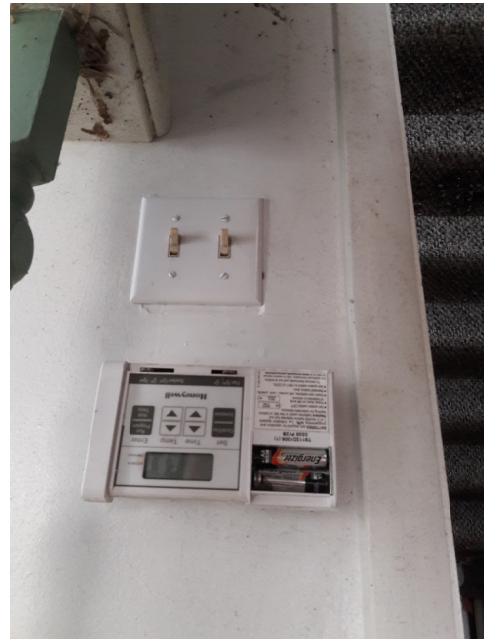
Thermostats

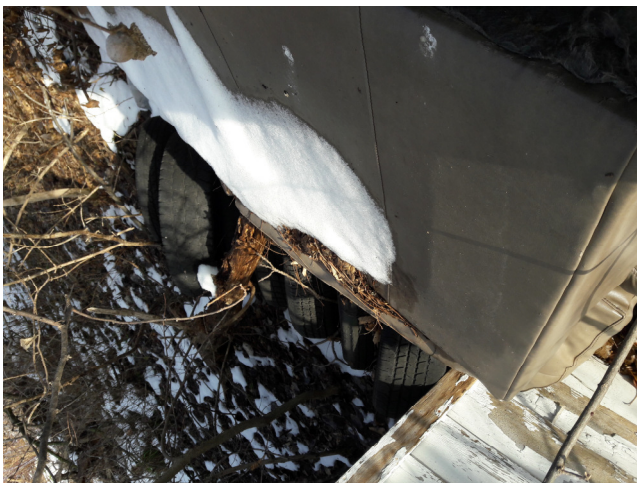
Tires

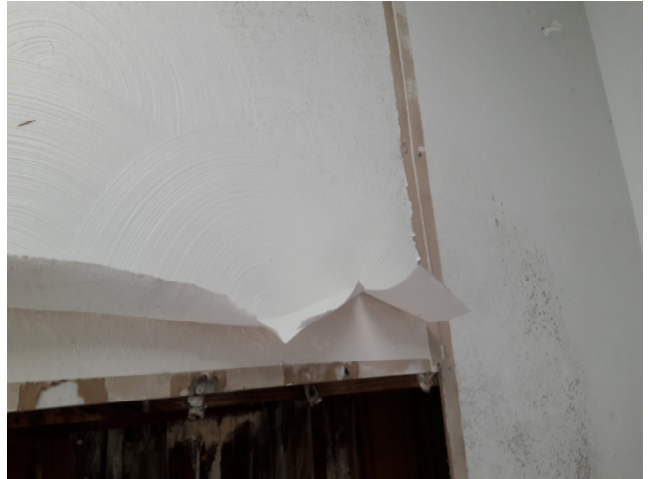
Texture, white

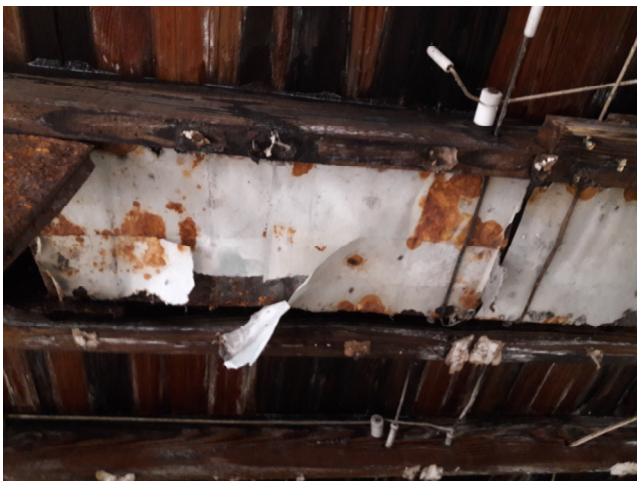
Duct Wrap, grey

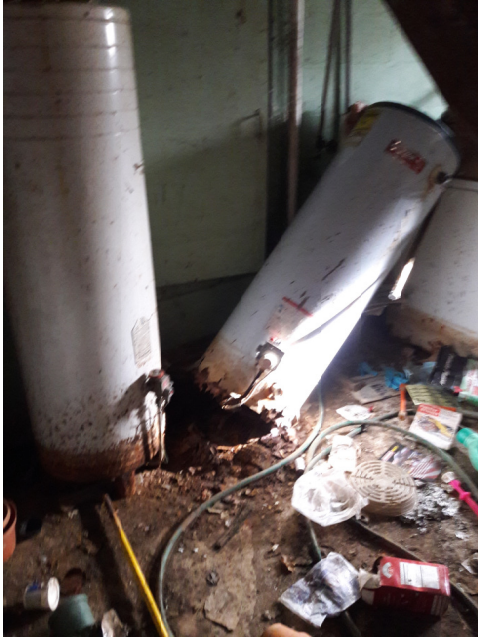
Hot Water Heater

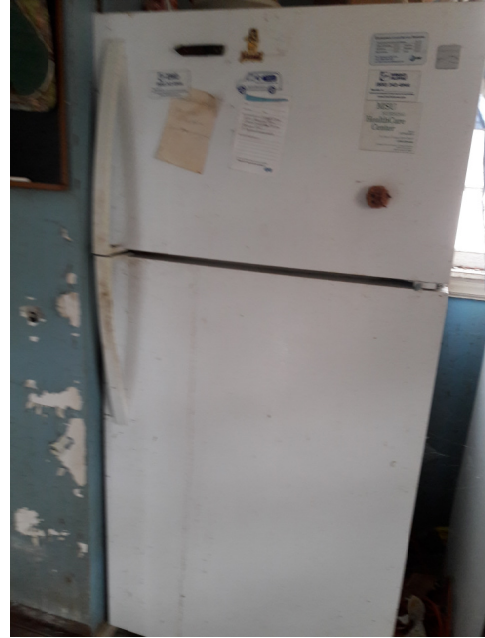
Refrigerators

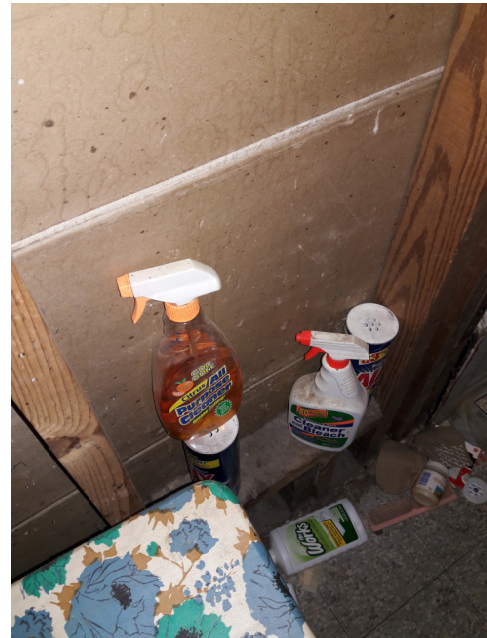
Misc. Items (cleaner, solvents)

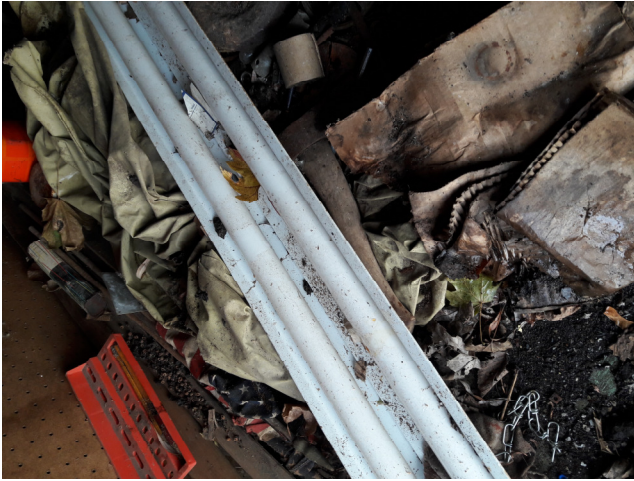
Florescent Light Bulbs

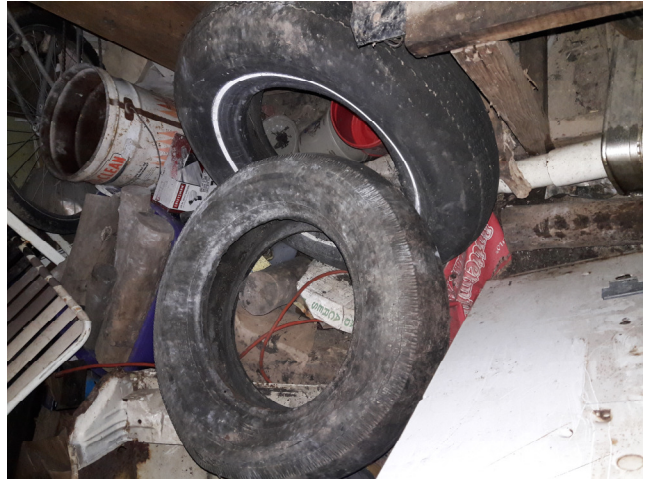
Tires

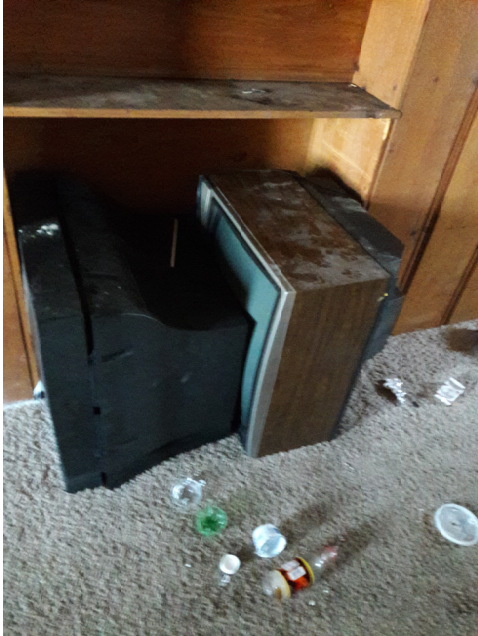
TV Screens/Electronics

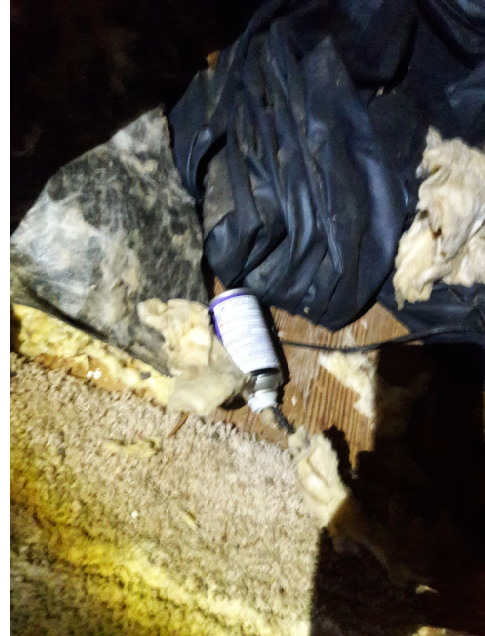
Misc. Items (solvents, cleaners)

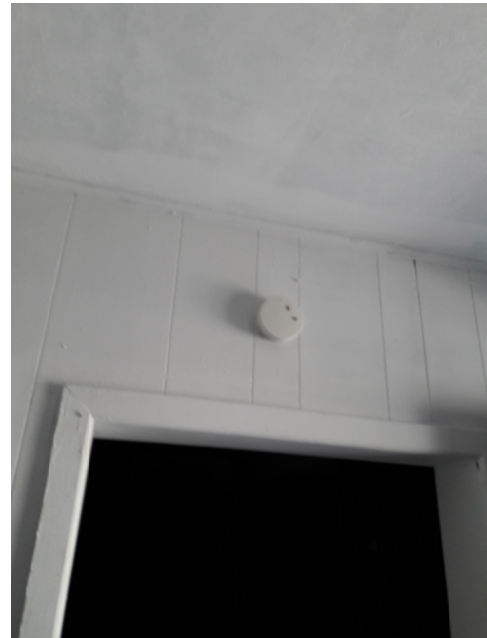
Smoke Detectors

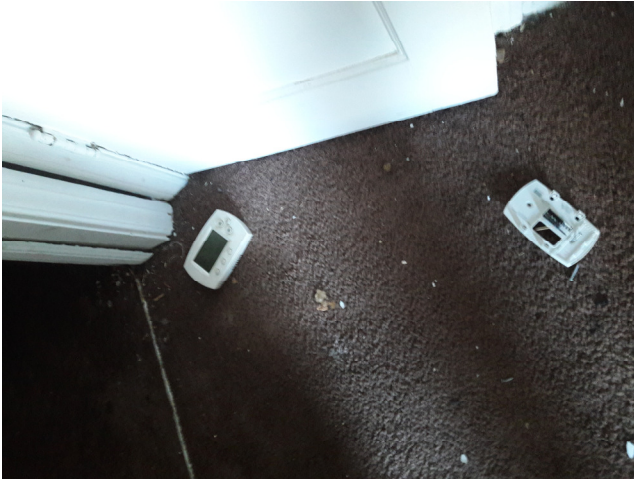
Thermostats

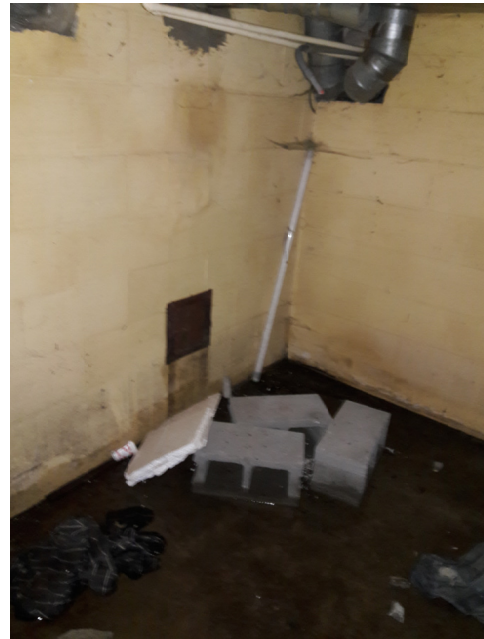
Florescent Light Bulbs
