PRE-DEMOLITION ENVIRONMENTAL INSPECTION SUMMARY REPORT

Ingham County Land Bank
3024 Turner Street
Lansing, MI 48906

Parcel:	33-01-05-376-201
House No:	5861 S MLK Blvd, Lansing, MI 48911
Date Inspected:	11/22/2017
Inspected By:	Bryan Dryer
Inspectors State Card #	A-40292

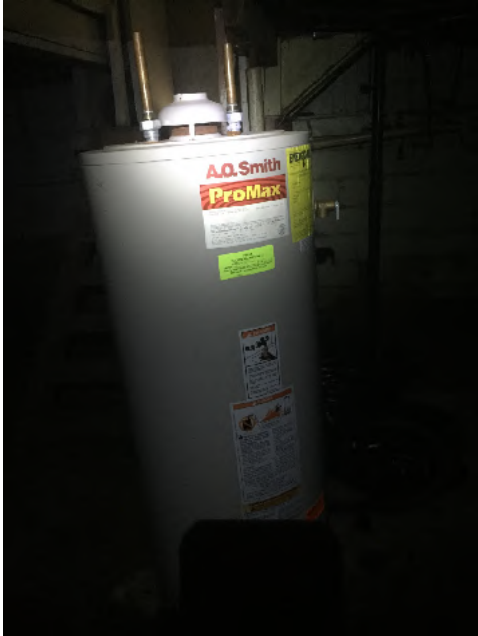
Water Heater

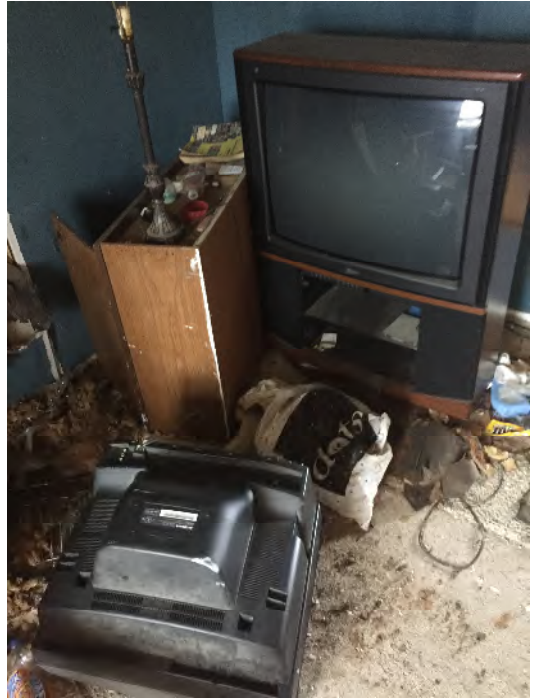
TV Screen

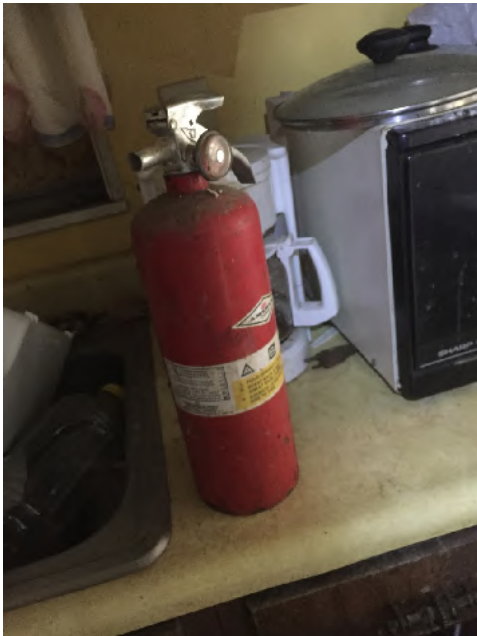
Fire Extinguisher

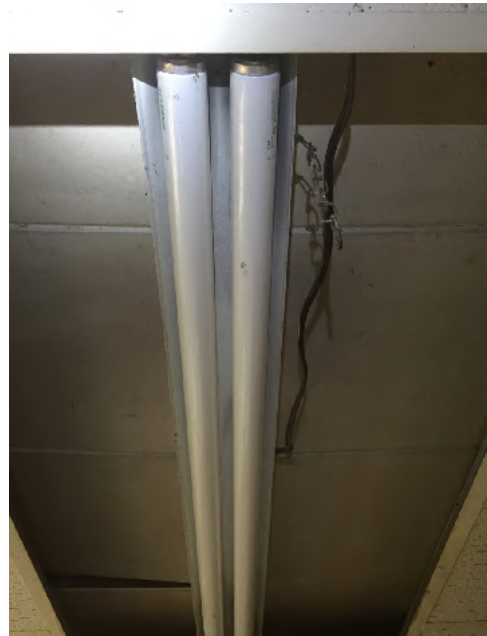
Florescent Light Bulb, Light Ballast

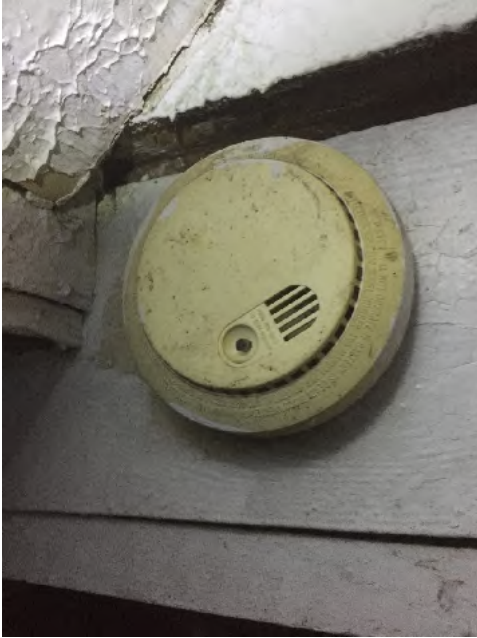
Smoke Detector

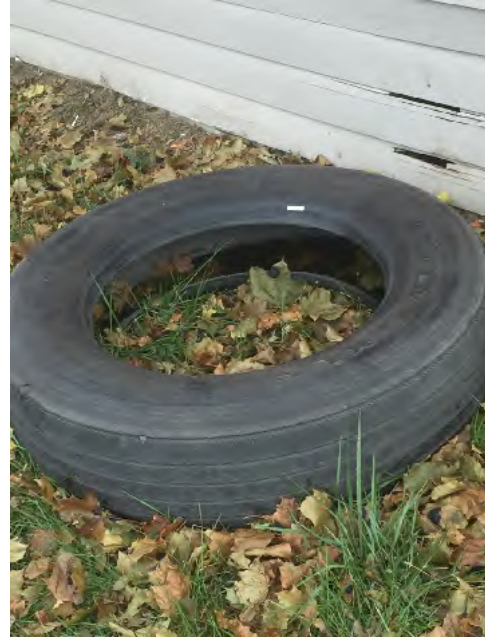
Tire

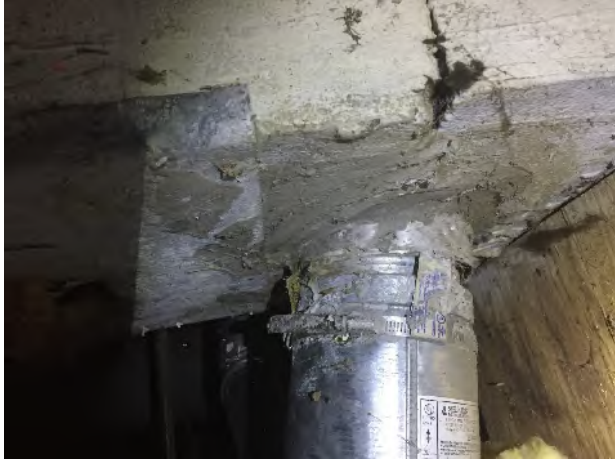
Duct Wrap

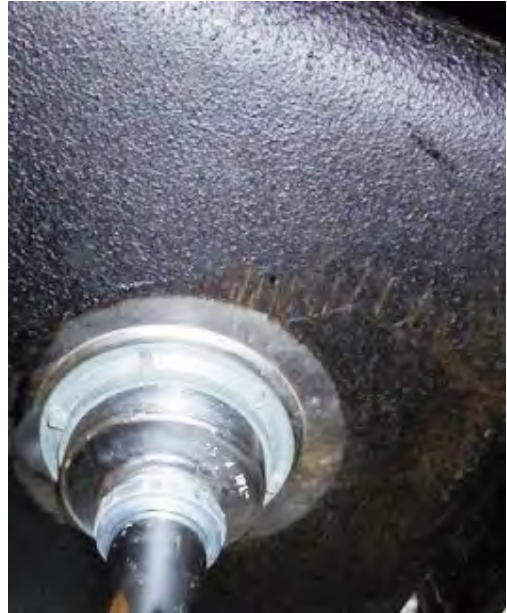
Sink Undercoat

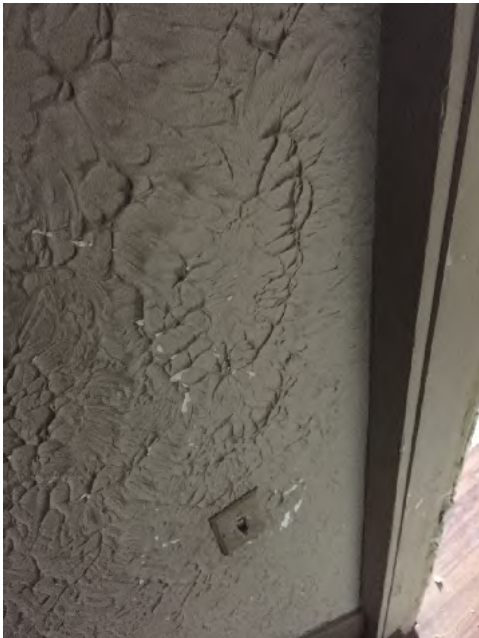
Textured Plaster

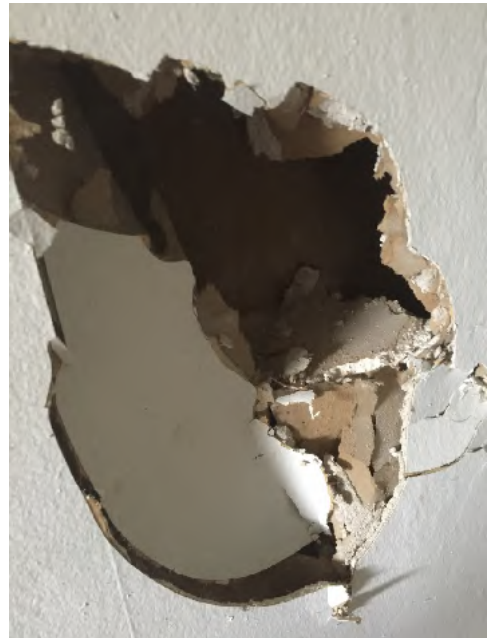
Rough Plaster

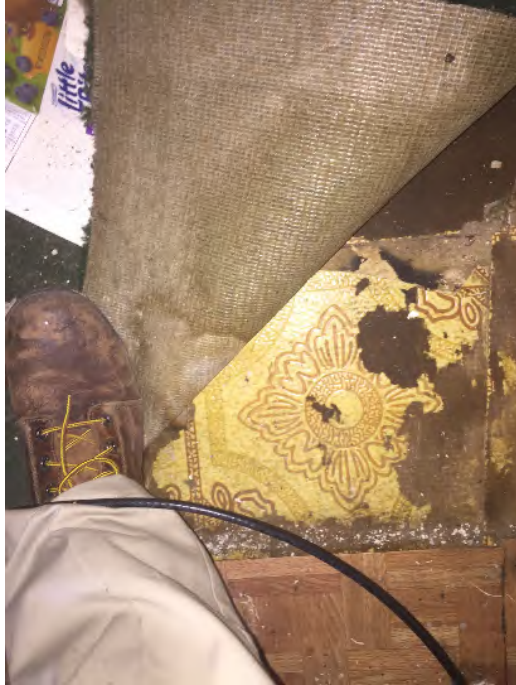
12x12 Floor Tile, yellow

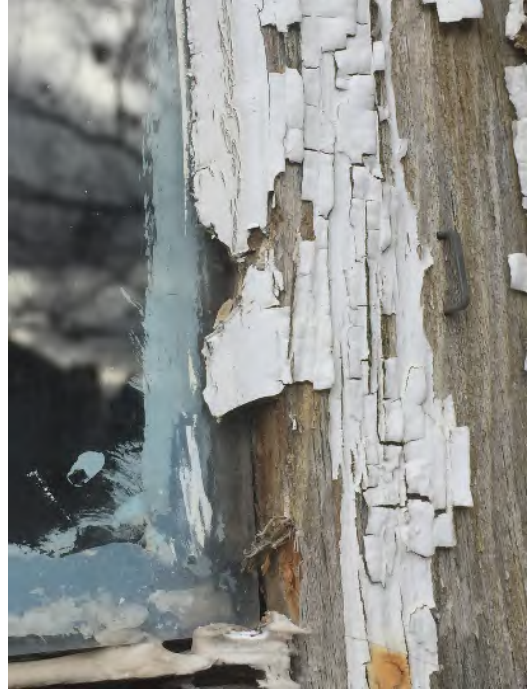
Window Glaze

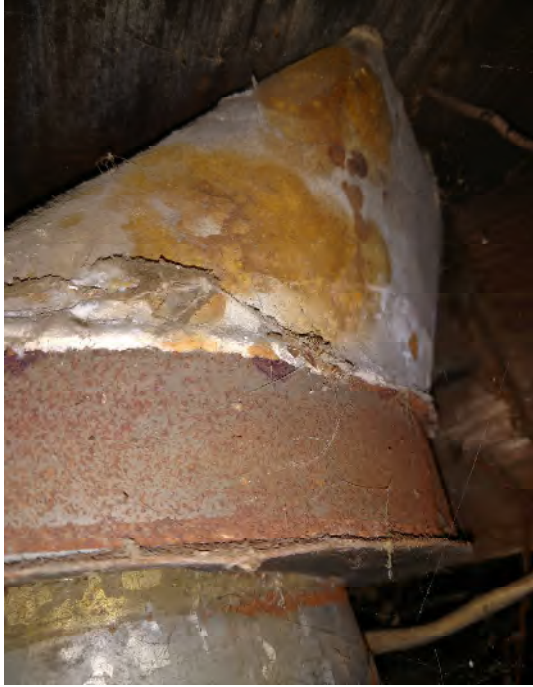
Duct wrap

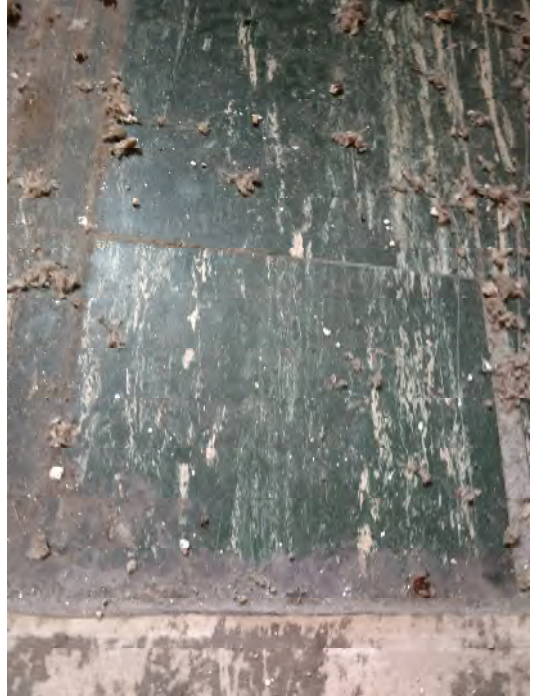
9x9 Tile, green

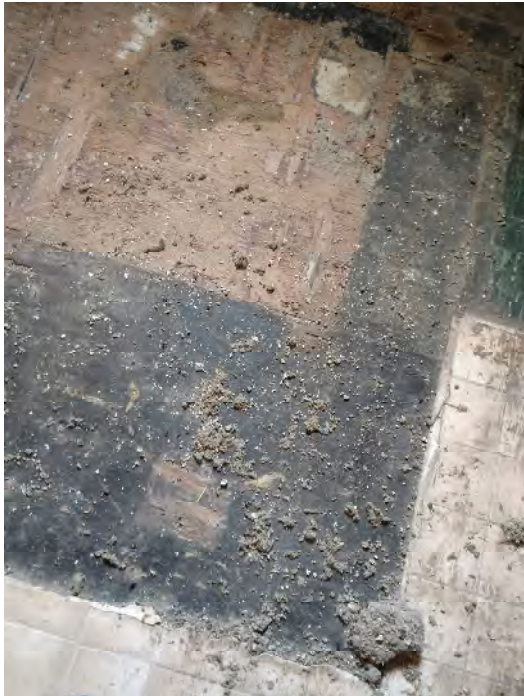
Vermiculite

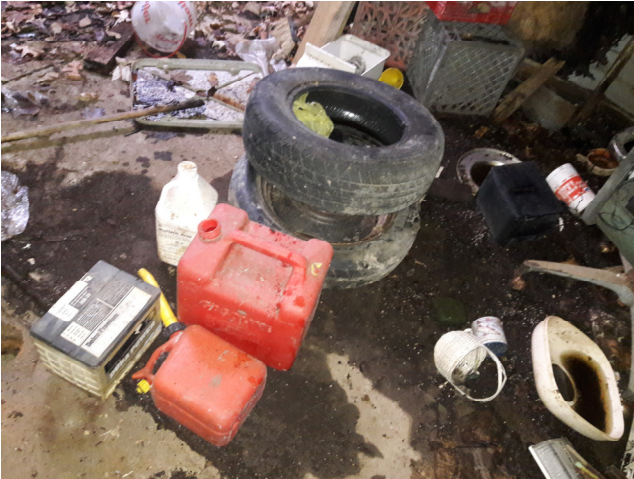
Car Battery, Tire

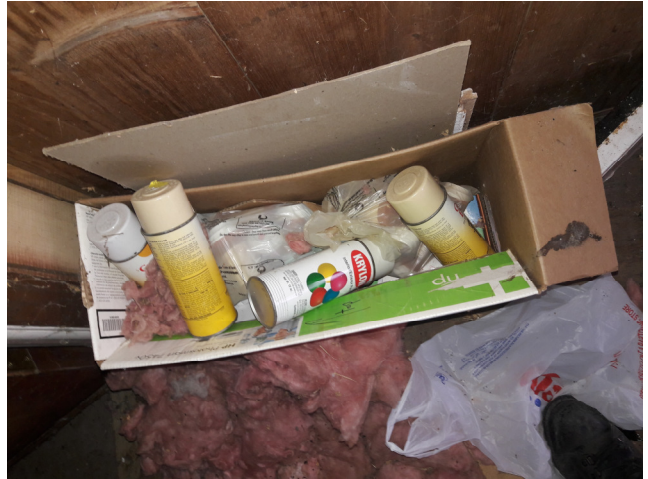
Spray Cans

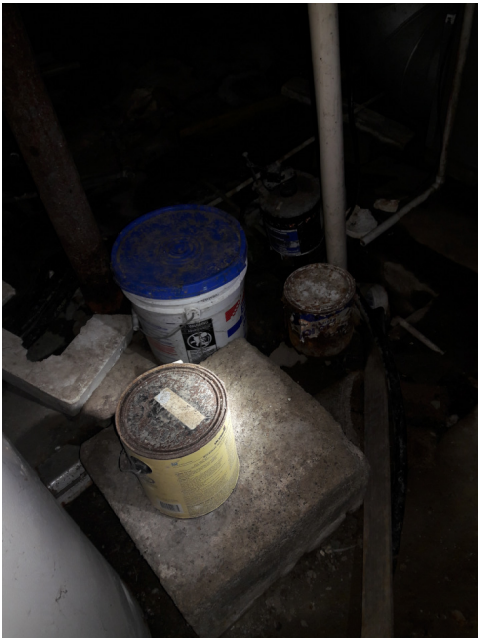
Paint Cans

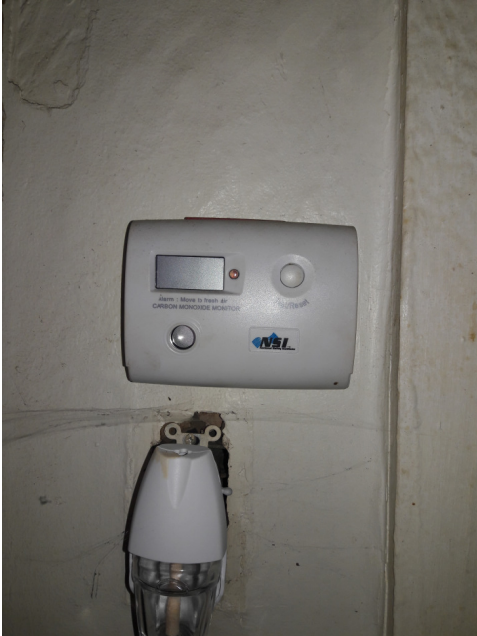
Thermostat

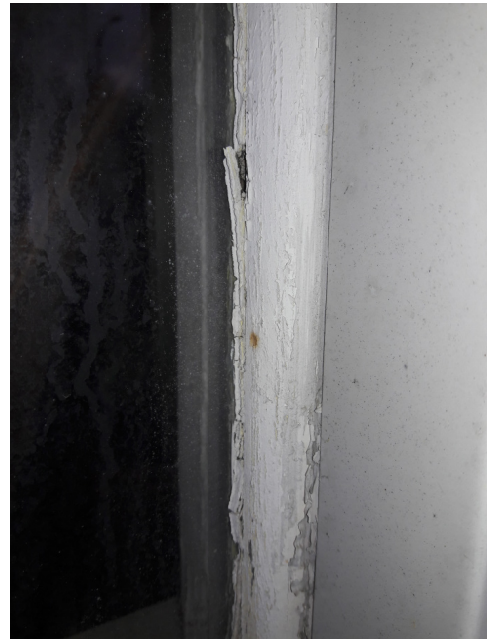
Glaze

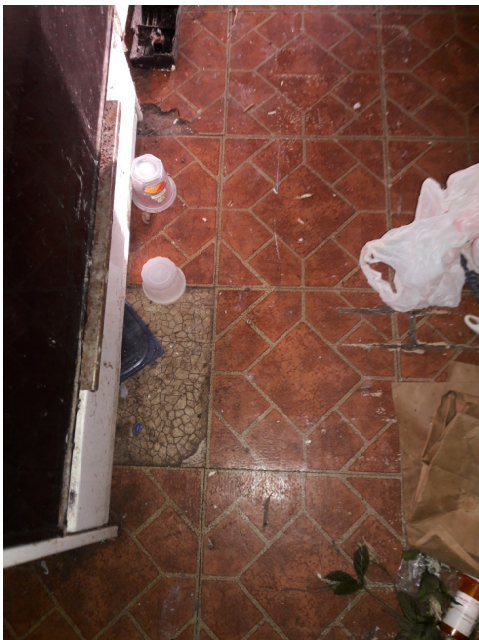
12x12 Floor, beige

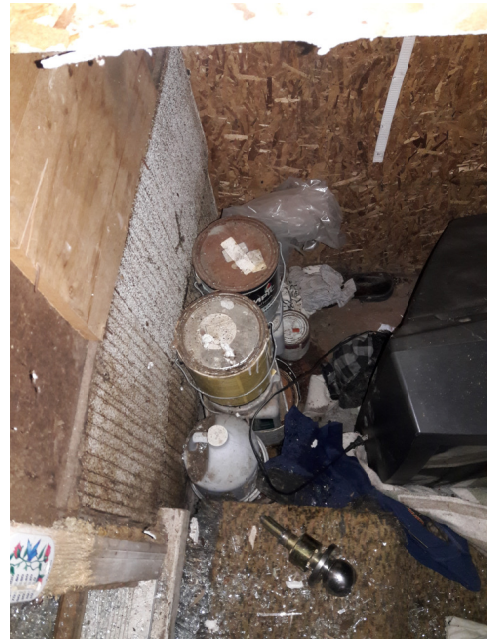
Paint Can

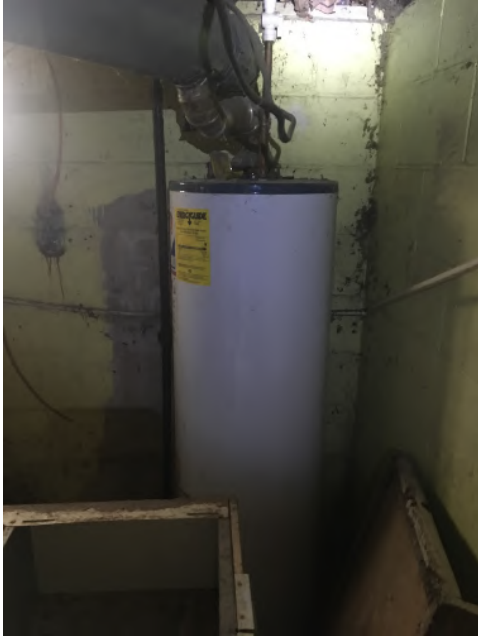
Water Heater

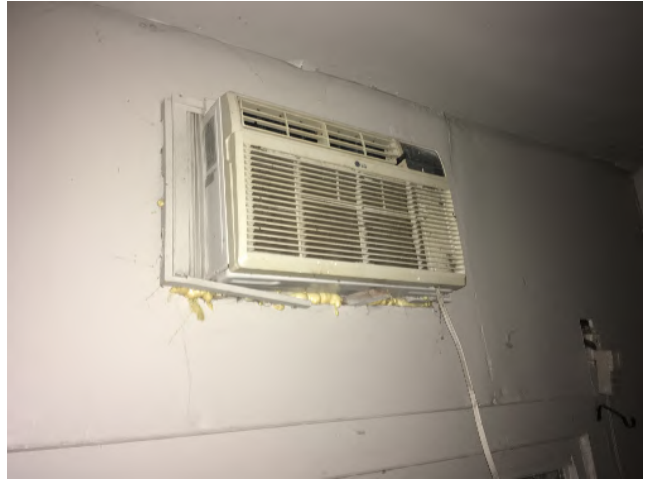
Air Conditioners/refrigerators/freezers

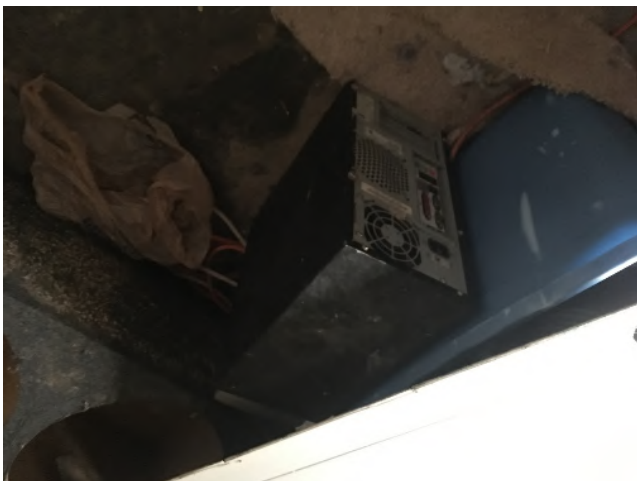
Monitors/Electronics

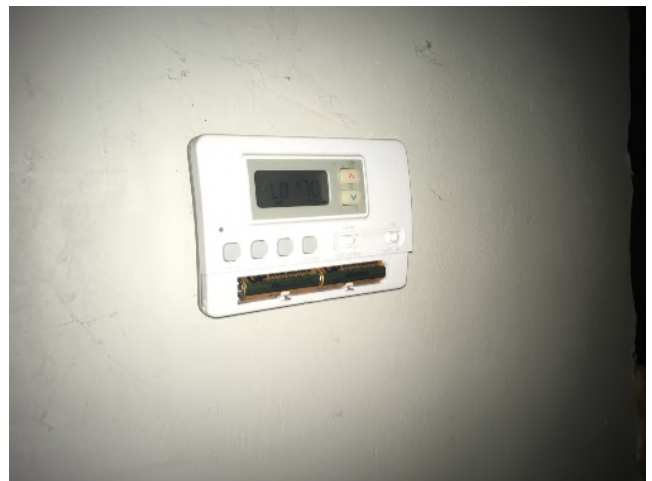
Thermostats

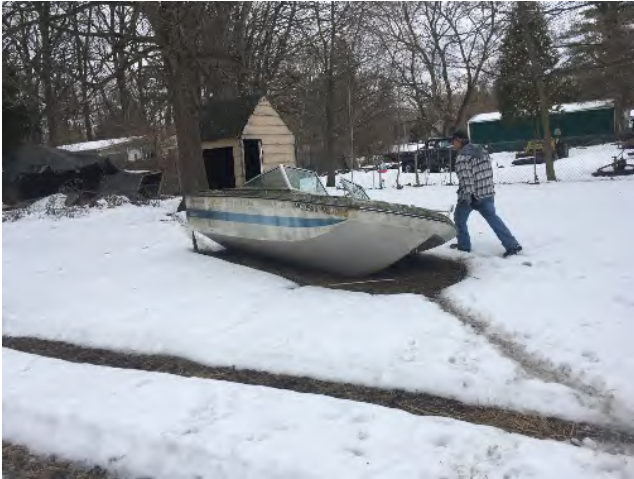
Boat

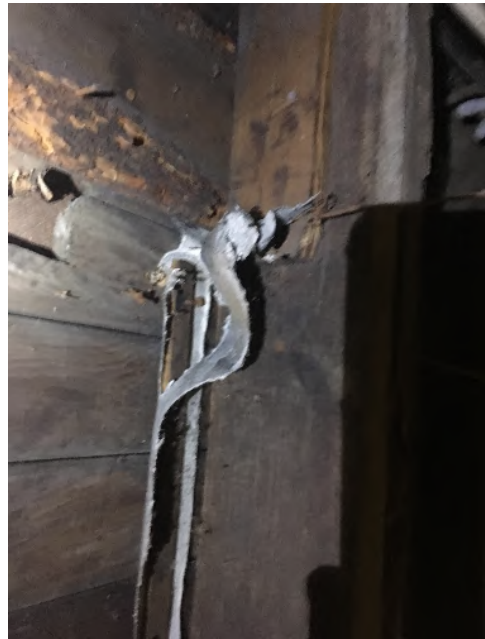
Duct wrap, white

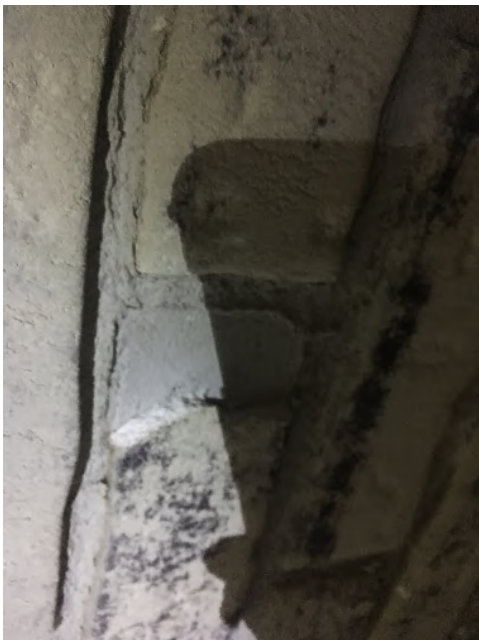
Mastic/texture, grey/green
