PRE-DEMOLITION ENVIRONMENTAL INSPECTION SUMMARY REPORT

Ingham County Land Bank
3024 Turner Street
Lansing, MI 48906

Parcel:	33-01-01-31-253-161
House No:	4020 Ingham St, Lansing, MI 48911
Date Inspected:	11/28/2017
Inspected By:	Jake Gleason
Inspectors State Card #	A-49991

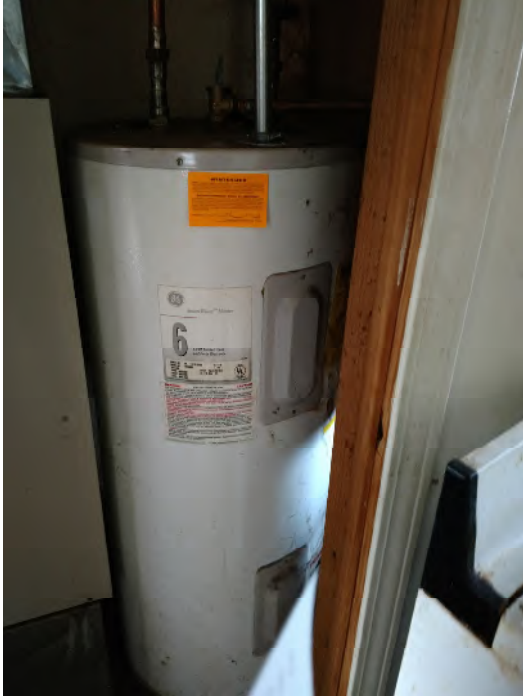
Material Description	Quantity & Units	Location
Hot Water Tank	1	Room 2
Refrigerator	1	Room 2
TV Screen	2	Room 4, 6
Smoke Detector	2	Room 5, 6

Hot Water Tank

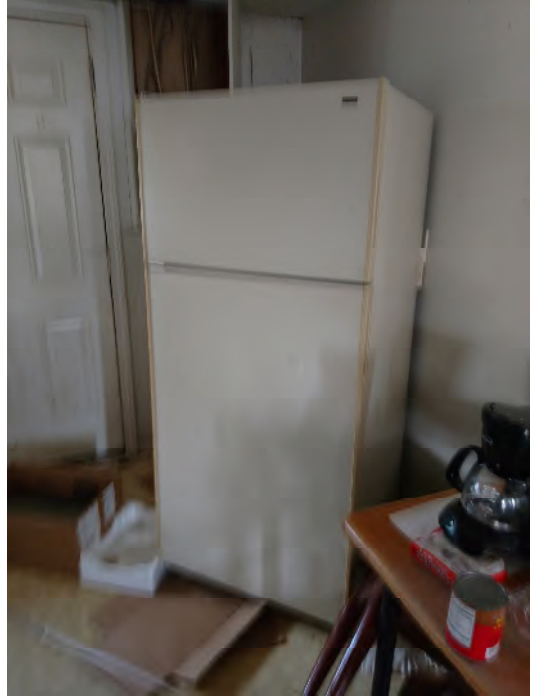
Refrigerator

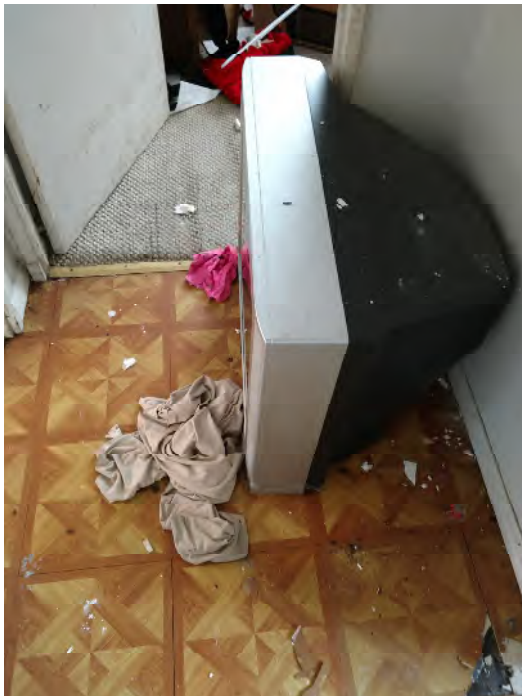
TV Screen

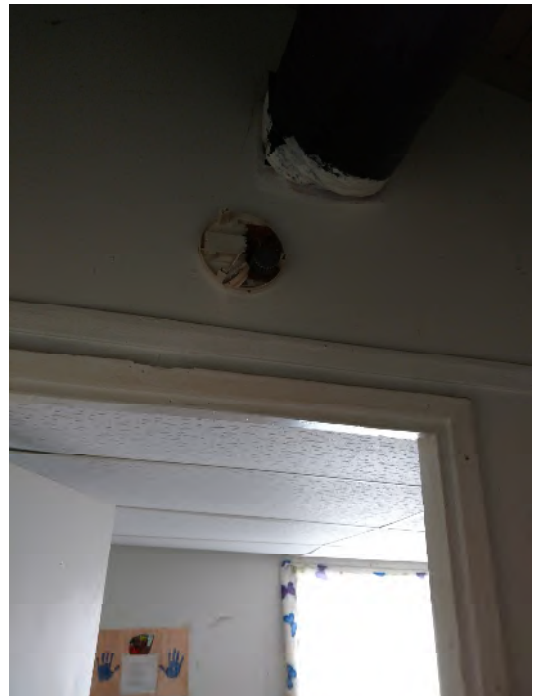
Smoke Detector

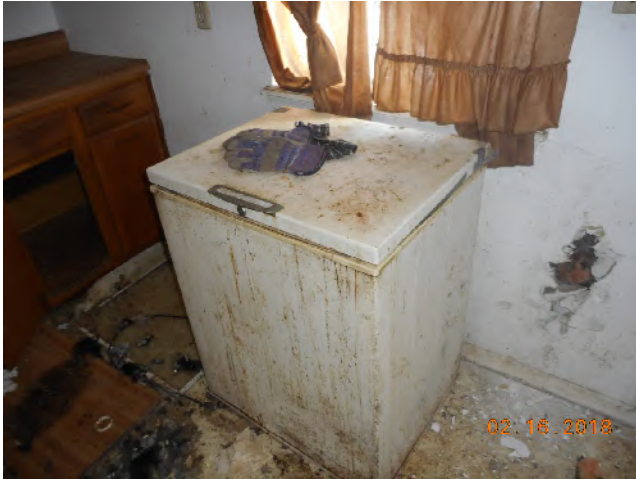
Freezers

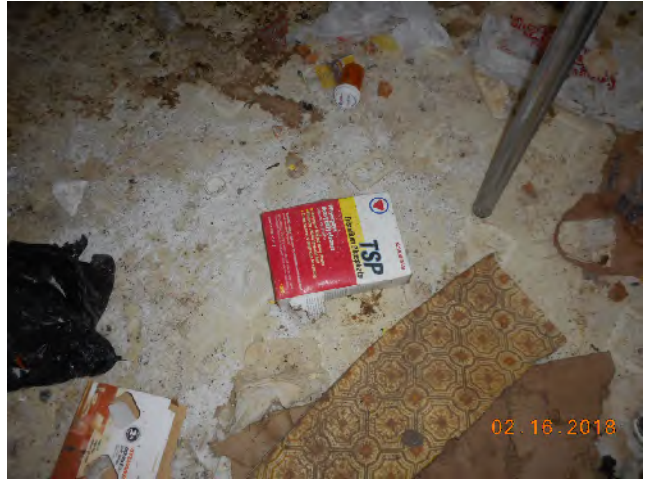
Misc. Items (solvents, cleaners, etc)

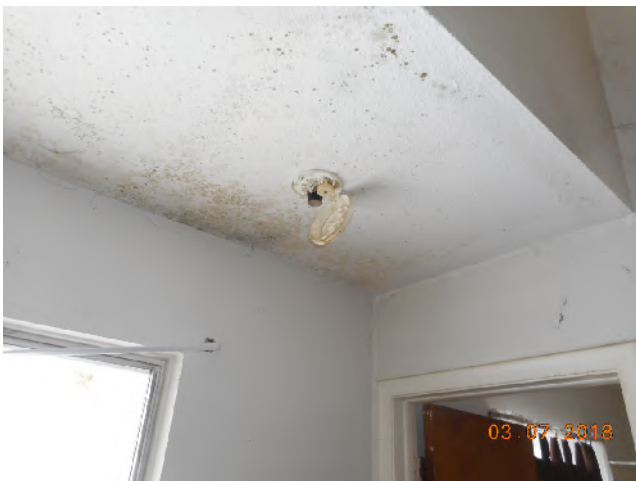
Smoke Detectors

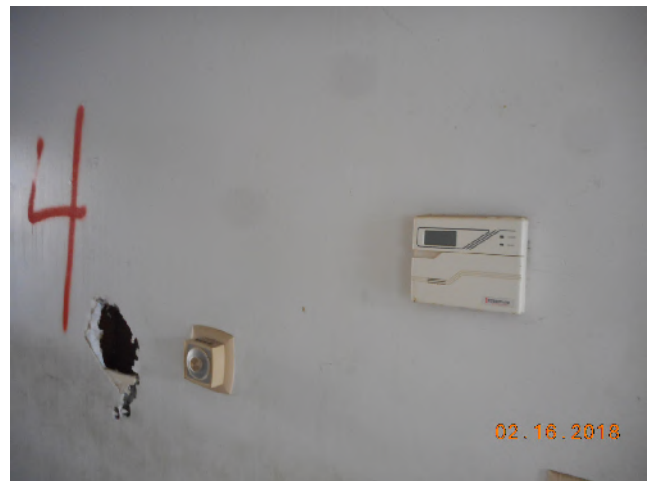
Thermostats

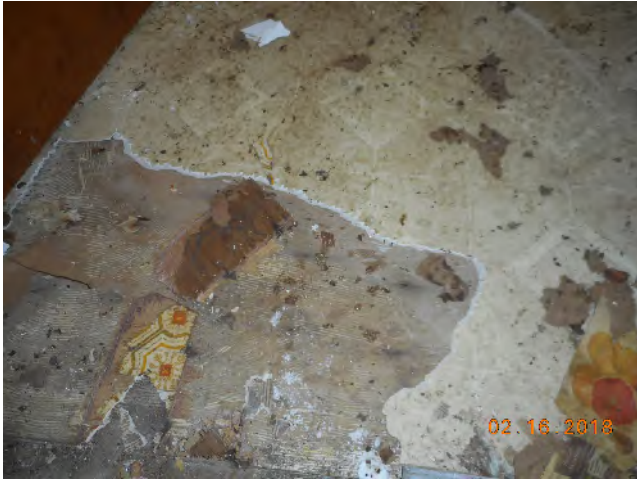
Linoleum, yellow/blue; Mastic

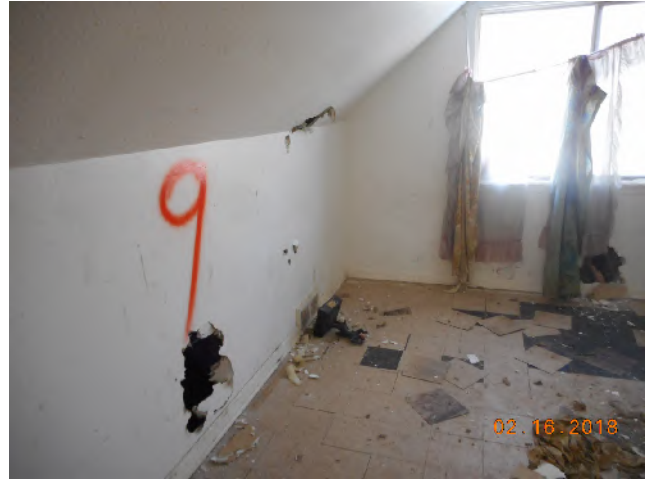
9x9 Tile, tan

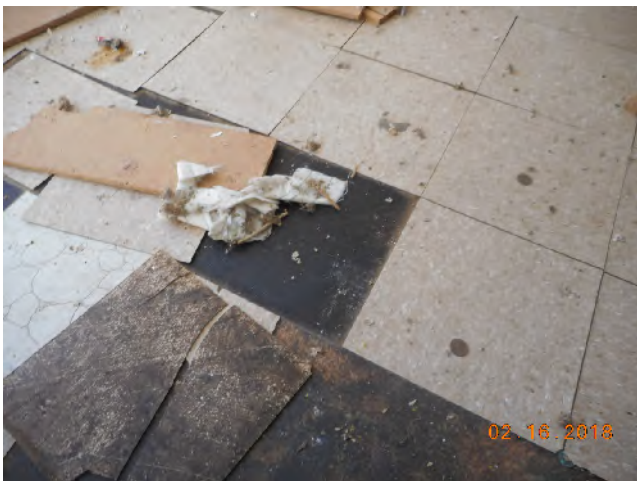
12x12 Tile, beige

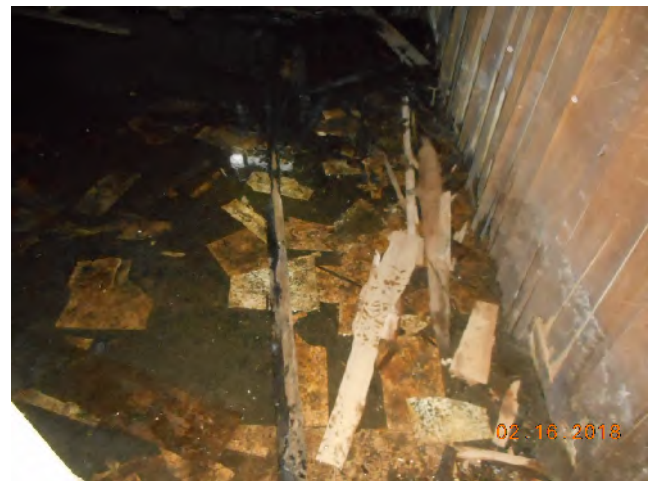
12x12 Tile, brown

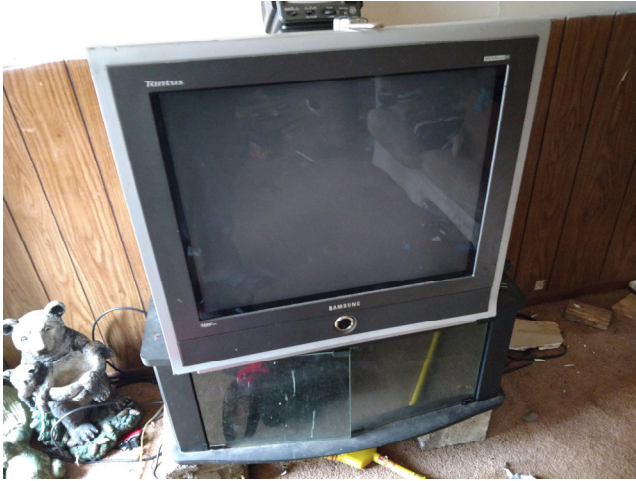
TV Screen, Electronics

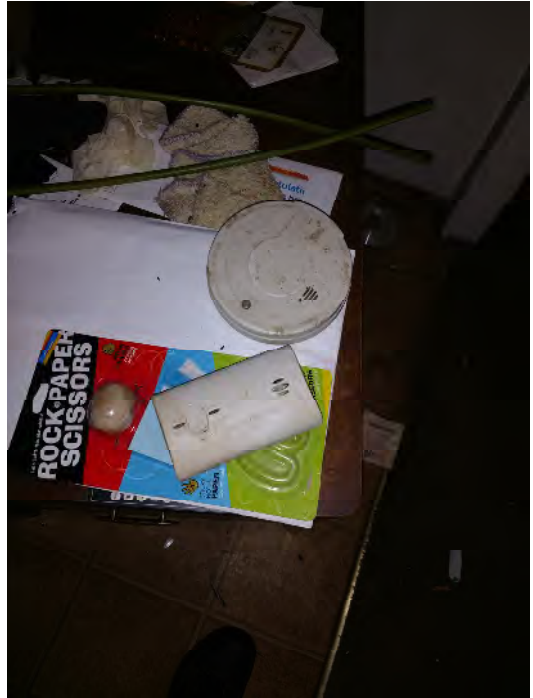
Smoke Detector

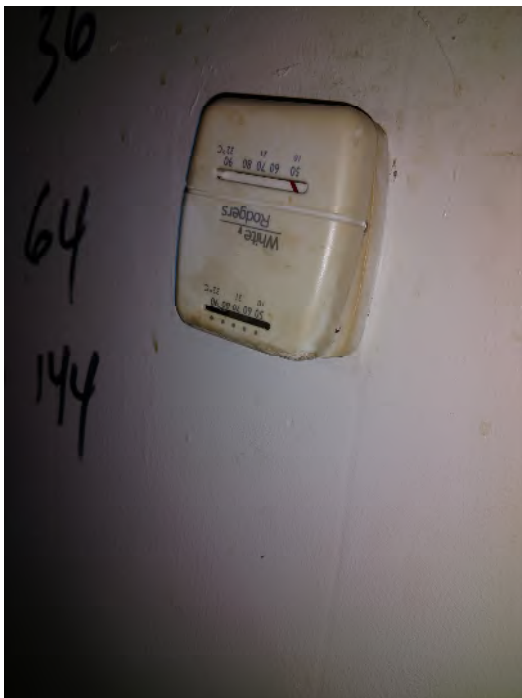
Thermostat

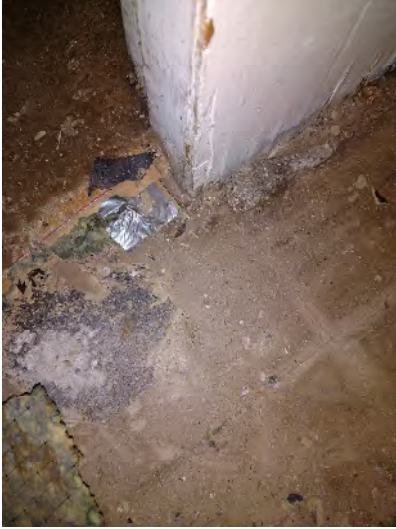
9x9 Floor Tile

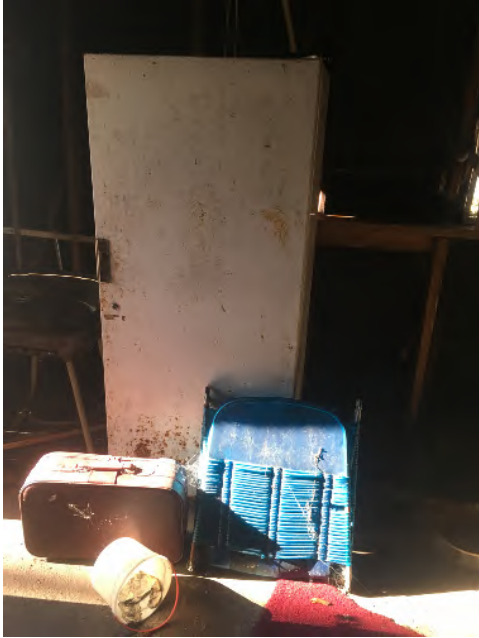
Refrigerator

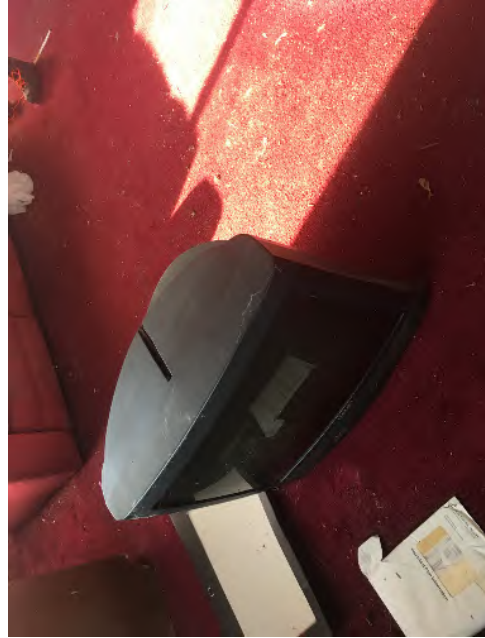
TV Screen

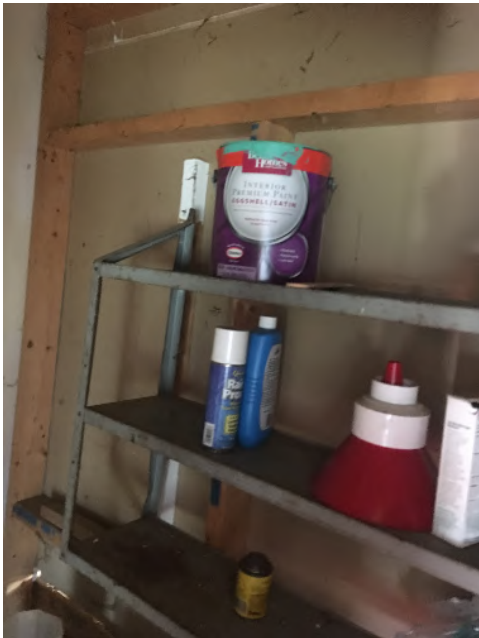
Paint Cans

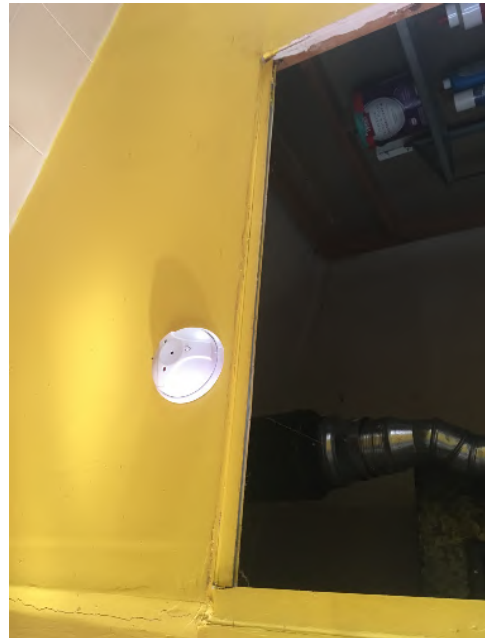
Smoke Detector

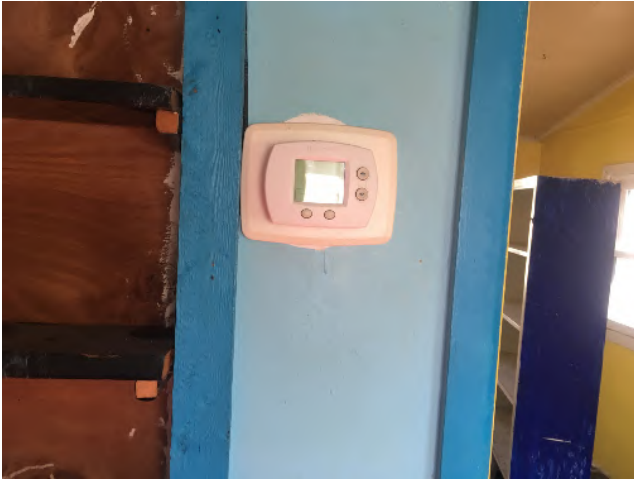
Thermostat

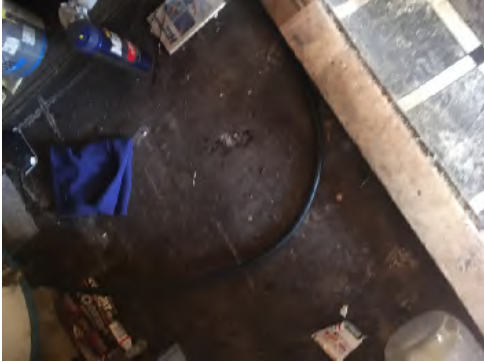
9x9 Floor Tile, black

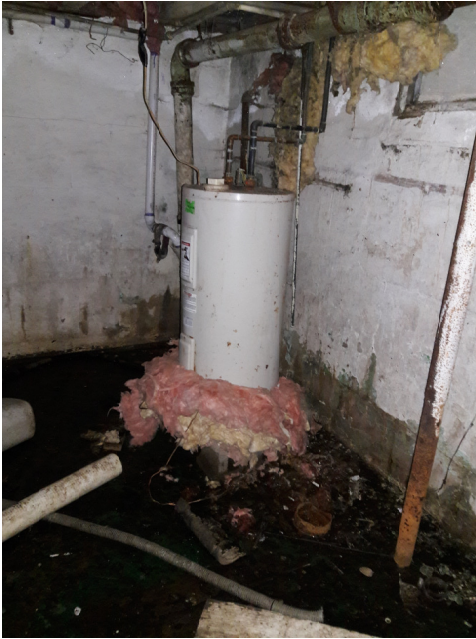
Hot Water Heater

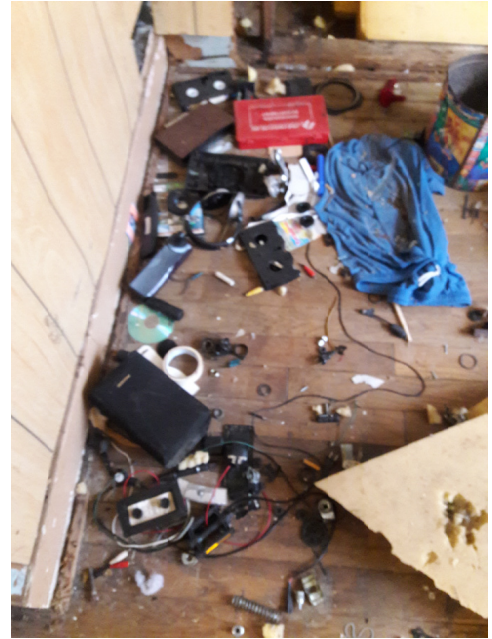
Electronics

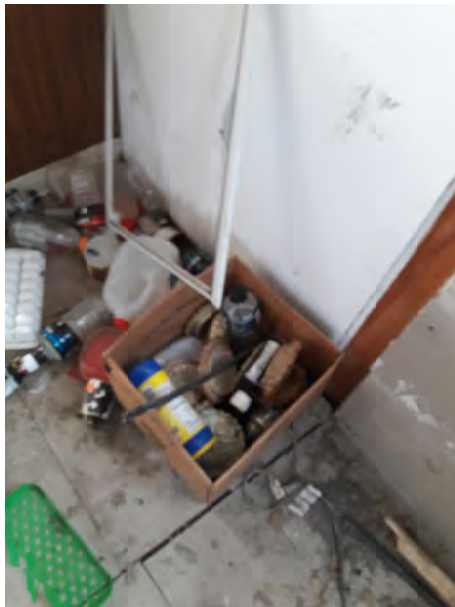
Misc. Items (solvents, cleaners)

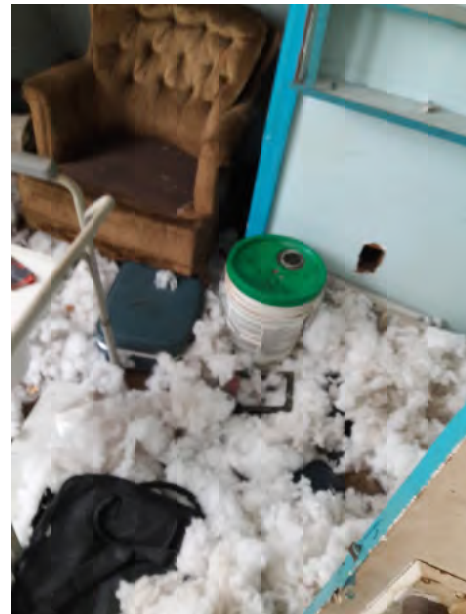
Paint Can

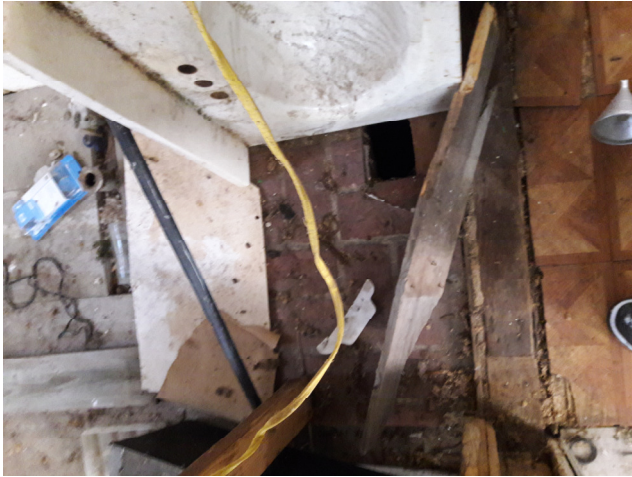
Linoleum, red

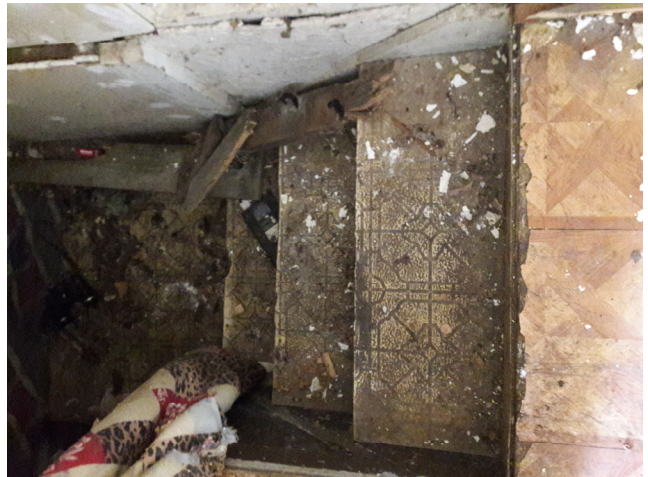
Linoleum, brown

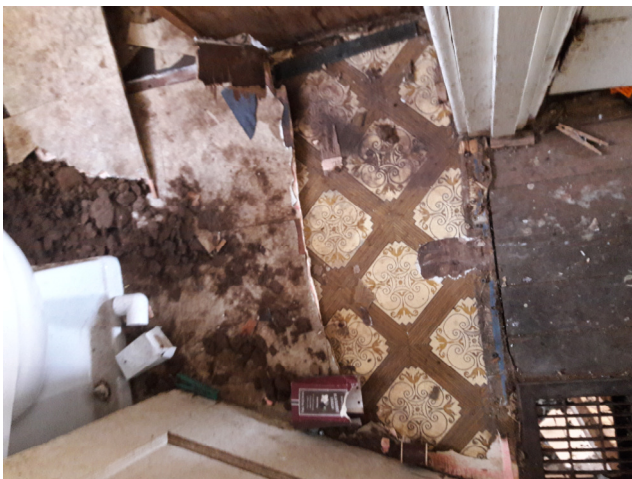
Linoleum, tan

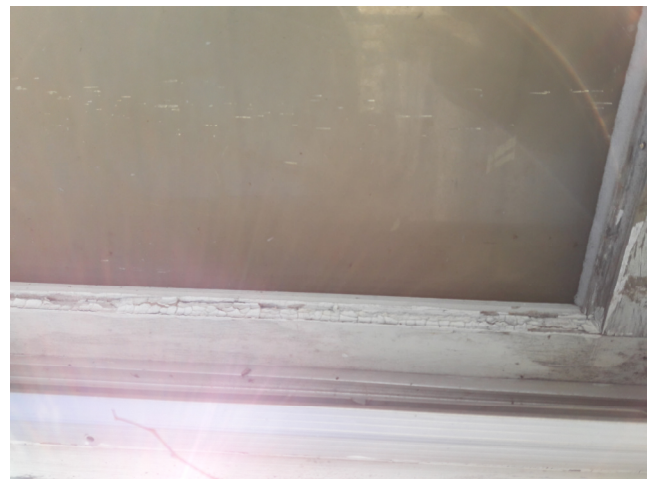
Window Glaze
