***RE: Asbestos Containing Material and Hazardous Materials Inspection
613 Avon St., Lansing, MI 48910
Parcel ID: 33-01-01-21-431-045***

Project No.: 19-1159
Ingham County Land Bank
Parcel ID: 33-01-01-21-431-045

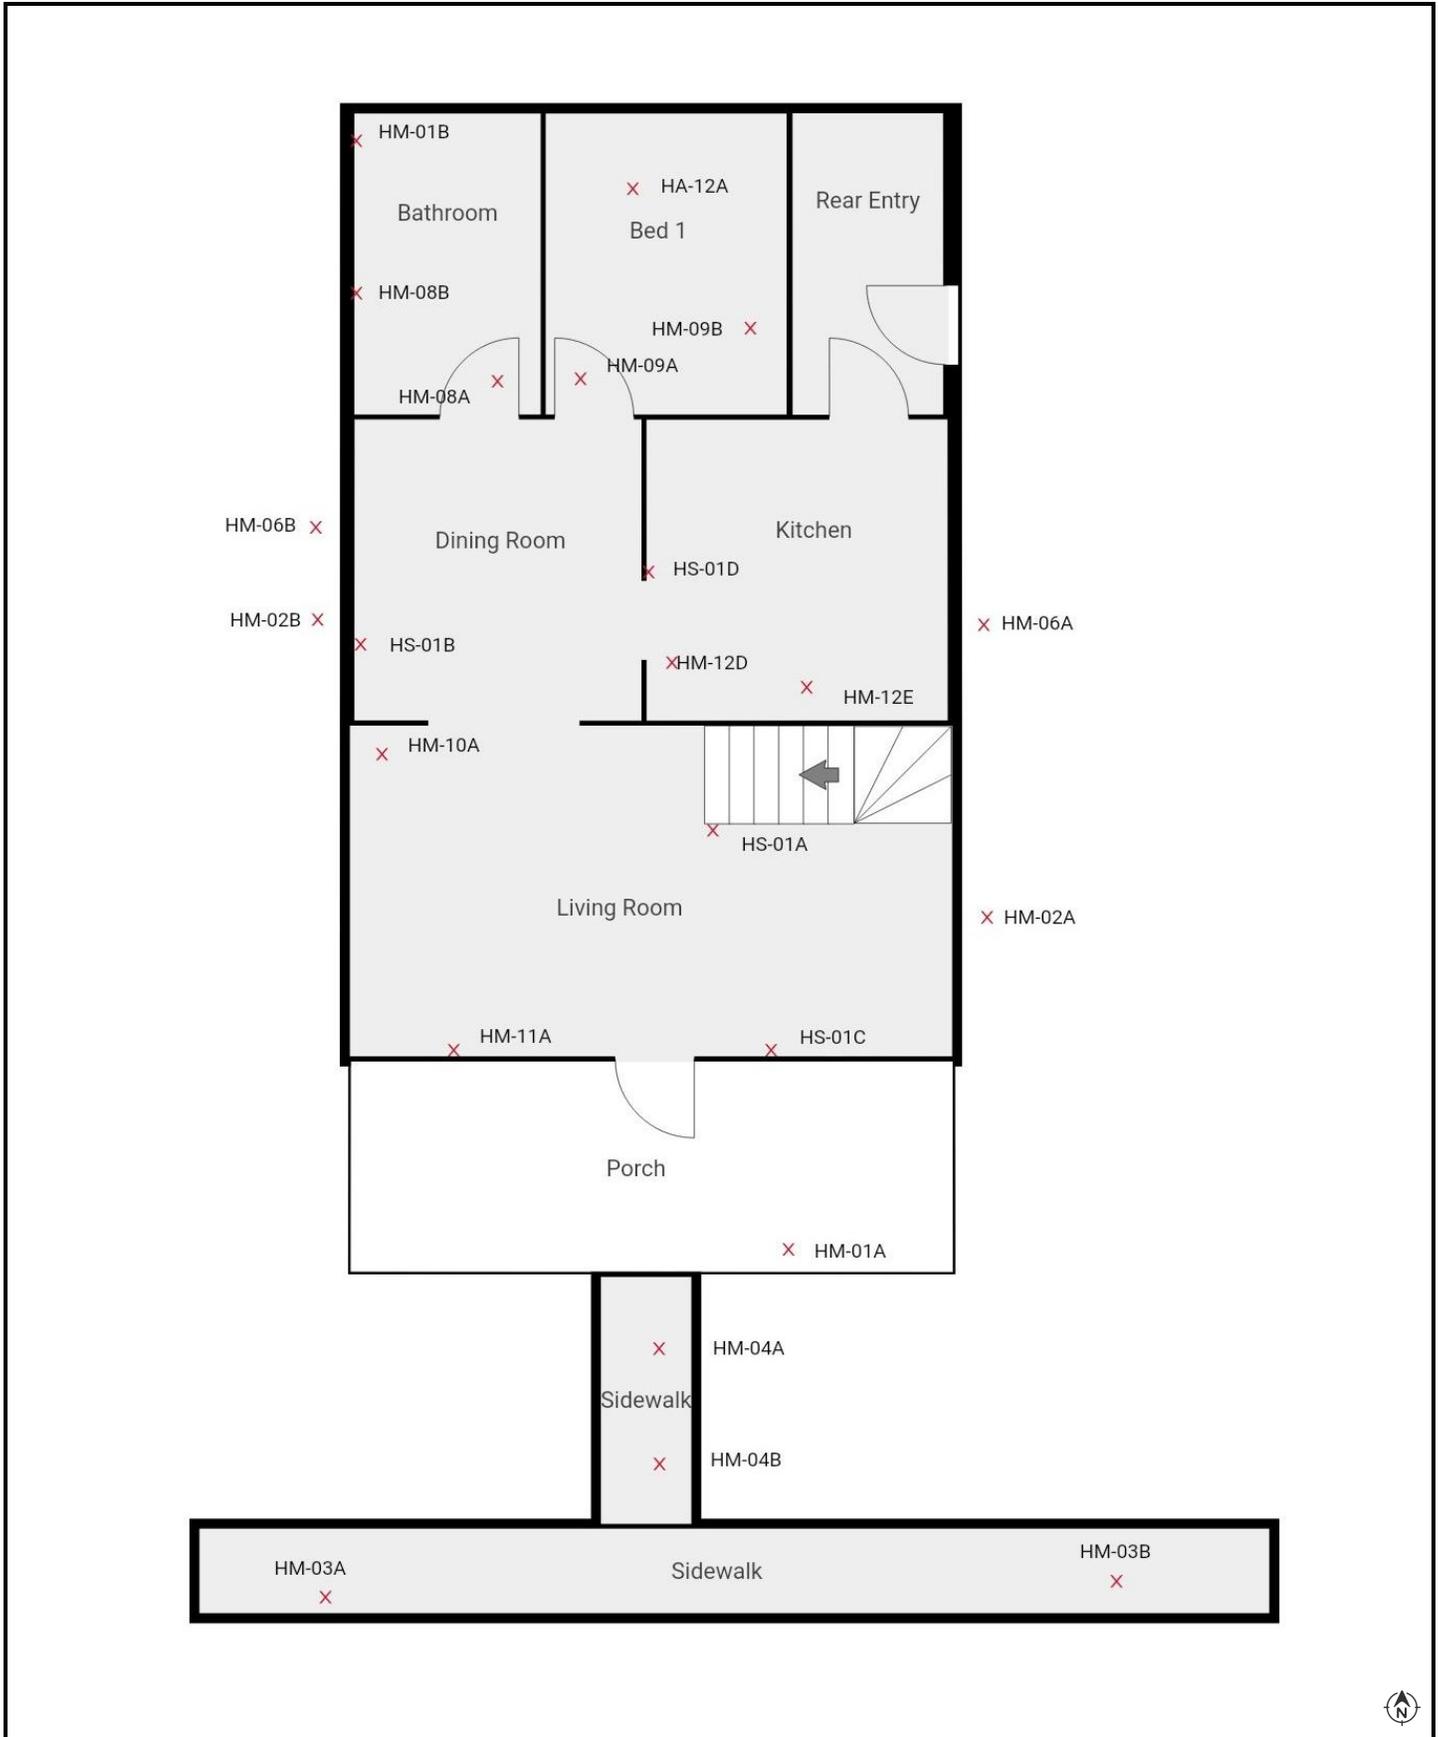
Figure 1a Site Diagram

Asbestos Sample Locations
613 Avon St.
Lansing, MI

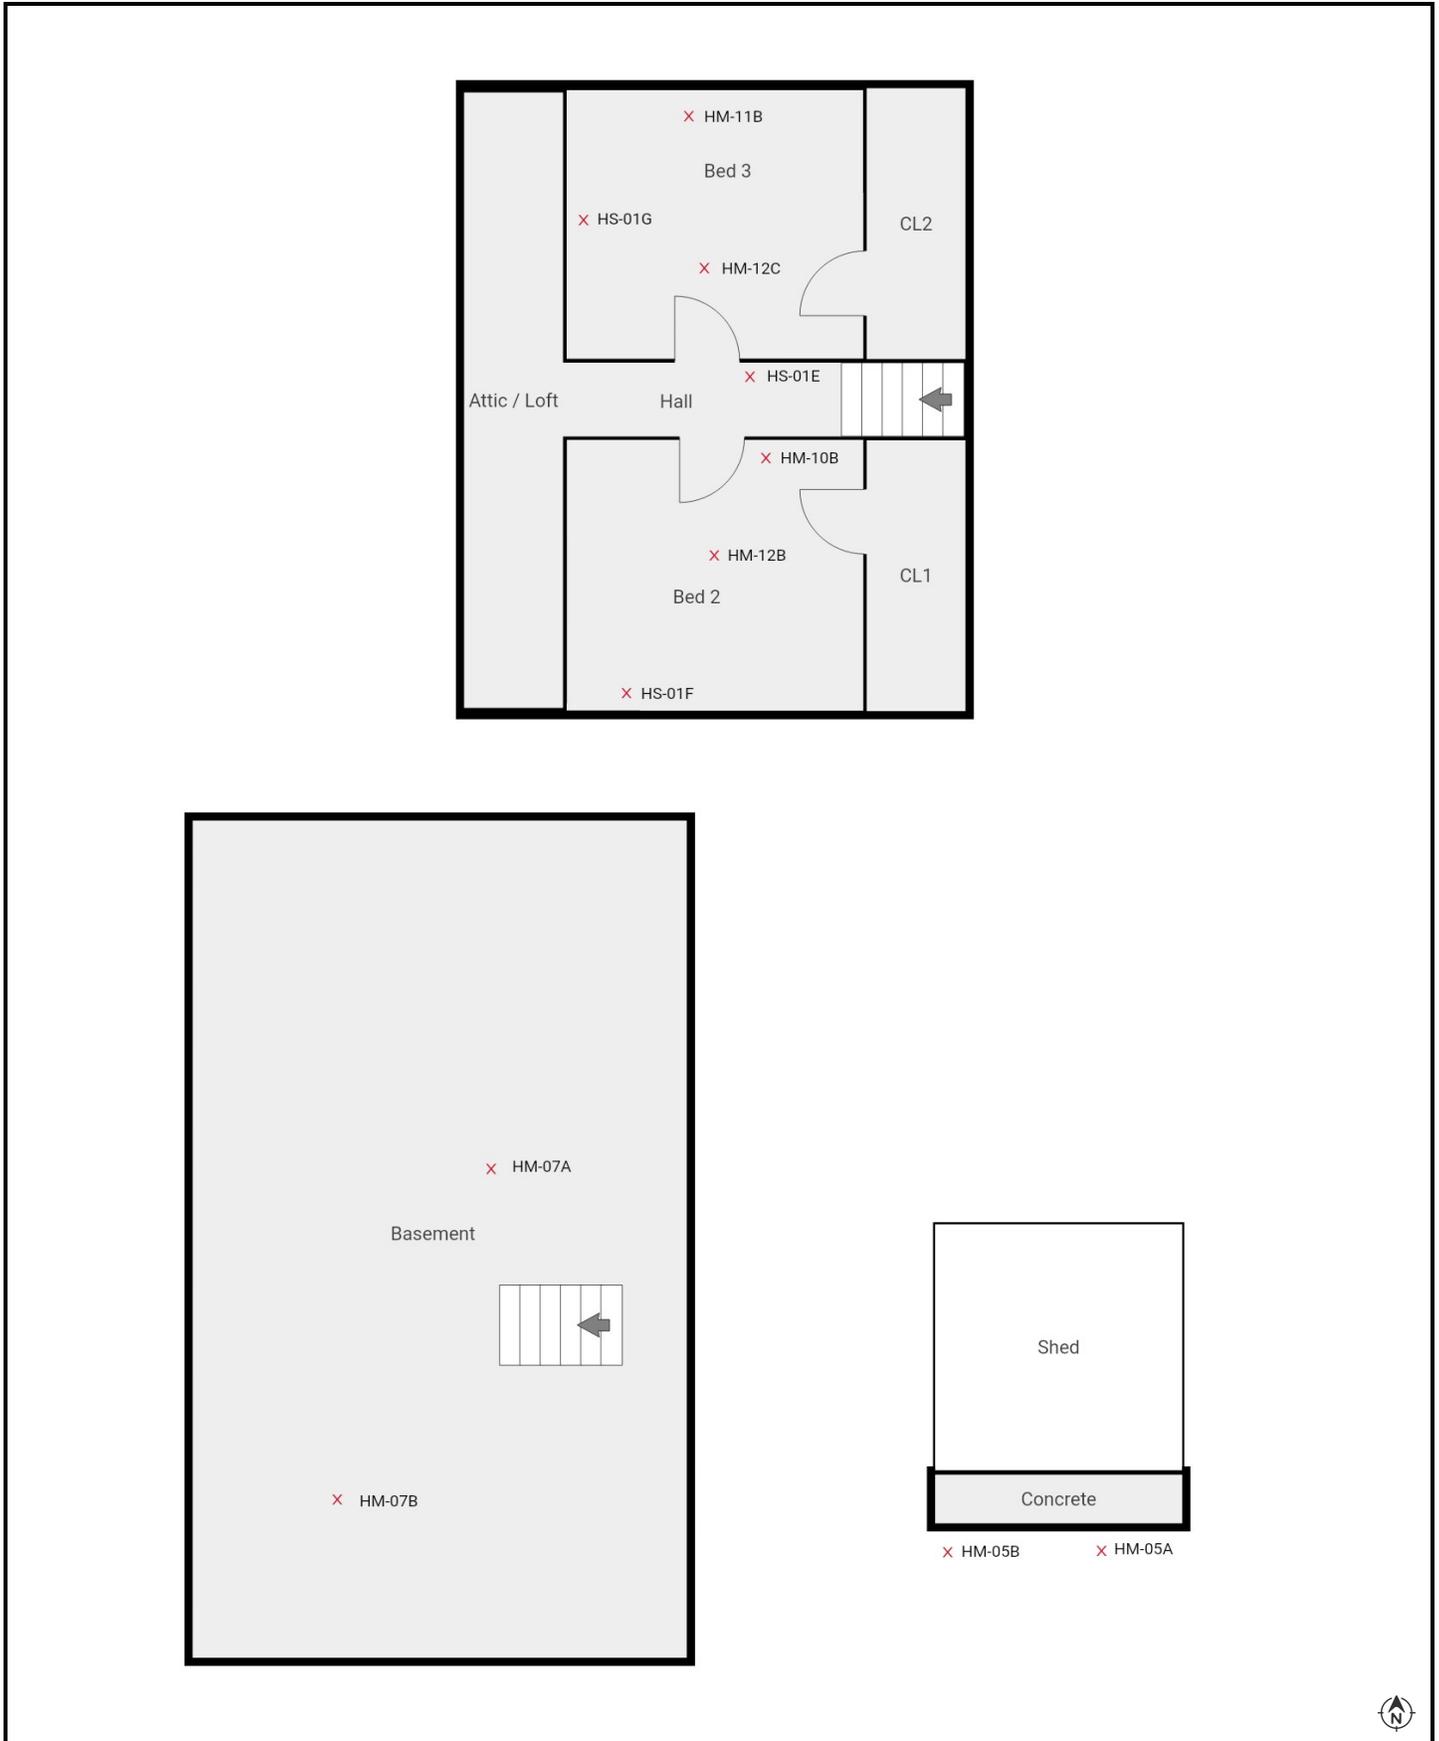
Figure 1b Site Diagram

Asbestos Sample Locations
613 Avon St.
Lansing, MI

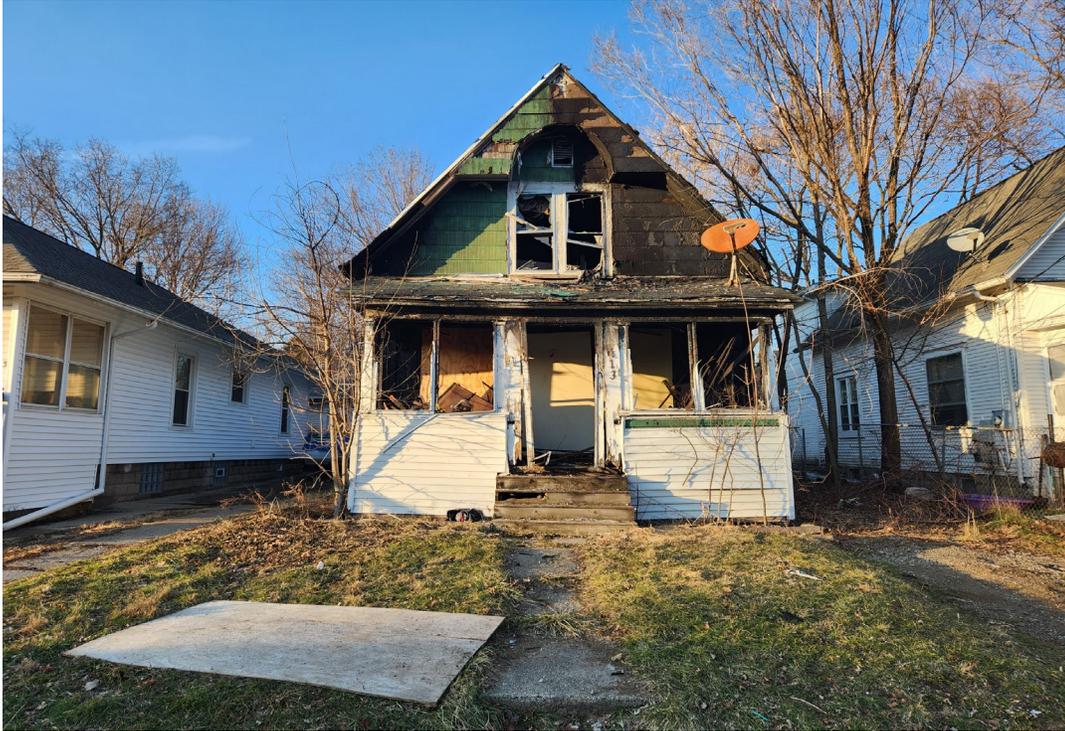
PHOTO: 1

SUBJECT: Building Front Exterior

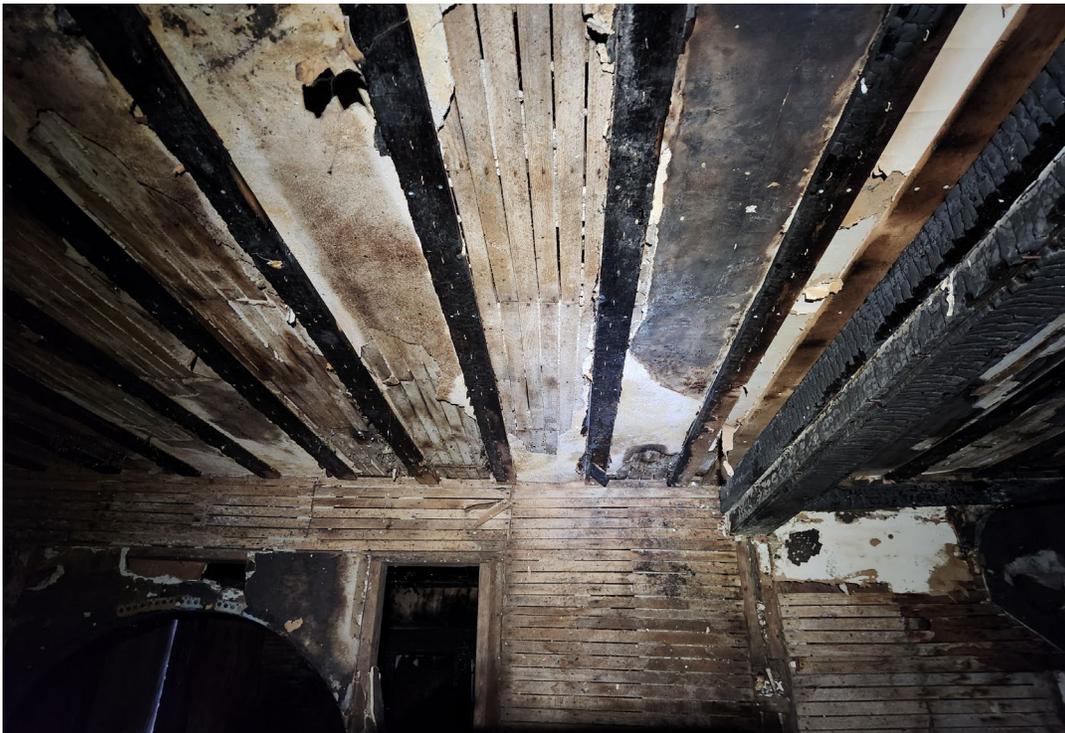
Plaster samples, collected from the Living Room, Dining Room, Bedrooms, Kitchen and Hallway were found to contain up to 2% asbestos following analysis. The assessment to quantify the extent of this material identified approximately 5,437 sq. ft. of plaster within the Building. Please note this is a severely fire damaged building which has comeingled with the asbestos containing interior plaster.

SUBJECT: Ceiling Plaster Living Room

Due to the severity of the fire damage within this Building, it is Red Cedars recommendation to demolish the building as a full ACM demo. There is no way to separate the building contents and structure from the asbestos containing wall and ceiling plaster.

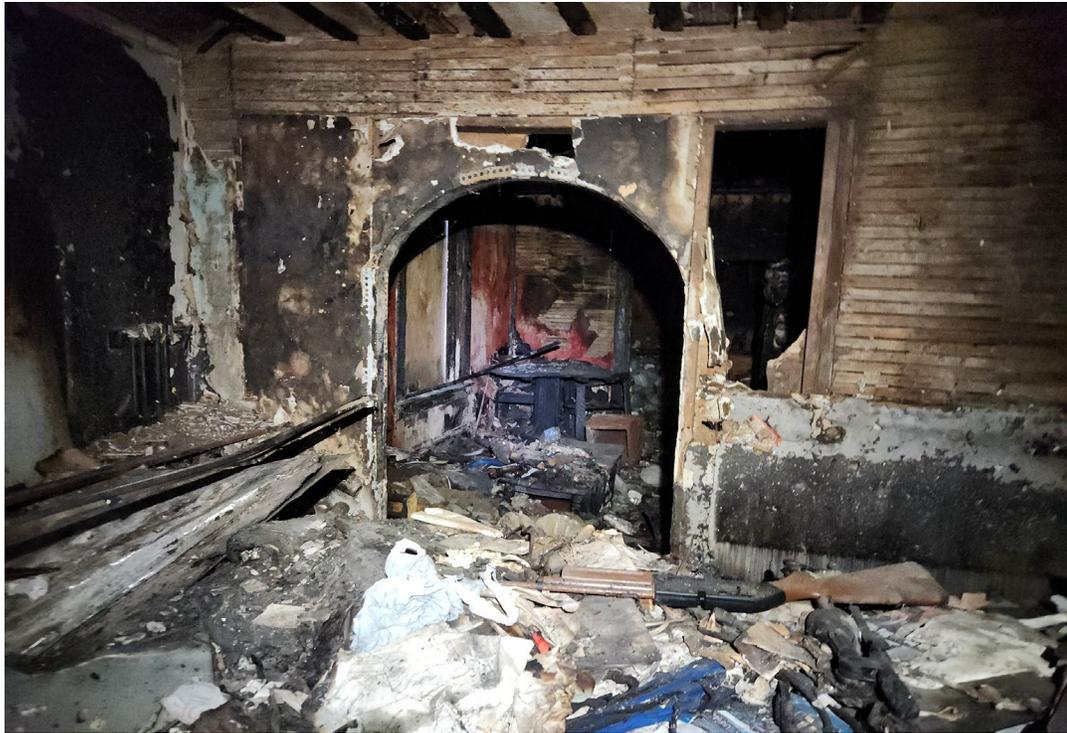
PHOTO: 3

SUBJECT: Severely Damaged, Co-Mingled Plaster and Debris.
