RE: *Asbestos Containing Material and Hazardous Materials Inspection*
1210 N MLK Jr. Blvd. Lansing, MI 48915
Parcel ID: 33-01-01-08-426-021

Project No.: 19-1159
Ingham County Land Bank
Parcel ID: 33-01-01-08-426-021

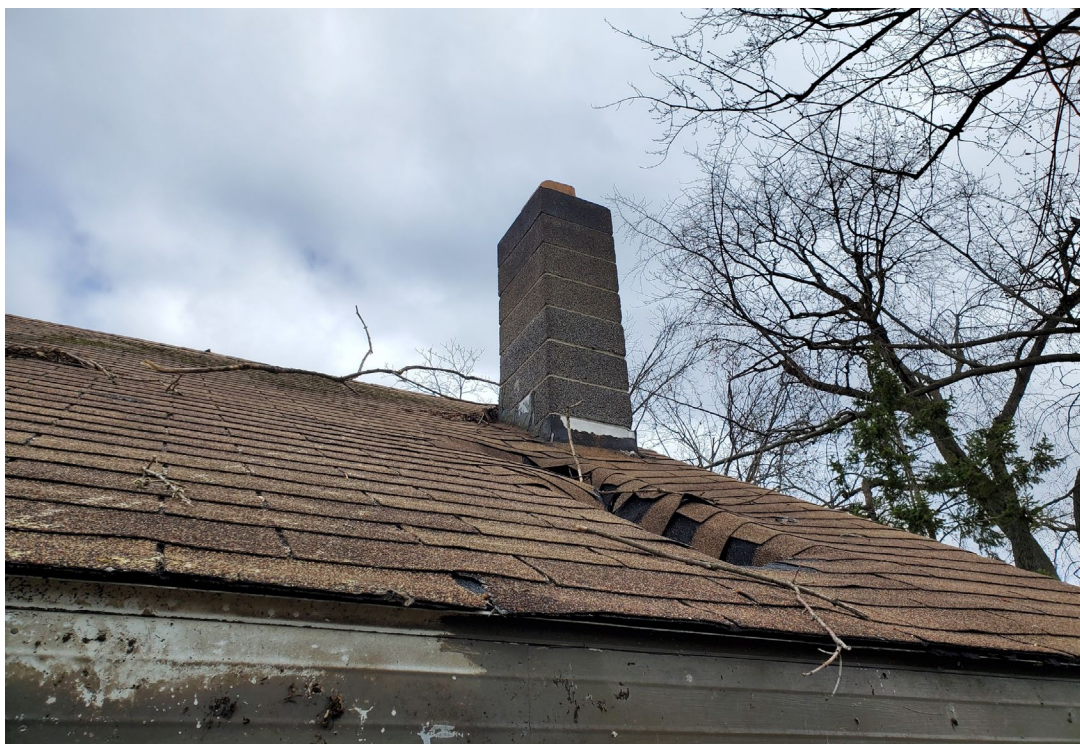
PHOTO: 3

Chimney Flashing samples collected during the completion of the inspection were found to contain up to 10% Chrysotile asbestos. The assessment to quantify the extent of this material identified 5 sq. ft. of chimney flashing materials on the Garage.

SUBJECT: Garage Chimney Flashing

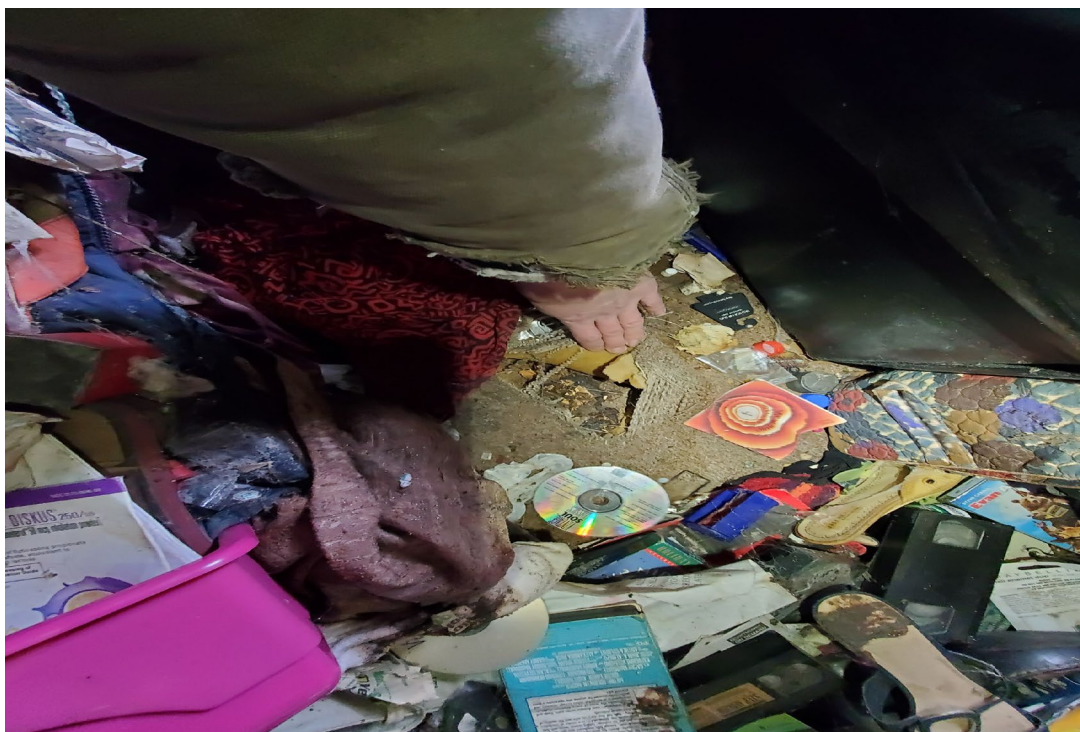
PHOTO: 4

Three types of resilient floor covering located throughout the Building were found to contain up to 10% Chrysotile asbestos. The assessment to quantify the extent of this material identified approximately 392 sq. ft. of this material within the Building. The locations of the and descriptions of the floor coverings are listed below:

SUBJECT: 9"x9" Brown Vinyl Floor Tile in SW Bedroom

The Category I resilient floor coverings are non-friable ACM's that should be abated to mitigate any future exposure.

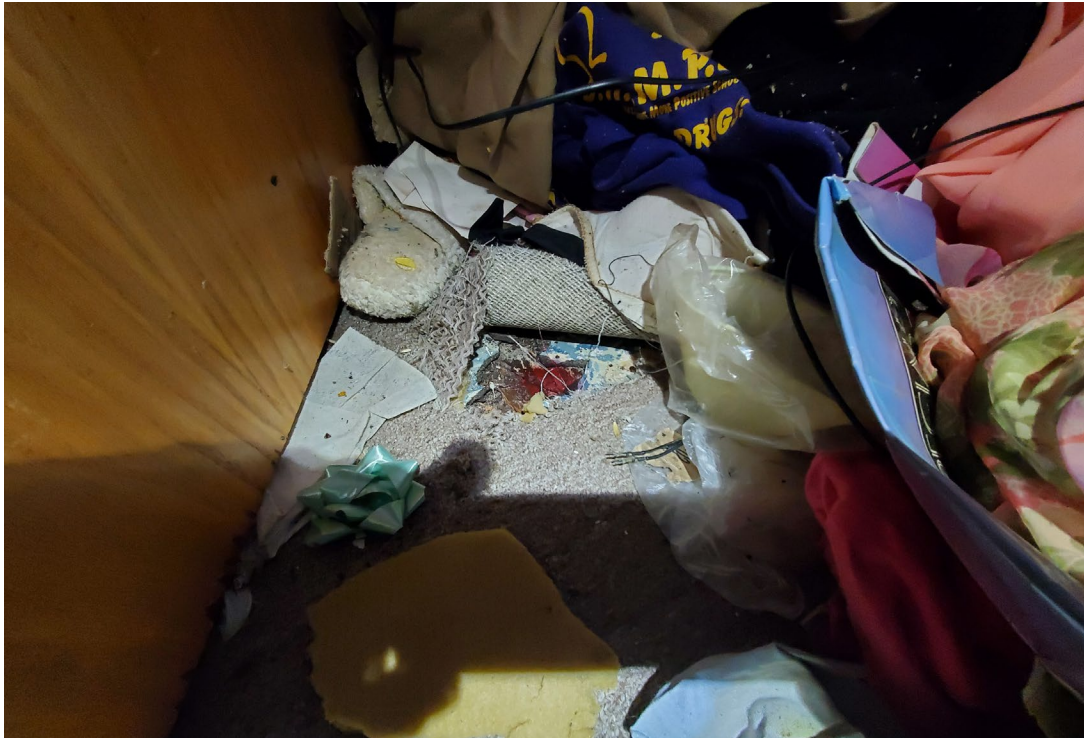
PHOTO: 5

SUBJECT: Blue Linoleum/9"x9" Vinyl Floor Tile in 2nd Fl. NE Bedroom

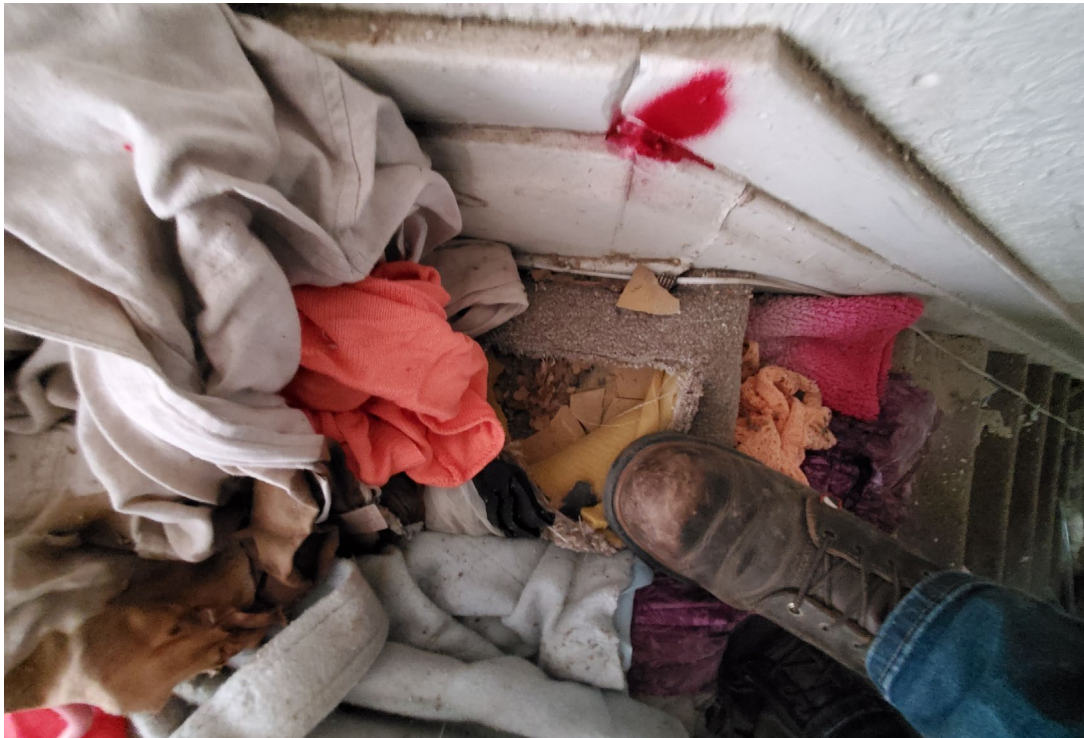
PHOTO: 6

SUBJECT: 12"x12" Yellow Vinyl Floor Tile on 2nd Fl. Landing

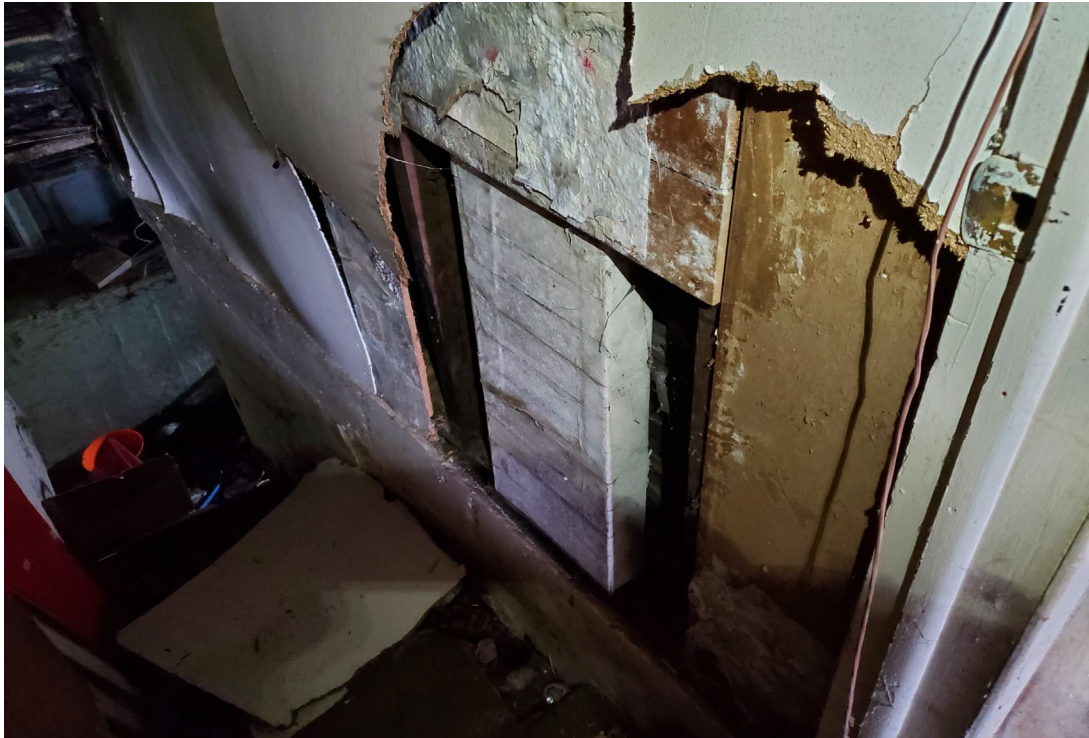
PHOTO: 7

Duct Wrap and Tape identified in the building in conjunction with the forced air heating system is classified as friable ACM. The visual assessment to quantify the extent of this material identified HVAC Duct Wrap at the following locations within the basement, first and second floors:

SUBJECT: HVAC Duct Wrap

HVAC material identified in the Building system and listed below is classified as friable ACM and should be removed prior to any renovation/demolition activities.

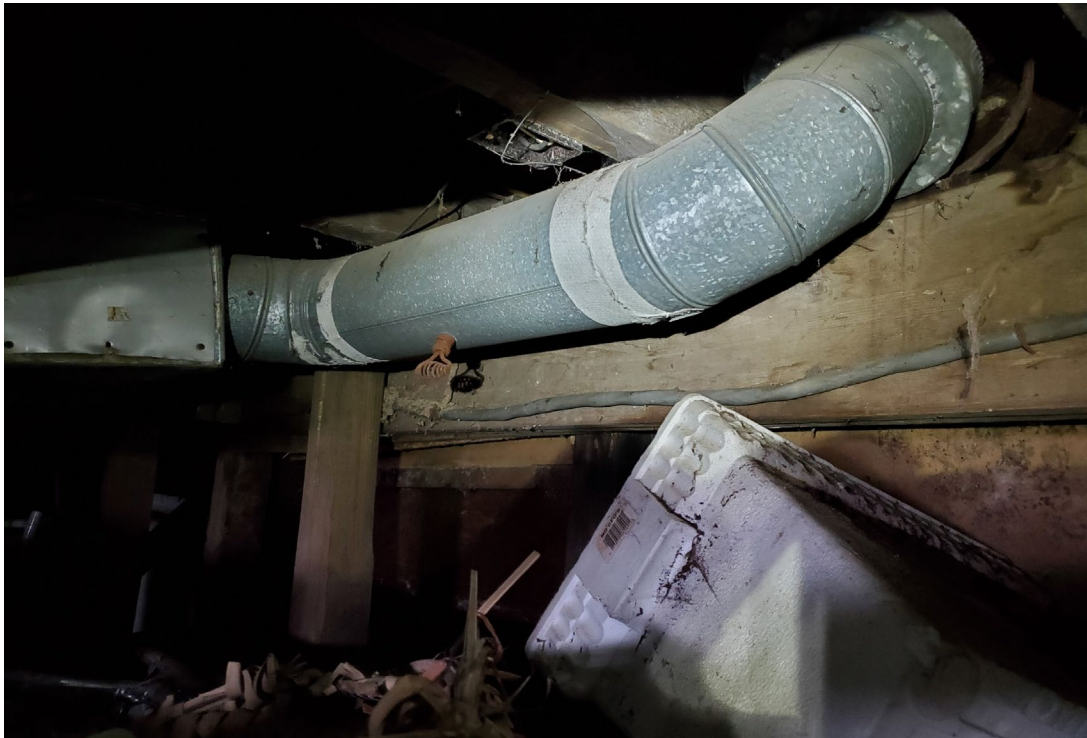
PHOTO: 8

SUBJECT: HVAC Tape
