April 7, 2025

***RE: Asbestos Containing Material and Hazardous Materials Inspection
2131 Pleasant View Ave. Lansing, MI 48910
Parcel ID: 33010132151001***

Project No.: 19-1159
Ingham County Land Bank
Parcel ID: 33010132151001

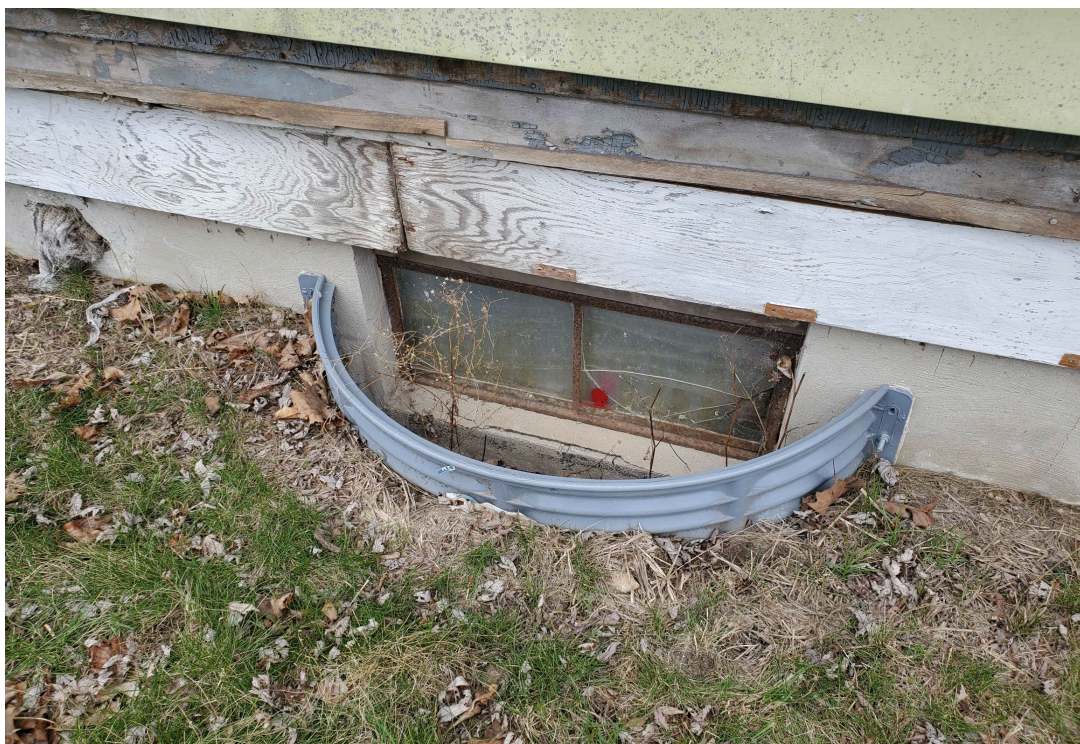
PHOTO: 3

A window glazing sample collected from a window in the Basement was found to contain up to 2% asbestos following analysis. The assessment to quantify the extent of this material identified seven windows at the following locations that would fall into the same homogenous group. The locations of the windows are listed below:

- Basement (7 windows 14" wide x 30" tall)

SUBJECT: Basement Window Glazing

Friable asbestos containing window glazing was identified on seven windows throughout the Building. The locations of these windows that should be abated prior to demolition/renovation activities are listed below:

- Basement (7 windows 14" wide x 30" tall)

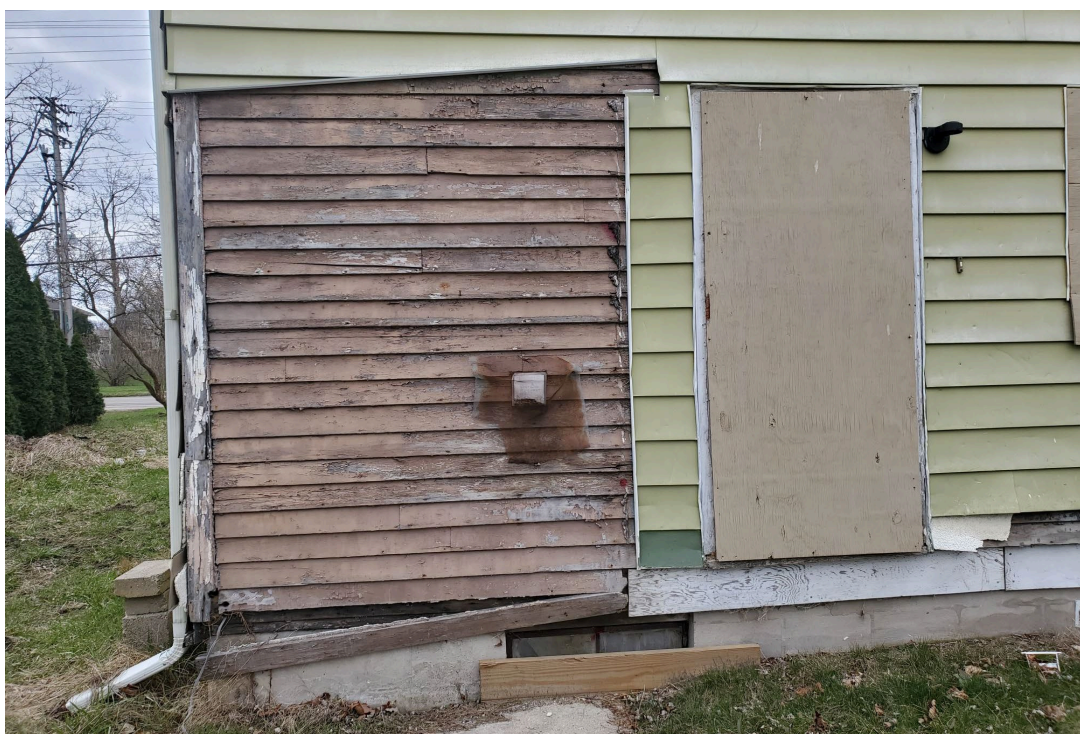
PHOTO: 4

Exterior trim caulk samples, collected from the East wall on the exterior of the Building were found to contain up to 5% asbestos following analysis. The assessment to quantify the extent of this material identified approximately 6 lin. ft. of blue green exterior trim caulk on and throughout the Building.

SUBJECT: Blue Green Exterior Caulk

Exterior trim caulk identified on the exterior of the Building must be abated prior to completion of any renovation/demolition activities at the Subject Property. Any Category II non-friable ACM that has a high probability of becoming or has become crumbled, pulverized, or reduced to powder by the forces expected to act on the material in the course of renovation or demolition operations must be properly abated.
