***RE: Asbestos Containing Material and Hazardous Materials Inspection
323 S Hayford Ave. Lansing, MI 48912
Parcel ID: 33010114310061***

Project No.: 19-1159
Ingham County Land Bank
Parcel ID: 33010114310061

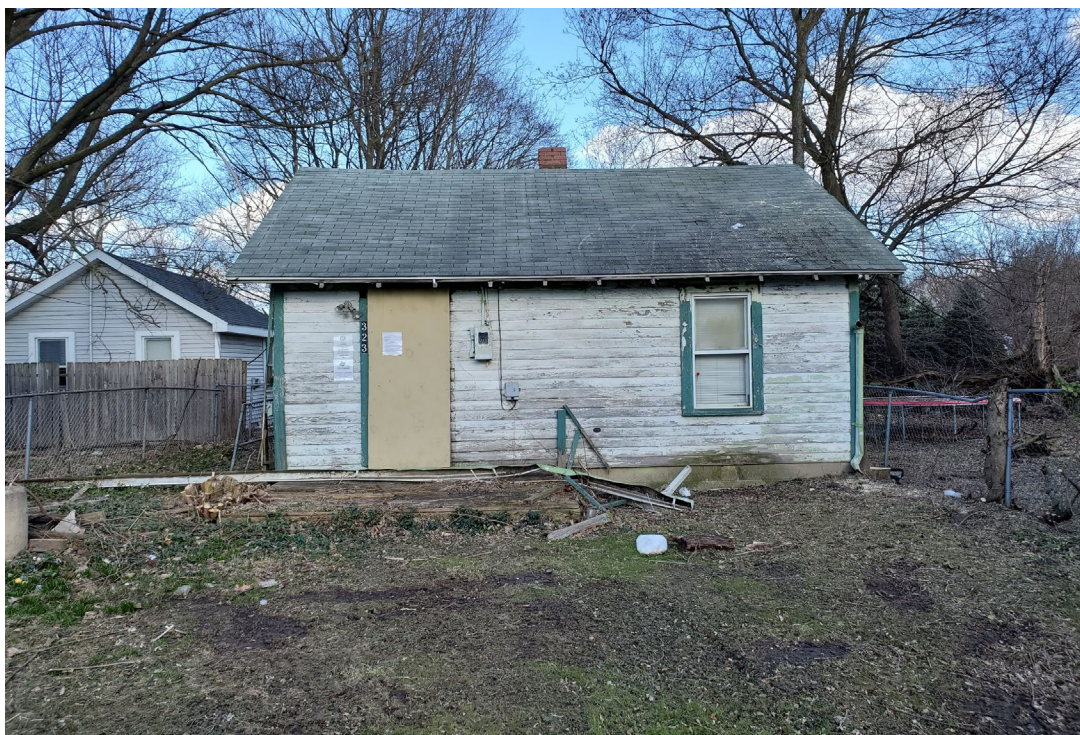
PHOTO: 1

SUBJECT: Building Front Exterior
