May 11, 2022

***RE: Asbestos Containing Material and Hazardous Materials Inspection
1027 Cady Ct., Lansing, MI 48906
Parcel ID: 33-01-01-10-329-321***

RE: *Asbestos Containing Material and Hazardous Materials Inspection*
929 Johnson Ave., Lansing, MI 48906
Parcel ID: 33-01-01-10-329-321

RE: *Asbestos Containing Material and Hazardous Materials Inspection*
819 Cleveland St., Lansing, MI 48906
Parcel ID: 33-01-01-10-377-231

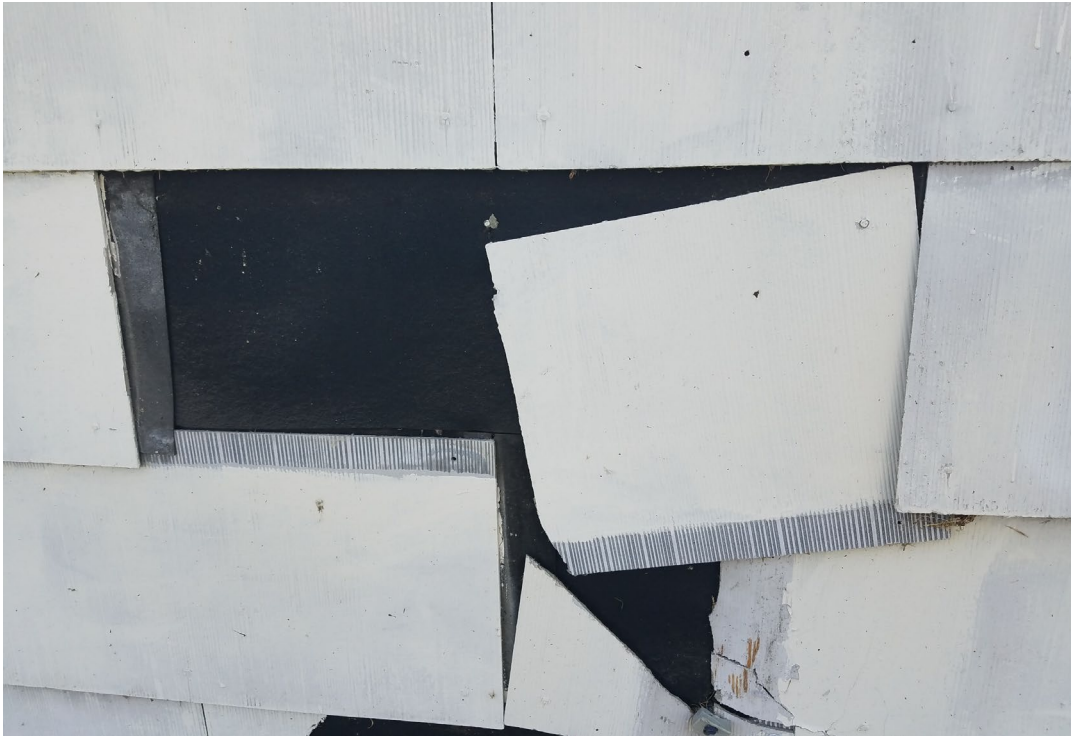
PHOTO: 2

SUBJECT: Transite Siding on Building

Asbestos Containing Material Description and Location					
Location	Material Description	Friable	Condition	Material Type	Approx. Quantity
Building Exterior	Transite Siding	No	Fair	M	1,180 sq. ft.
Michigan Basement "Shelf"	Transite Siding Debris	No	Fair	M	250 sq. ft.

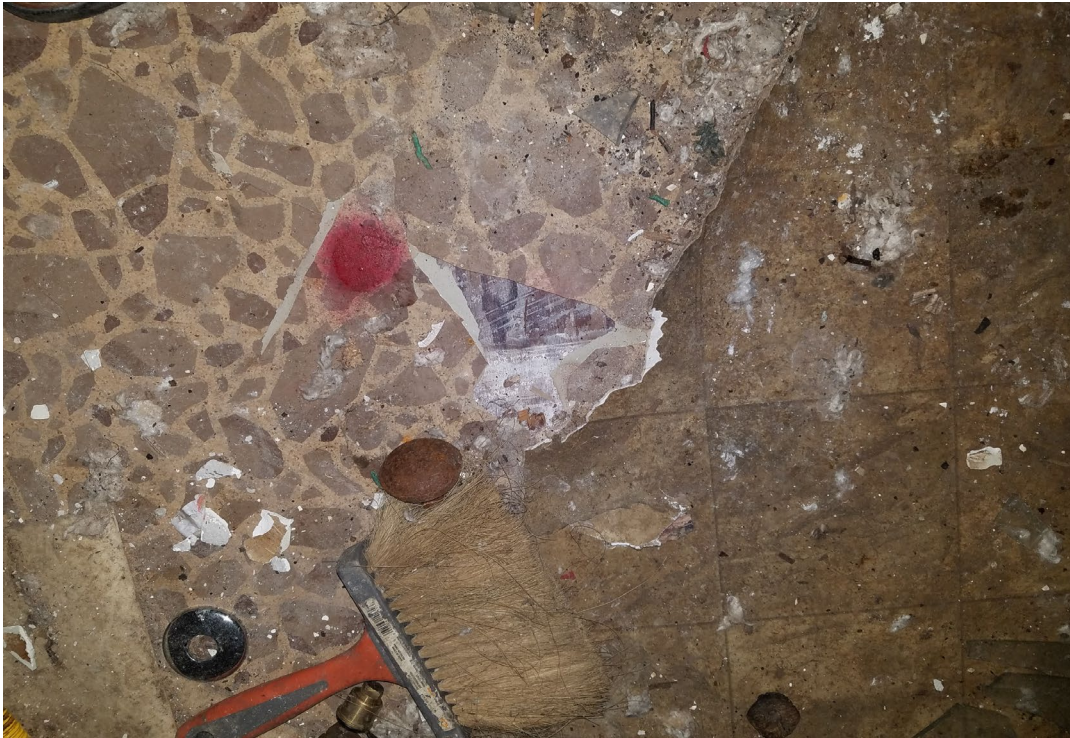
PHOTO: 3

Two types of resilient floor covering (Layered Yellow Linoleum and Beige Brick Linoleum) located within the kitchen and bath were found to contain up to 10% Chrysotile asbestos. The assessment to quantify the extent of this material identified approximately 150 sq. ft. of this material within the Building.

SUBJECT: Kitchen Flooring with Asbestos Mastic

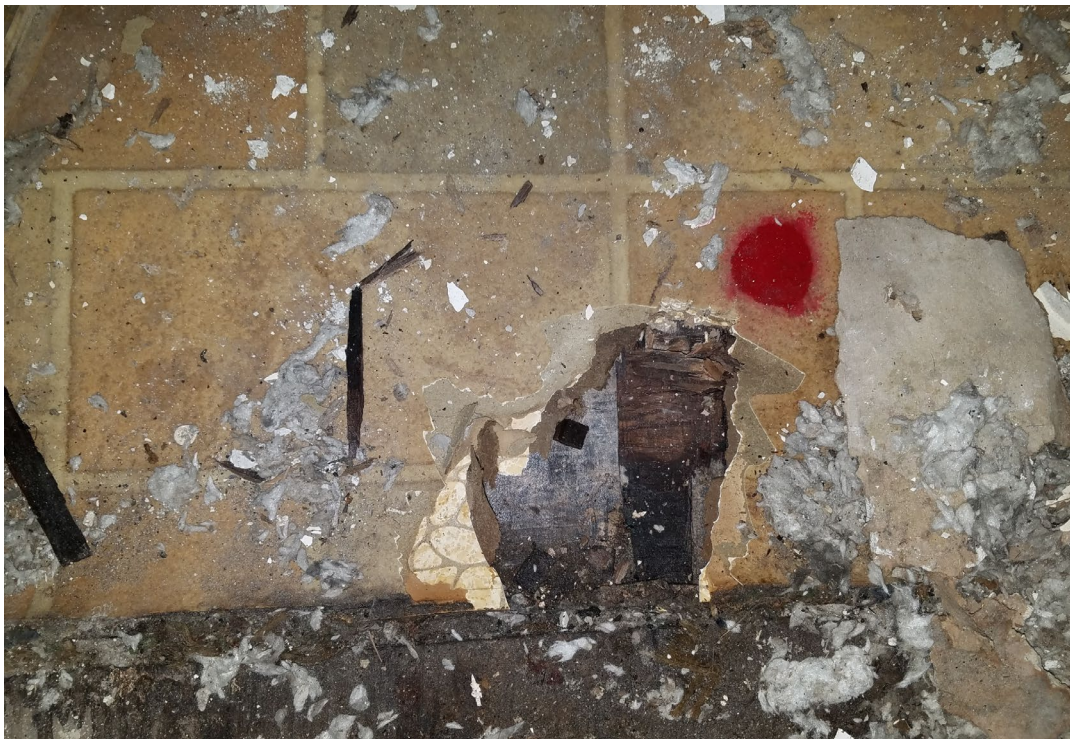
PHOTO: 4

SUBJECT: Bathroom Flooring with Asbestos Mastic

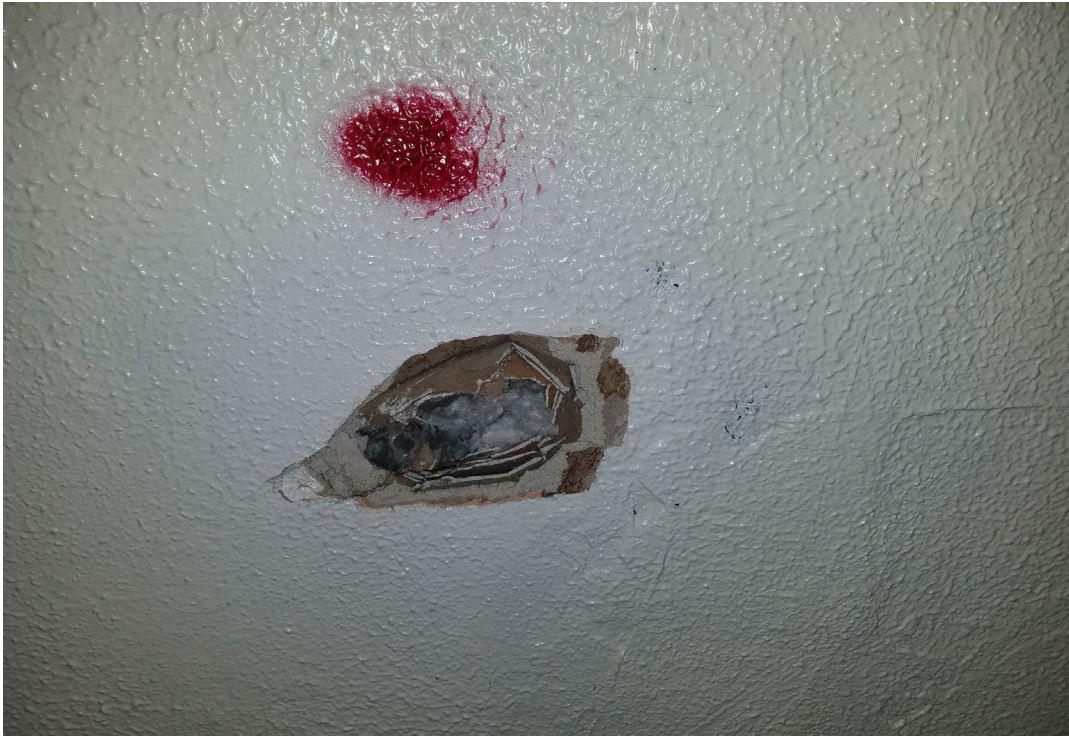
PHOTO: 5

Sand Plaster samples, collected from the Building were found to contain up to 1.5% asbestos following analysis. The assessment to quantify the extent of this material identified approximately 1,875 sq. ft. of sand plaster within the Building.

SUBJECT: Plaster Base Coat with Asbestos

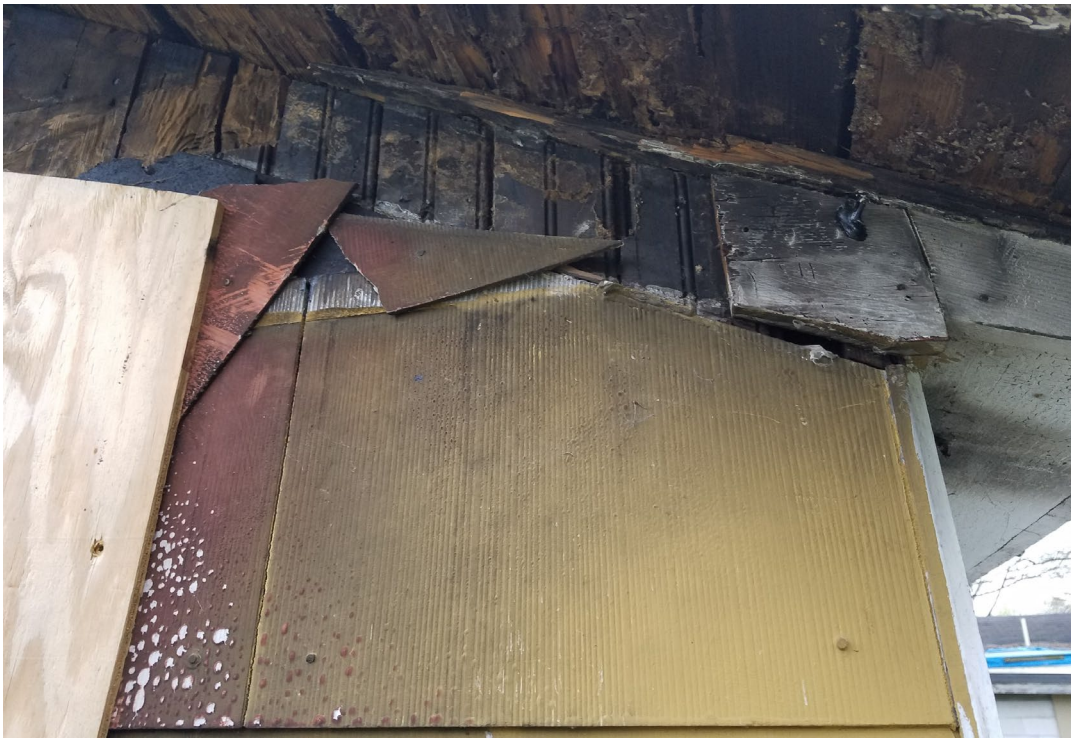
PHOTO: 2
SUBJECT: View of Transite Siding

Asbestos Containing Material Description and Location					
Location	Material Description	Friable	Condition	Material Type	Approx. Quantity
Building Exterior	Transite Siding	No	Fair	M	675 sq. ft.

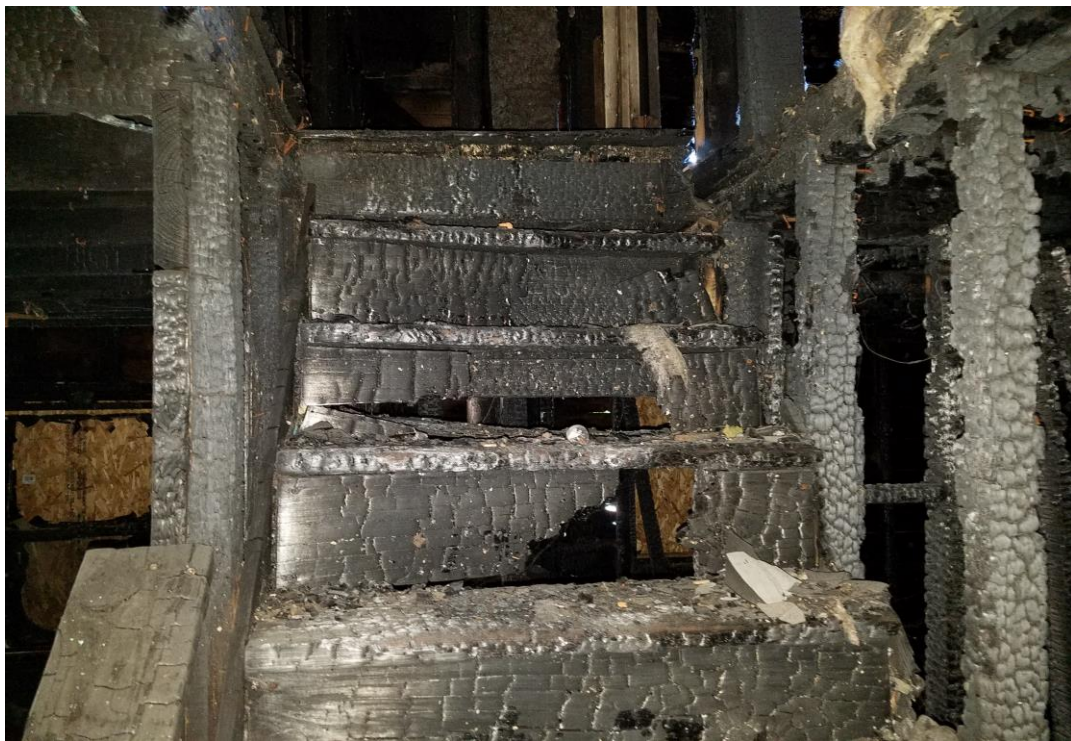
Please note this was Building under construction and most of the Lath and Plaster had been previously removed. Also, this is a structurally compromised fire burned building. All abatement contractors should personally assess the site prior to submitting a bid as alternative methods may need to be used for safety reasons.

PHOTO: 2
SUBJECT: Fire Damaged Stairwell

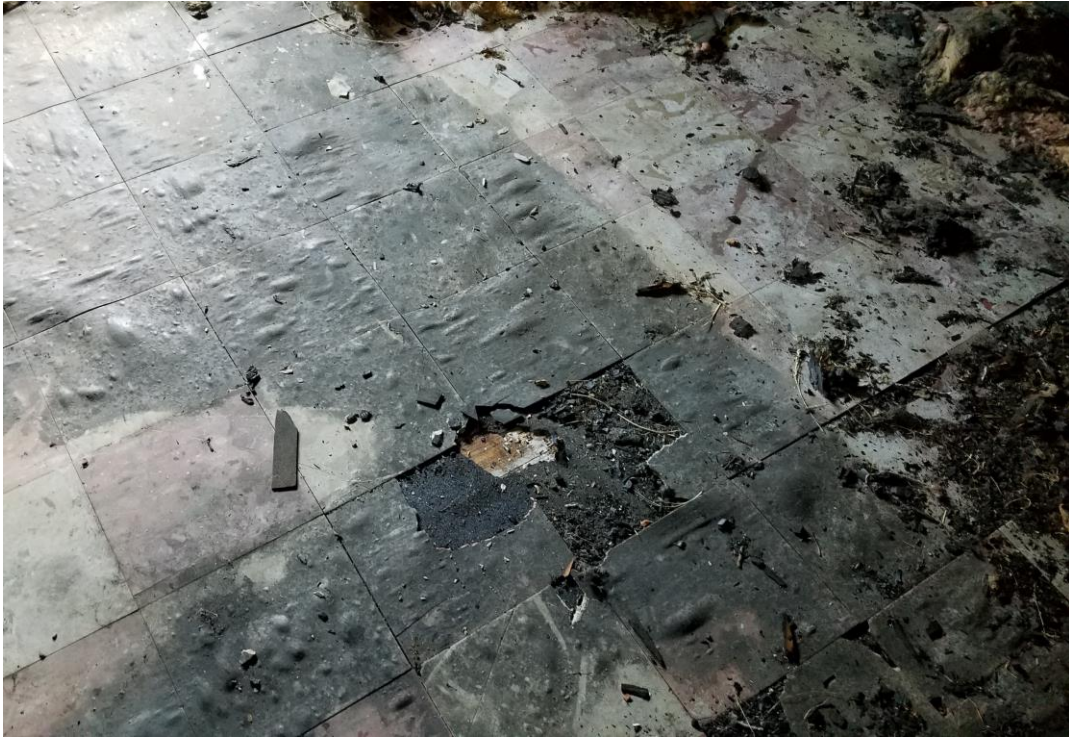
PHOTO: 3

A resilient floor covering (9x9 White & Pink VFT/Felt) located within the 2nd Fl. W Bedroom was found to contain up to 5% Chrysotile asbestos. The assessment to quantify the extent of this material identified approximately 180 sq. ft. of this material within the Building.

SUBJECT: 9x9 White & Pink VFT 2nd Fl. W Bedroom

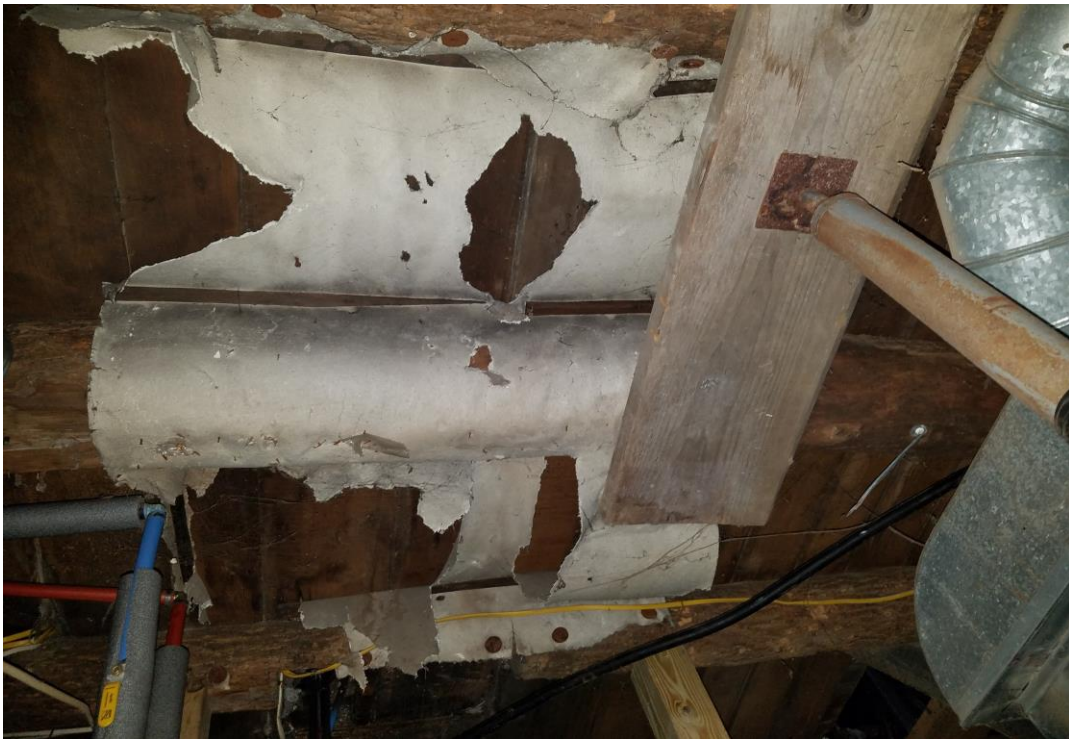
PHOTO: 4

SUBJECT: HVAC Paper in Basement

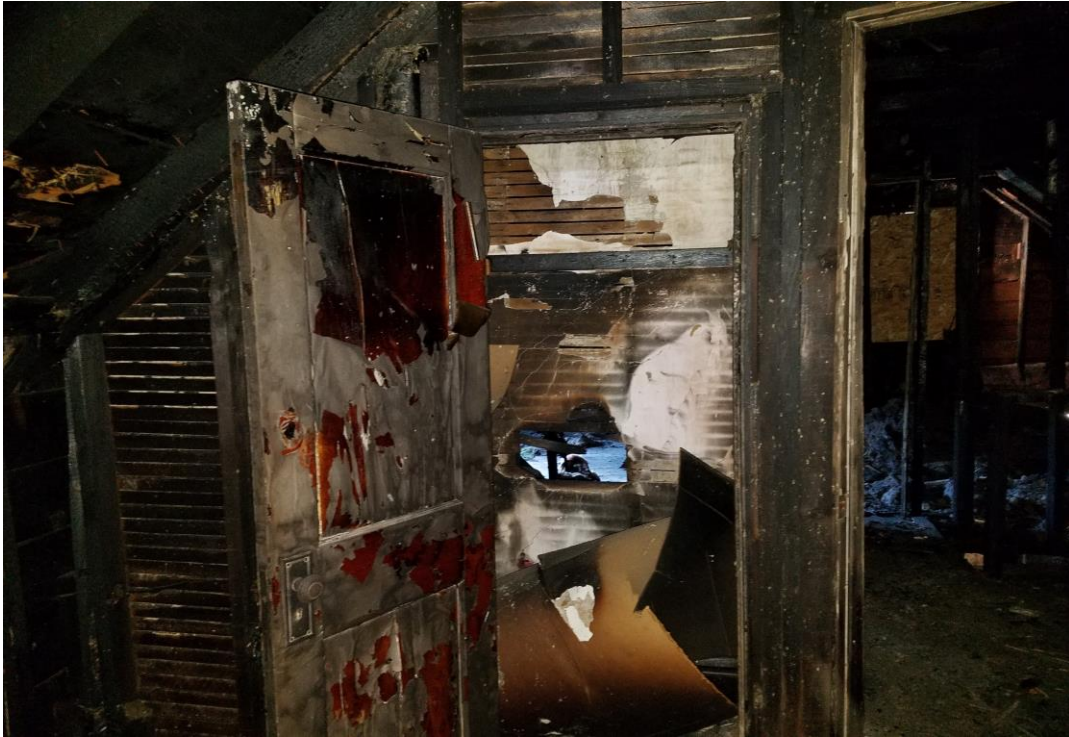
Plaster samples, collected from the 2nd Fl. Closet were found to contain up to 1.75% asbestos following analysis. The assessment to quantify the extent of this material identified approximately 140 sq. ft. of plaster within the Building still on the Walls on Ceiling. There is also approximately 1,800 sq. ft. of plaster debris on Basement, 1st and 2nd Floors that needs to be abated.

PHOTO: 5
SUBJECT: Plaster in Closet 2nd Floor

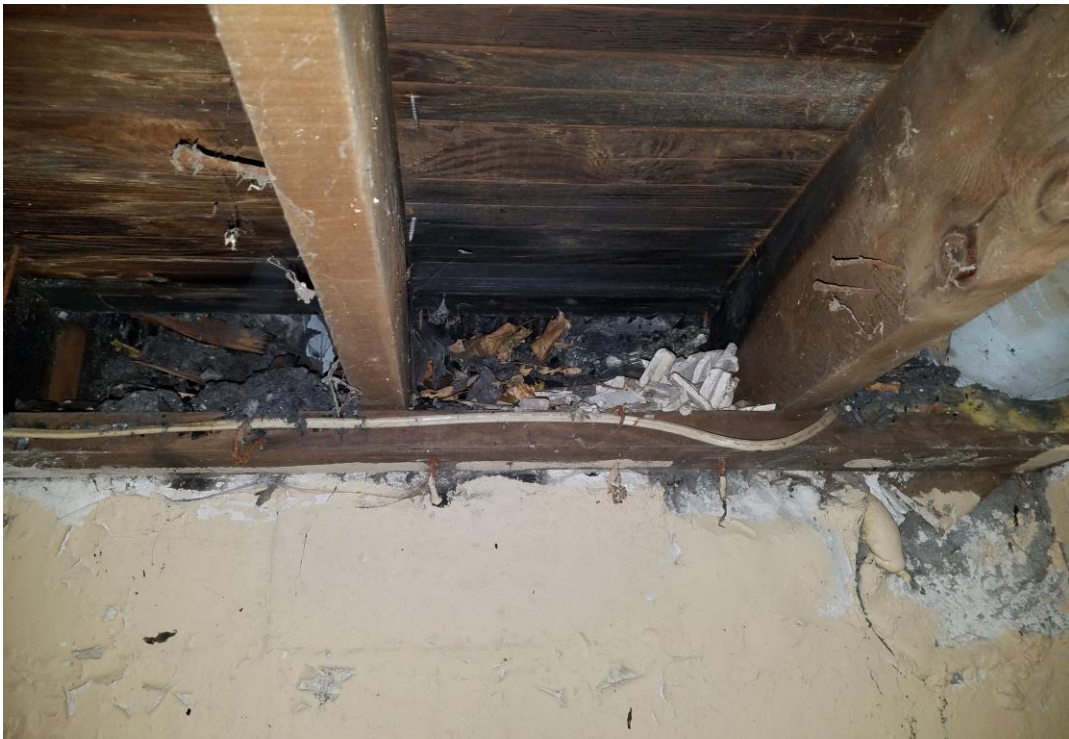
PHOTO: 6
SUBJECT: Plaster Debris in Basement

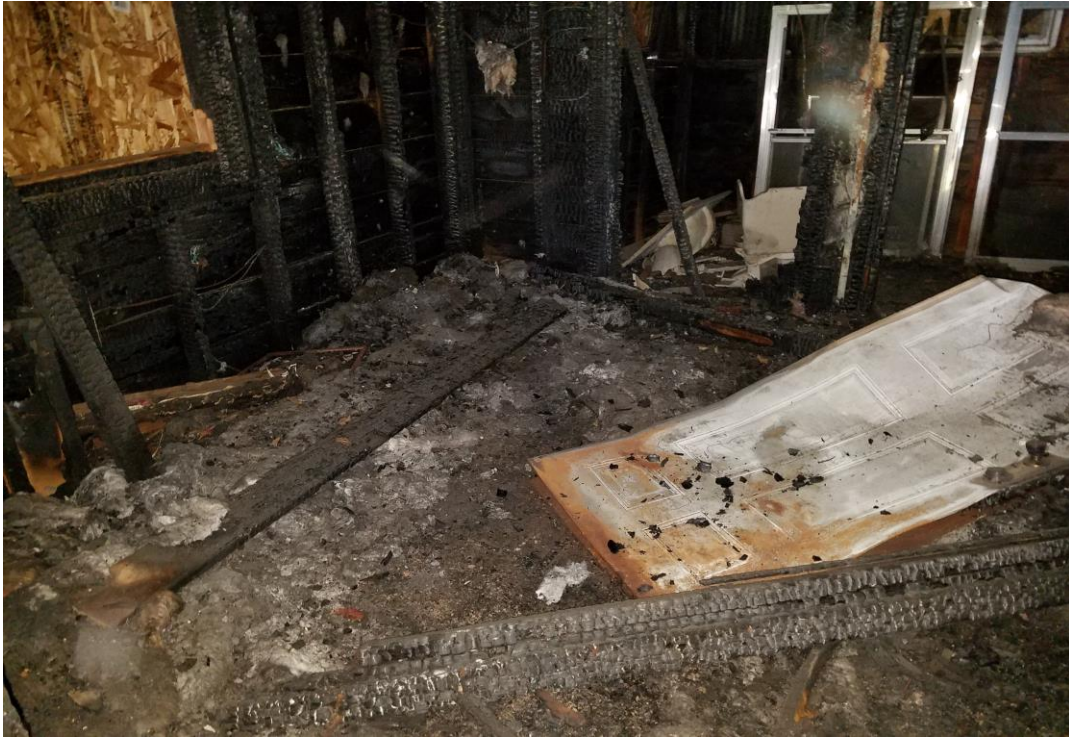
PHOTO: 7

SUBJECT: Plaster and General Debris In Kitchen

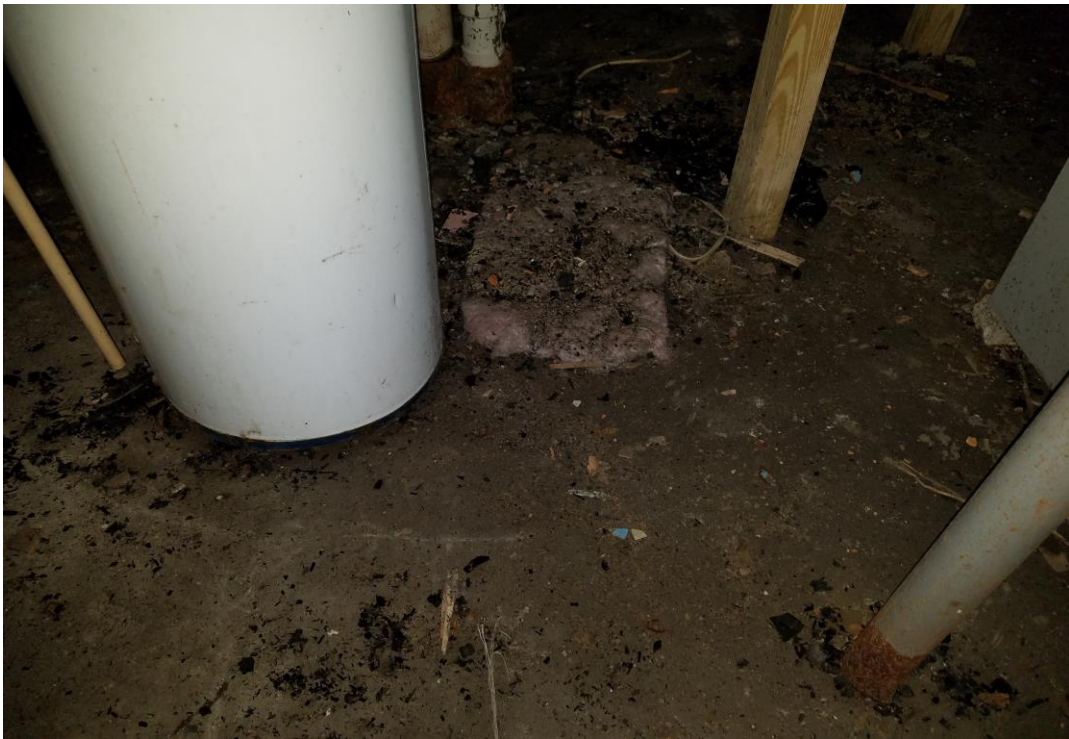
PHOTO: 8

SUBJECT: Plaster debris Basement Floor

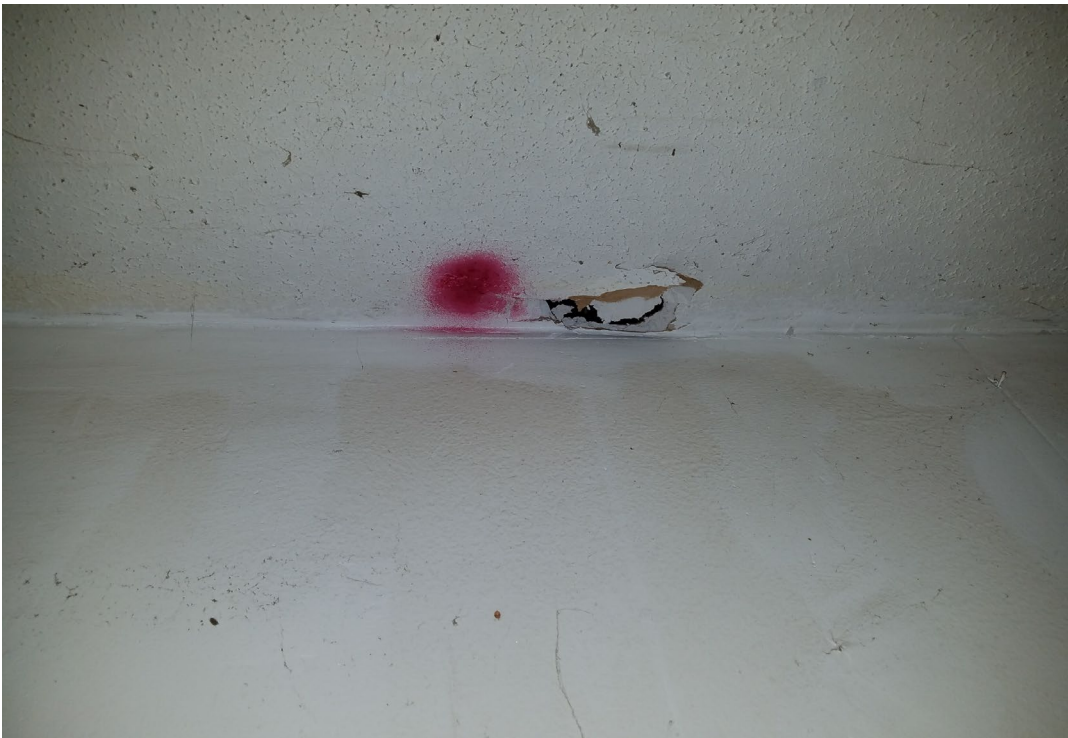
PHOTO: 2

SUBJECT: View of Drywall & Compound in Living Room

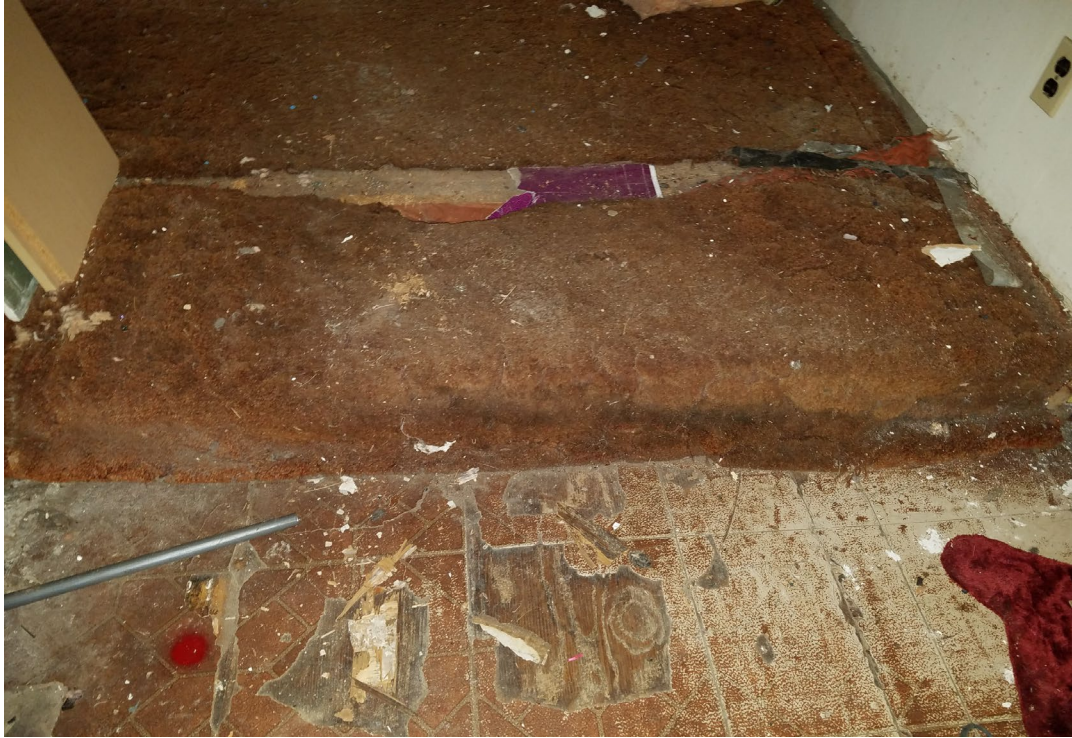
PHOTO: 3

SUBJECT: View of raised floor in Living Room on top of Tan 12x12 VFT

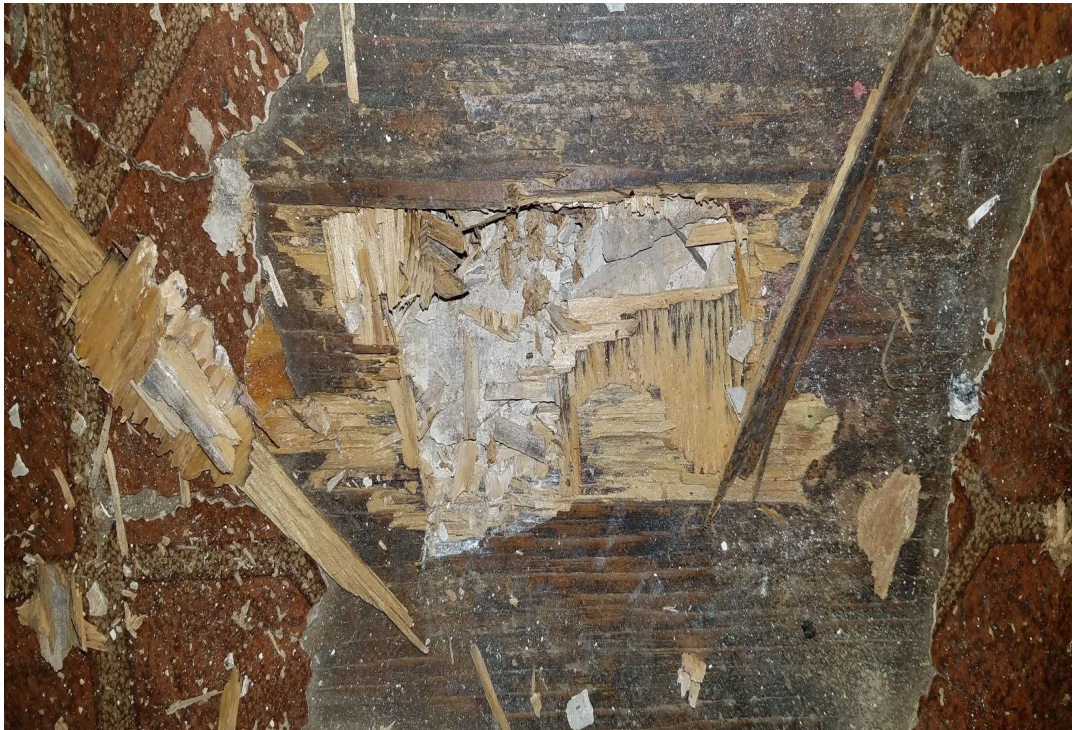
PHOTO: 4

SUBJECT: View of Pebbled Tan 12x12 VFT in Side Entry
