RE: *Asbestos Containing Material and Hazardous Materials Inspection*
913 Motor Ave., Lansing, MI 48910
Parcel ID: 33-01-01-22-309-101

RE: *Asbestos Containing Material and Hazardous Materials Inspection*
1735 Lyon's Ave., Lansing, MI 48910
Parcel ID: 33-01-01-22-352-261

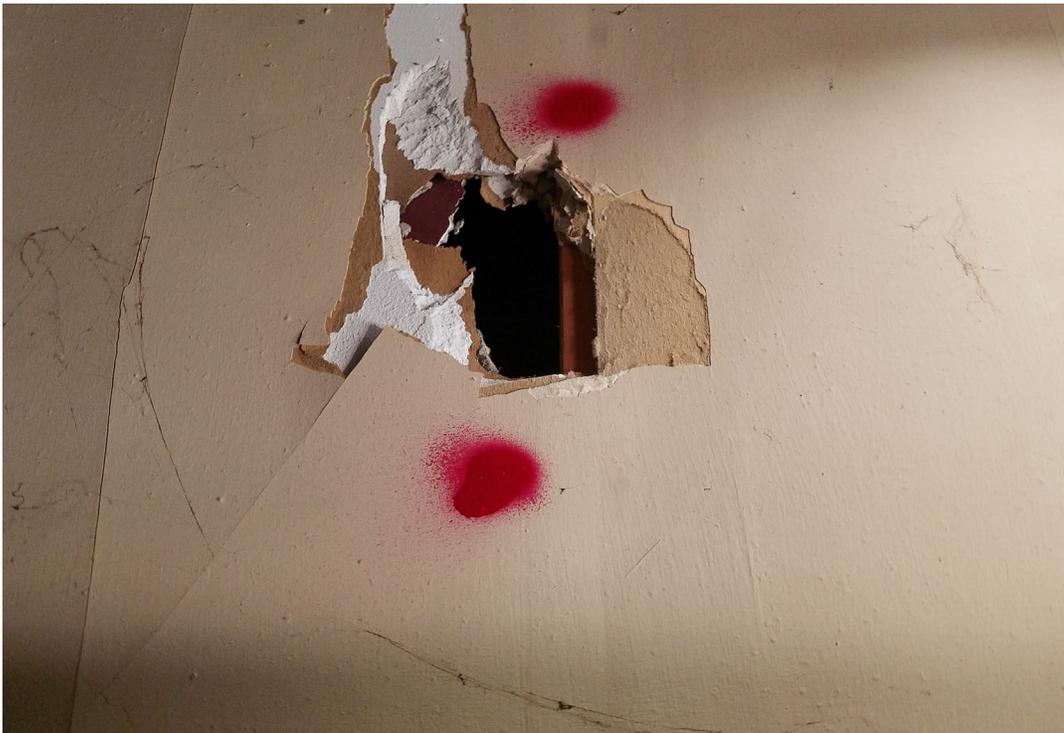
Drywall Compound samples, collected from the Building were found to contain up to 1.5% asbestos following analysis. The assessment to quantify the extent of this material identified approximately 1,165 sq. ft. of drywall compound within the Building.

PHOTO: 2
SUBJECT: Drywall Compound E Bedroom Ceiling

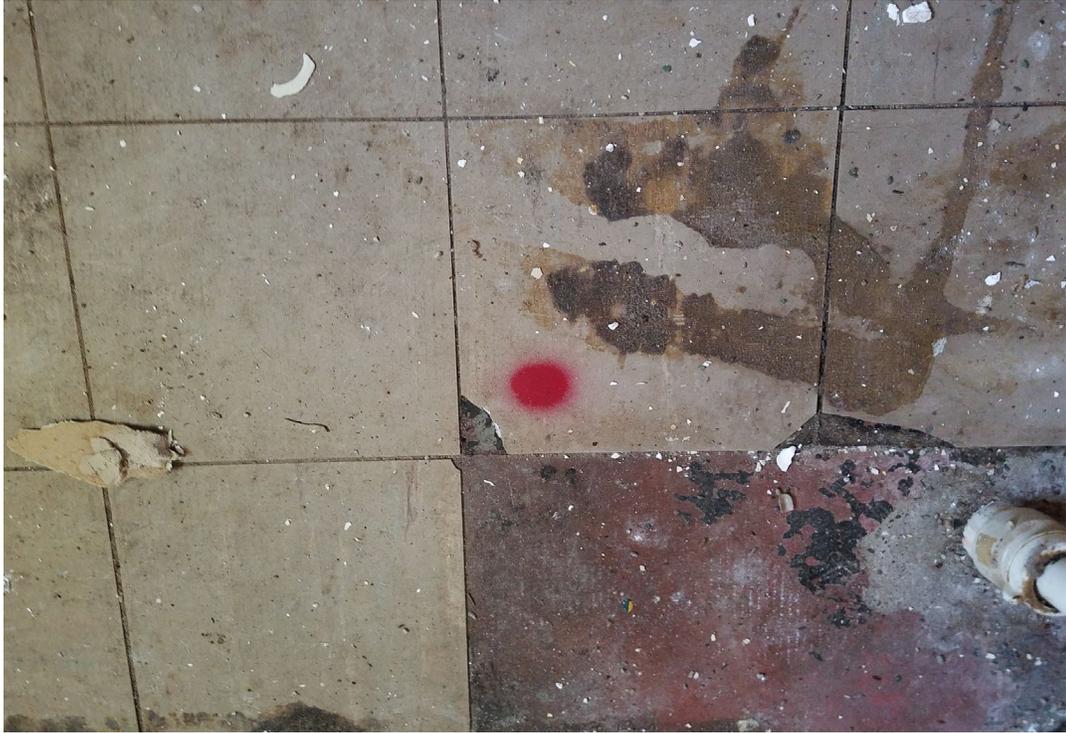
PHOTO: 3

A resilient floor covering (9x9 Tan VFT on Concrete) located within the bathroom was found to contain up to 5% Chrysotile asbestos. The assessment to quantify the extent of this material identified approximately 45 sq. ft. of this material within the Building.

SUBJECT: Bathroom 9x9 Tan VFT

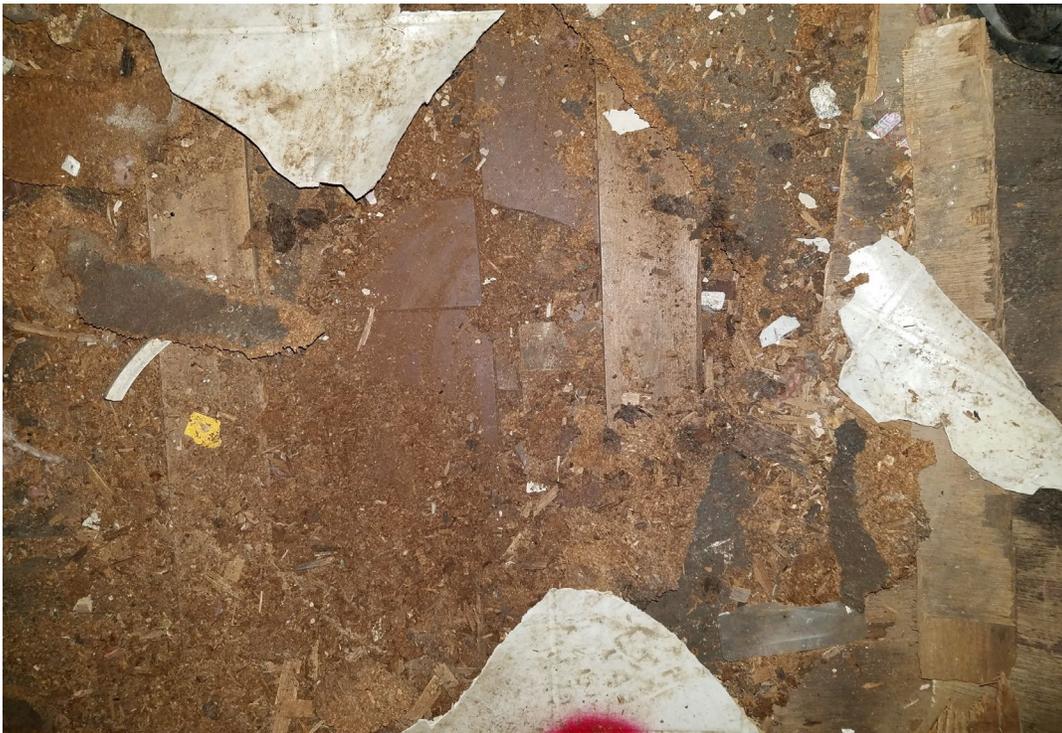
Two types of resilient floor covering (White Layered Linoleum (Brown Tile beneath raised floor system) and (Gray Layered Linoleum (Brown Tile beneath raised floor system) located within the kitchen and bath were found to contain up to 5% Chrysotile asbestos. The assessment to quantify the extent of this material identified approximately 210 sq. ft. of this material within the Building.

PHOTO: 2
SUBJECT: Kitchen Brown 9x9 Tile beneath Raised Floor System

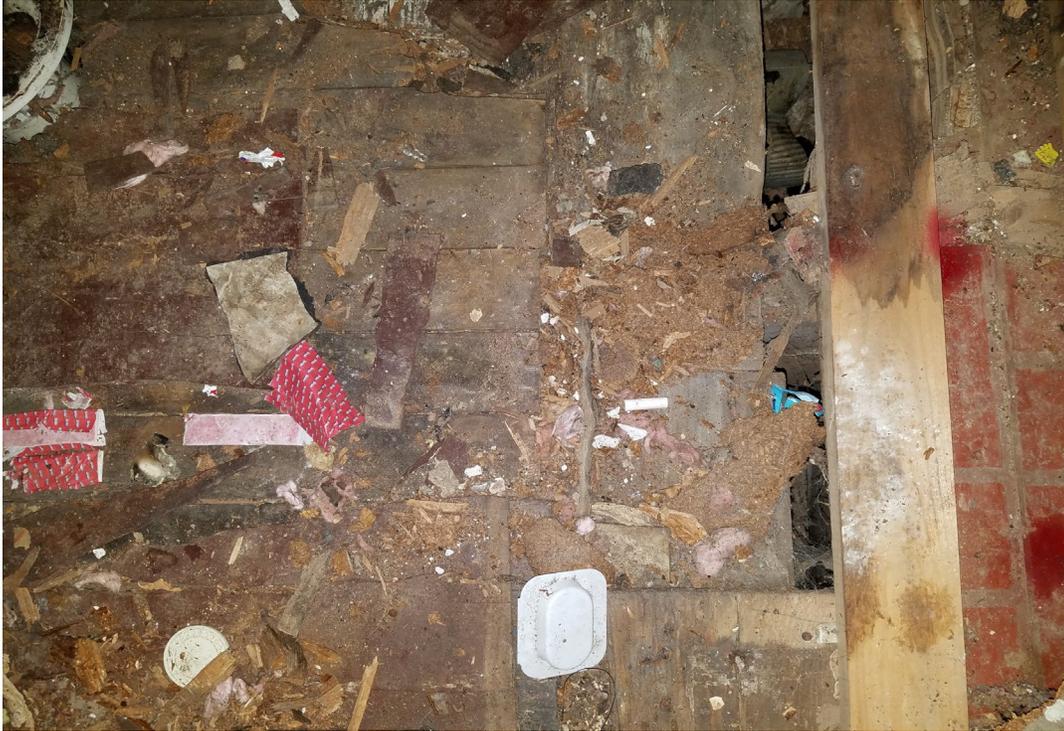
PHOTO: 3

SUBJECT: Bathroom Brown 9x9 Tile beneath Raised Floor System

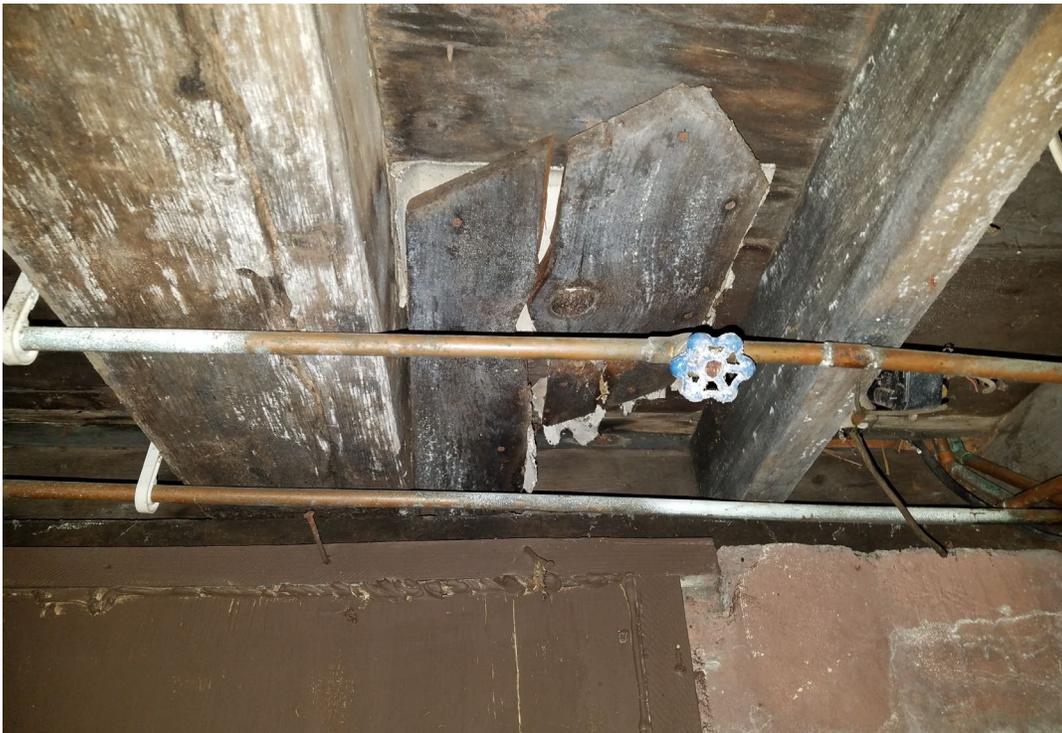
PHOTO: 4

SUBJECT: HVAC Duct Wrap on Covered Register in Basement

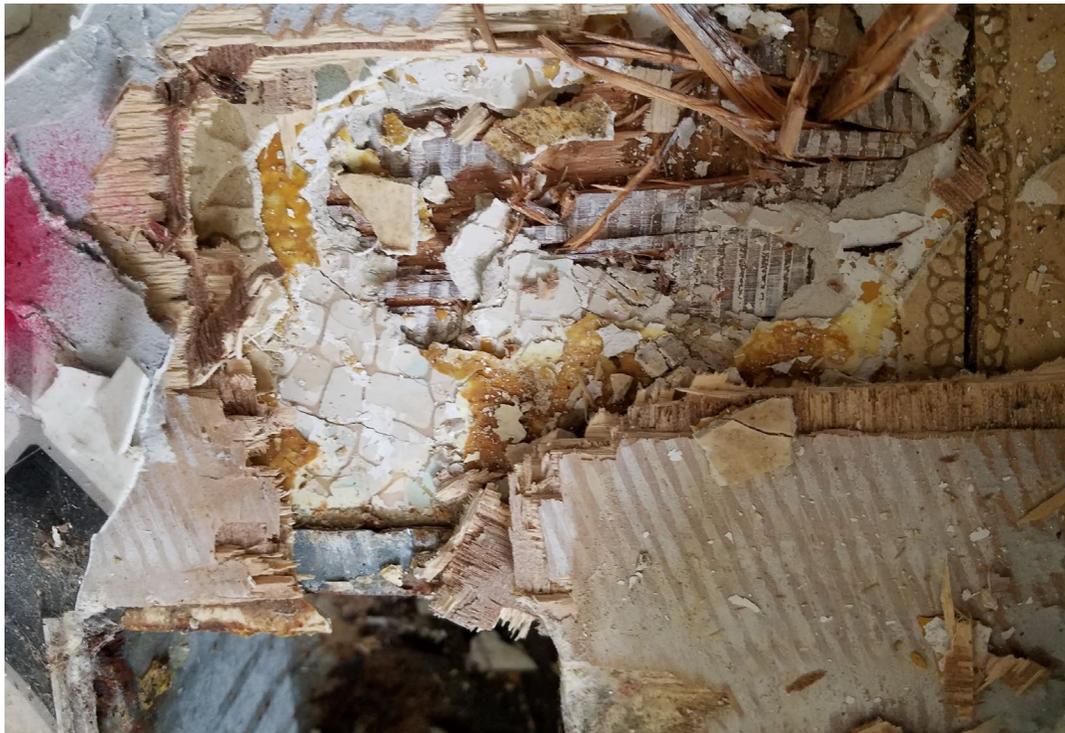
PHOTO: 2
SUBJECT: Asbestos Flooring in W Bathroom

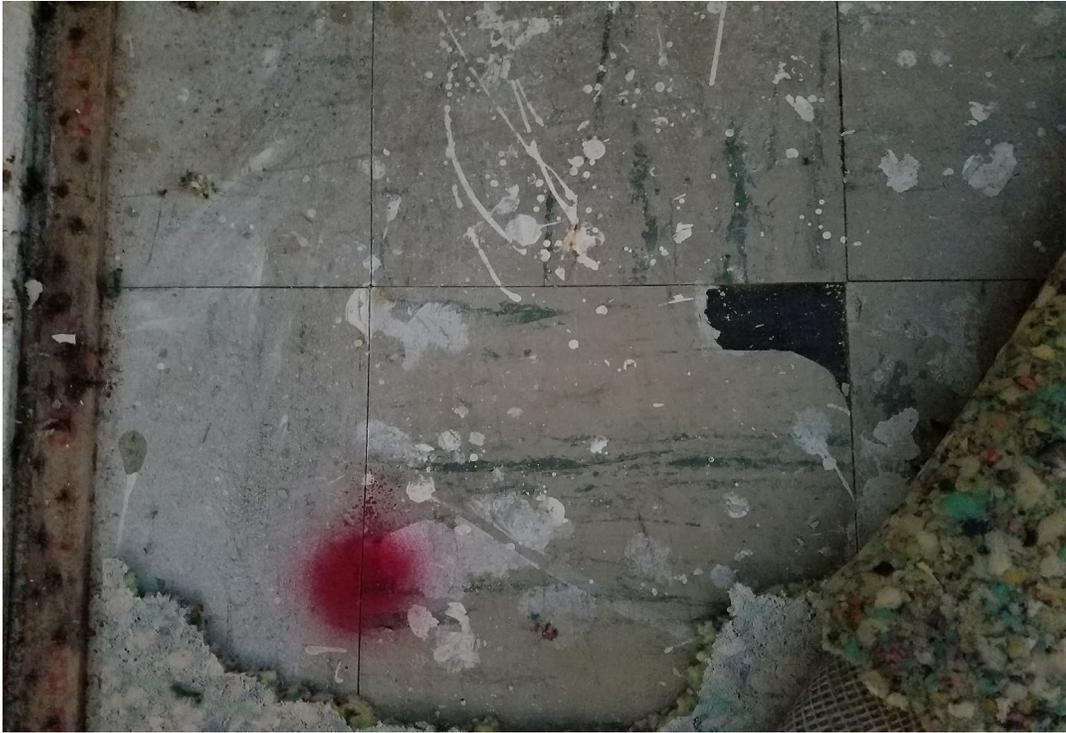
PHOTO: 3

SUBJECT: Asbestos Flooring in NW Bedroom

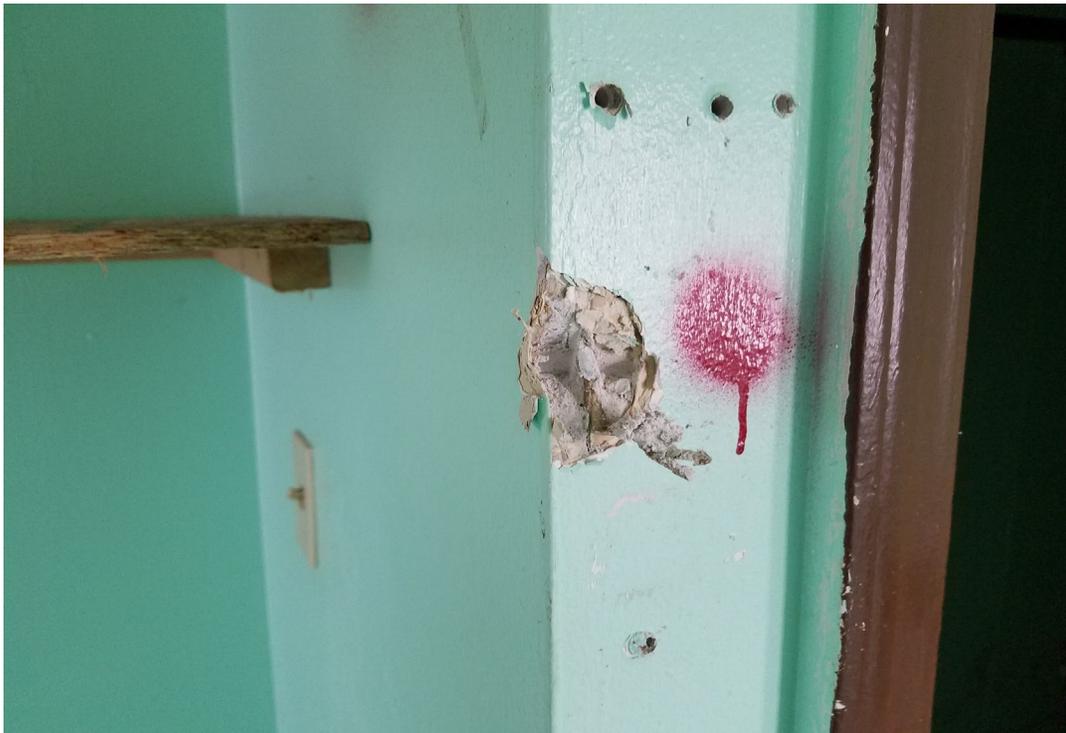
PHOTO: 4

SUBJECT: Asbestos Drywall Compound in SW Bedroom

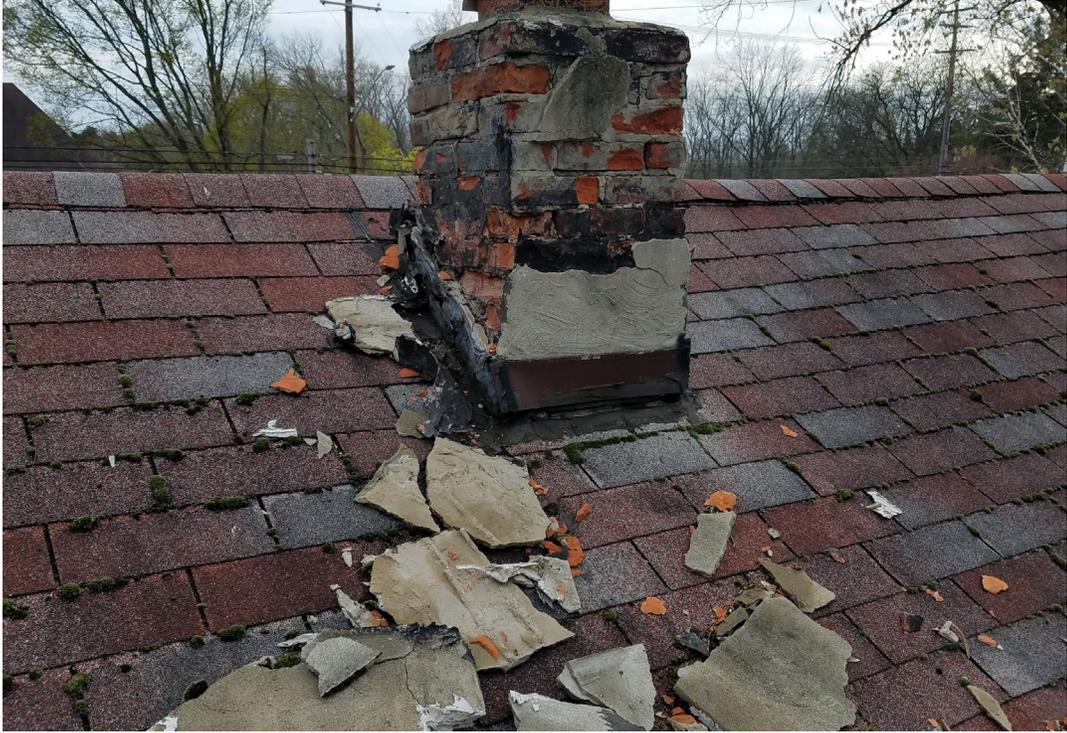
PHOTO: 5
SUBJECT: Asbestos Chimney Flashing

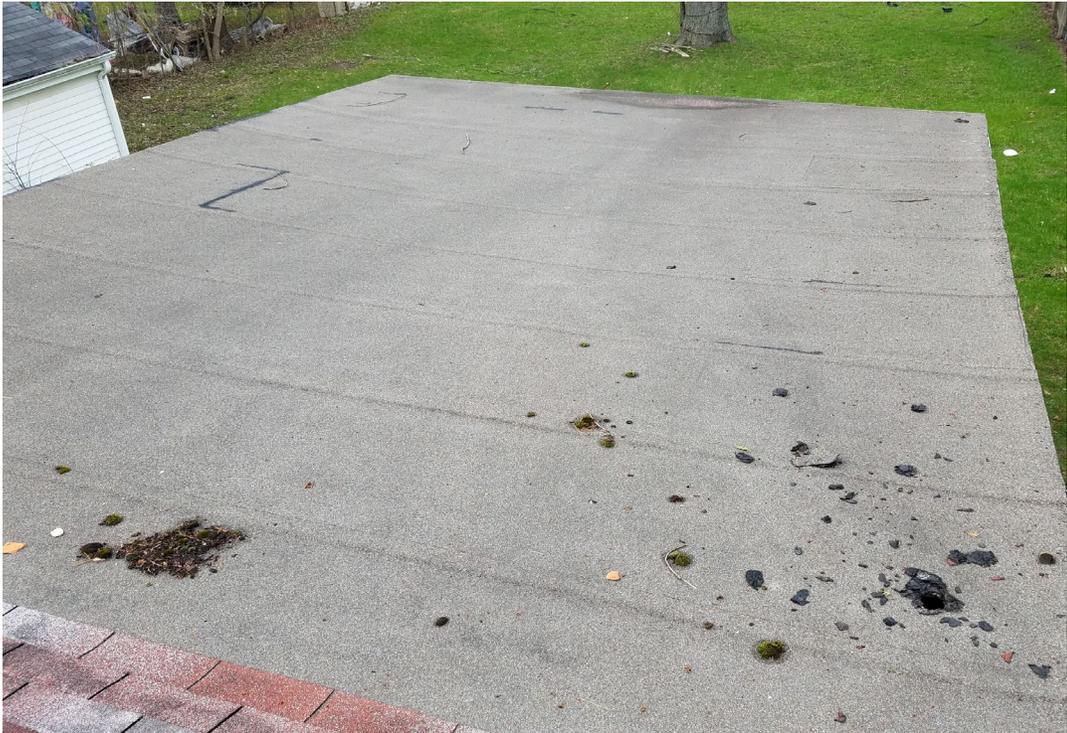
PHOTO: 6
SUBJECT: Asbestos Roofing (bottom layer is asbestos) on Rear Entry
