May 20, 2020

RE: Asbestos Containing Material and Hazardous Materials Inspection

135 S Magnolia Ave., Lansing, MI 48912

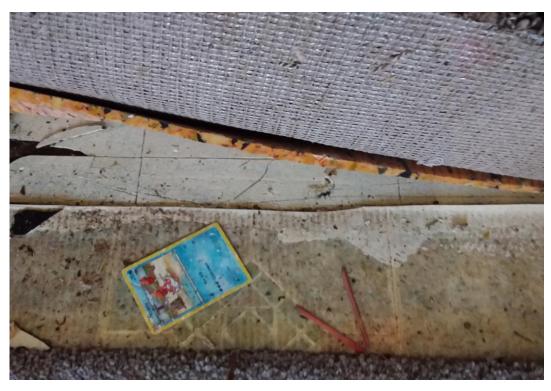
PHOTO: 2 BY: A. Paquet

A resilient floor covering (Brown 9x9 VFT) located within the Living Room and W Bedroom was found to contain up to 5% Chrysotile asbestos. The assessment to quantify the extent of this material identified approximately 325 sq. ft. of this material within the Building.

**SUBJECT:** Brown 9x9 VFT

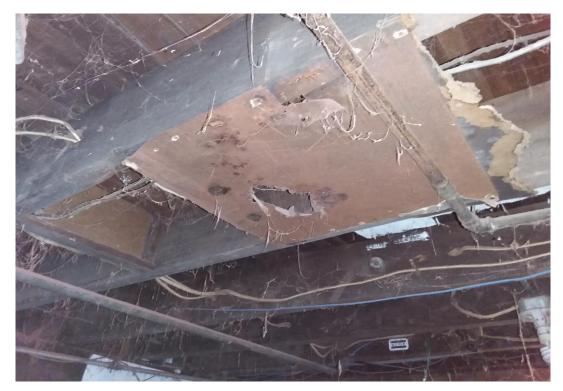
PHOTO: 3 BY: A. Paquet

**SUBJECT:** Basement HVAC Wrap

Asbestos Containing Material Description and Location						
Location	Material Description		Condition	Material Type	Approx. Quantity	
Basement (misc. HVAC wrap on Old Ductwork, 1 sq. ft.)	HVAC Duct Wrap	Yes	Fair	TSI	1 sq. ft.

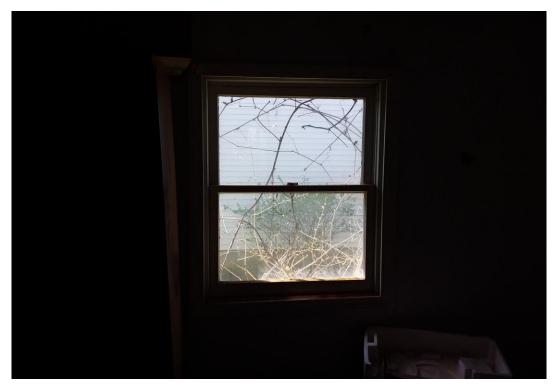
PHOTO: 4 BY: A. Paquet

A window glazing sample collected from a window in the W Bedroom was found to contain up to 2% asbestos following analysis. The assessment to quantify the extent of this material identified windows at the following locations that would fall into the same homogenous group. The locations of the windows are listed below:

**SUBJECT:** Typical Window/Glazing

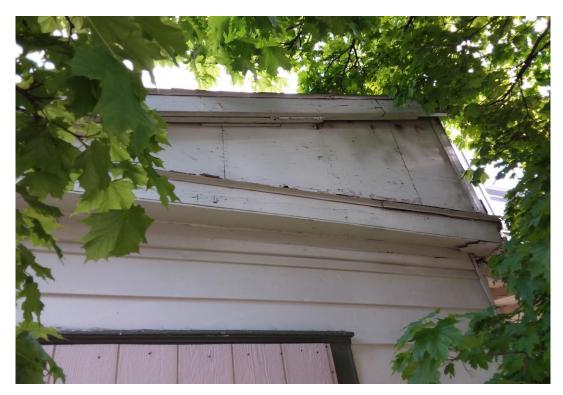
PHOTO: 2 BY: A. Paquet

Asphalt roof samples collected during the completion of the inspection were found to contain up to 10% Chrysotile asbestos. The assessment to quantify the extent of this material identified 200 sq. ft. of asphalt roofing materials (covered by a newer roof system) on the Building.

**SUBJECT:** Asphalt Roofing (under newer roof)

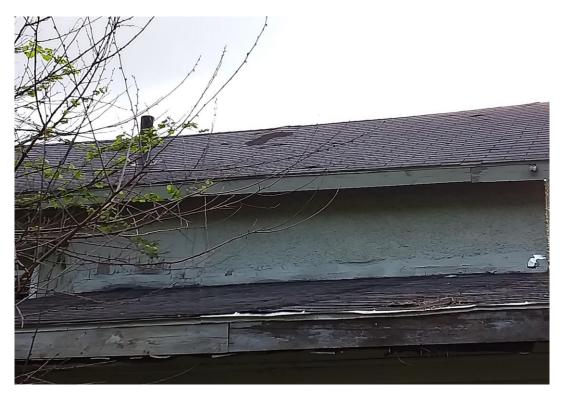
Flashing samples collected during the completion of the inspection were found to contain up to 10% Chrysotile asbestos. The assessment to quantify the extent of this material identified 50 sq. ft. of flashing materials on the Building.

PHOTO: 3
SUBJECT: Flashing on Roof/Wall junction, Roof Vents
BY: A. Paquet

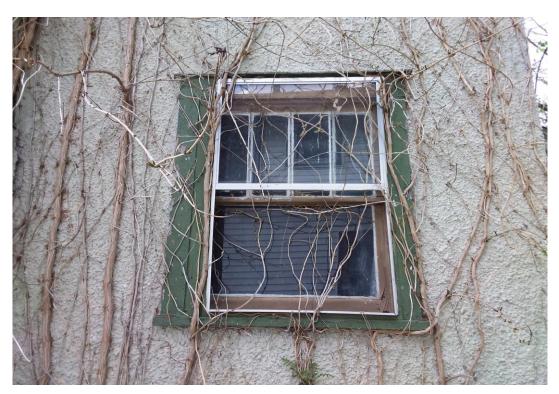
PHOTO: 4 BY: A. Paquet

A window glazing sample collected from a window in the Living Room was found to contain up to 5% asbestos following analysis. The assessment to quantify the extent of this material identified windows at the following locations that would fall into the same homogenous group. The locations of the windows are listed below:

**SUBJECT:** Typical Window

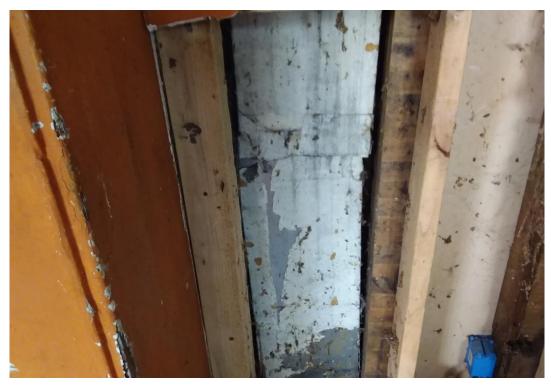
PHOTO: 6 BY: A. Paquet

**SUBJECT:** Typical HVAC Wall Chase

Asbestos Containing Material Description and Location						
Location	Material Description	Friable	Condition	Material Type	Approx. Quantity	
Kitchen (1 register, 15 sq. ft.)  2 <sup>nd</sup> Fl. N Bedroom (1 register, 10 sq. ft. and vertical chase to basement, 25 sq. ft.)  2 <sup>nd</sup> Fl. W Bedroom (1 register, 10 sq. ft. and vertical chase to basement, 25 sq. ft.)	HVAC Duct Wrap	Yes	Fair	TSI	85 sq. ft.

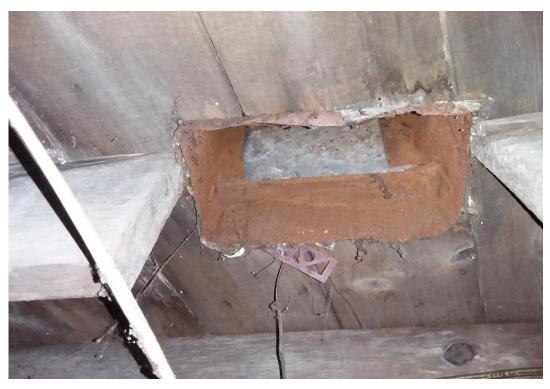
PHOTO: 2 BY: A. Paquet

**SUBJECT:** Typical HVAC Register

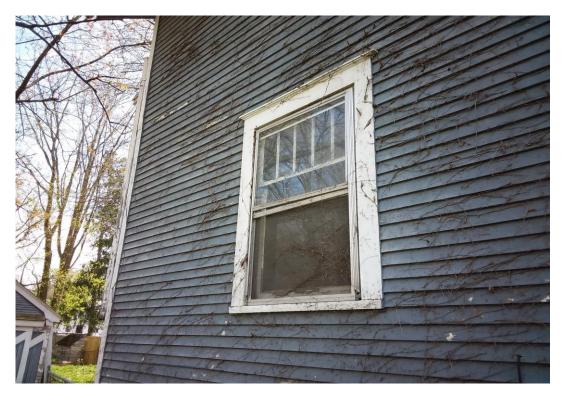
PHOTO: 3 BY: A. Paquet

A window glazing sample collected from a window in the NE Bedroom was found to contain up to 5% asbestos following analysis. The assessment to quantify the extent of this material identified windows at the following locations that would fall into the same homogenous group. The locations of the windows are listed below:

**SUBJECT:** Typical Window with Glazing

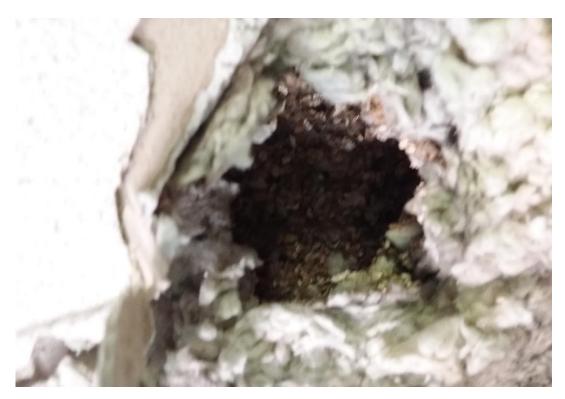
PHOTO: 4 BY: A. Paquet

**SUBJECT:** Vermiculite Insulation

Asbestos Containing Material Description and Location						
Location	Material Description	Friable	Condition	Material Type	Approx. Quantity	
Kitchen (1 register, 10 sq. ft.) Bathroom (1 register, 10 sq. ft.)  2 <sup>nd</sup> Fl. NE Bedroom (1 register, 10 sq. ft. and vertical chase to basement, 25 sq. ft.)  2 <sup>nd</sup> Fl. NW Bedroom (1 register, 10 sq. ft. and vertical chase to basement, 25 sq. ft.)  2 <sup>nd</sup> Fl. SE Bedroom (1 register, 10 sq. ft. and vertical chase to basement, 25 sq. ft.)	HVAC Duct Wrap	Yes	Fair	TSI	125 sq. ft.	
Attic (200 sq. ft. at 6" depth including cellulose insulation)	Vermiculite	Yes	Fair	M	200 sq. ft. at 6" depth

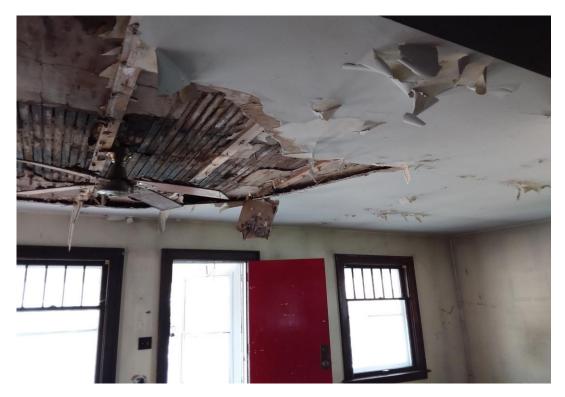
PHOTO: 5 BY: A. Paquet

Drywall Compound samples collected from the Living Room were found to contain up to 1.75% asbestos following analysis. The assessment to quantify the extent of this material identified approximately 1,560 sq. ft. of drywall compound within the Building.

**SUBJECT:** Drywall & Compound

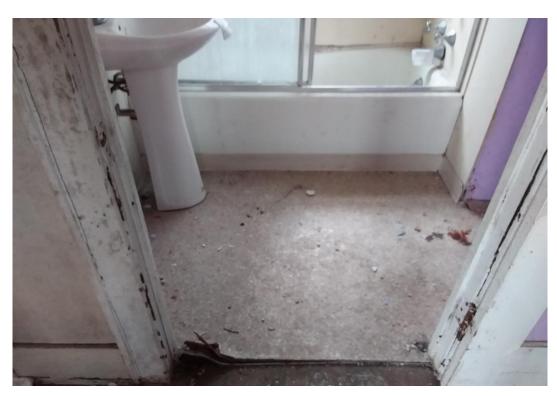
PHOTO: 2 BY: A. Paquet

A resilient floor covering (Stone Linoleum) located within the kitchen were found to contain up to 20% Chrysotile asbestos. The assessment to quantify the extent of this material identified approximately 50 sq. ft. of this material within the Building.

**SUBJECT:** Bathroom Stone Linoleum

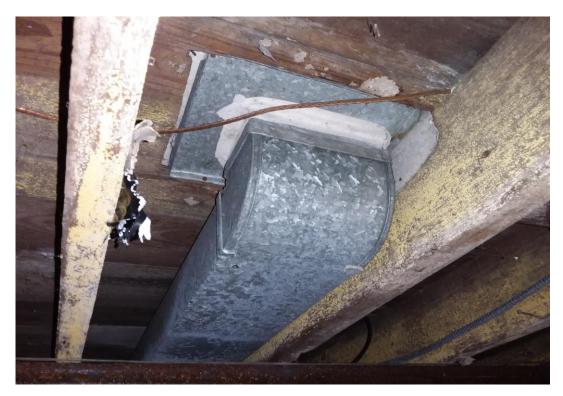
PHOTO: 3 BY: A. Paquet

**SUBJECT:** Typical HVAC Register

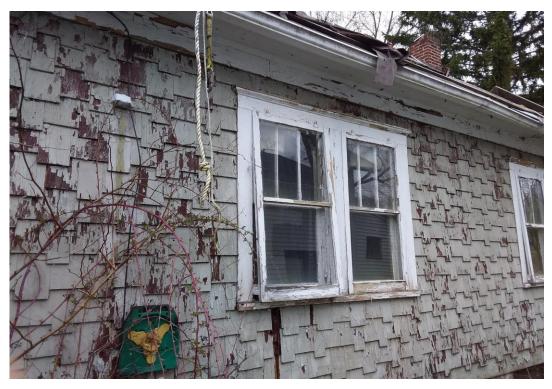
PHOTO: 4 BY: A. Paquet

A window glazing sample collected from a Storm Window in the Living Room was found to contain up to 1.5% asbestos following analysis. The assessment to quantify the extent of this material identified windows at the following locations that would fall into the same homogenous group. The locations of the windows are listed below:

SUBJECT: Typical Storm Window
