P.O. Box 13216
Lansing, MI 48901
Phone: 888.449.4566
Fax: 888.448.8739
www.redcedarconsulting.net

***RE: Asbestos Containing Material and Hazardous Materials Inspection
412 Pearl St., Lansing, MI 48906
Parcel ID: 33-01-01-09-278-331***

RE: *Asbestos Containing Material and Hazardous Materials Inspection*
636 S Mifflin Ave., Lansing, MI 48912
Parcel ID: 33-01-01-14-381-172

RE: *Asbestos Containing Material and Hazardous Materials Inspection*
607 Helen St., Lansing, MI 48912
Parcel ID: 33-01-01-16-478-051

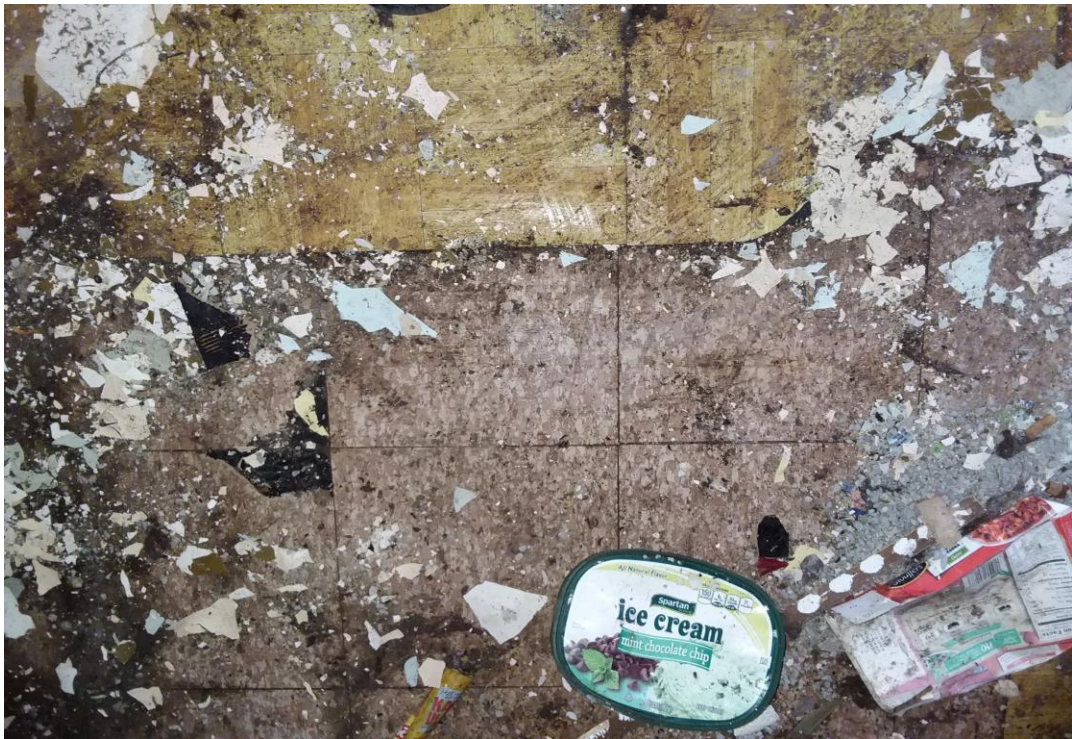
A resilient floor covering (Wood Grain 12x12 VFT) located within the kitchen was found to contain up to 5% Chrysotile asbestos. The assessment to quantify the extent of this material identified approximately 135 sq. ft. of this material within the Building.

PHOTO: 2
SUBJECT: Wood Grain 12x12 VFT over Tan 9x9 VFT and Mastic

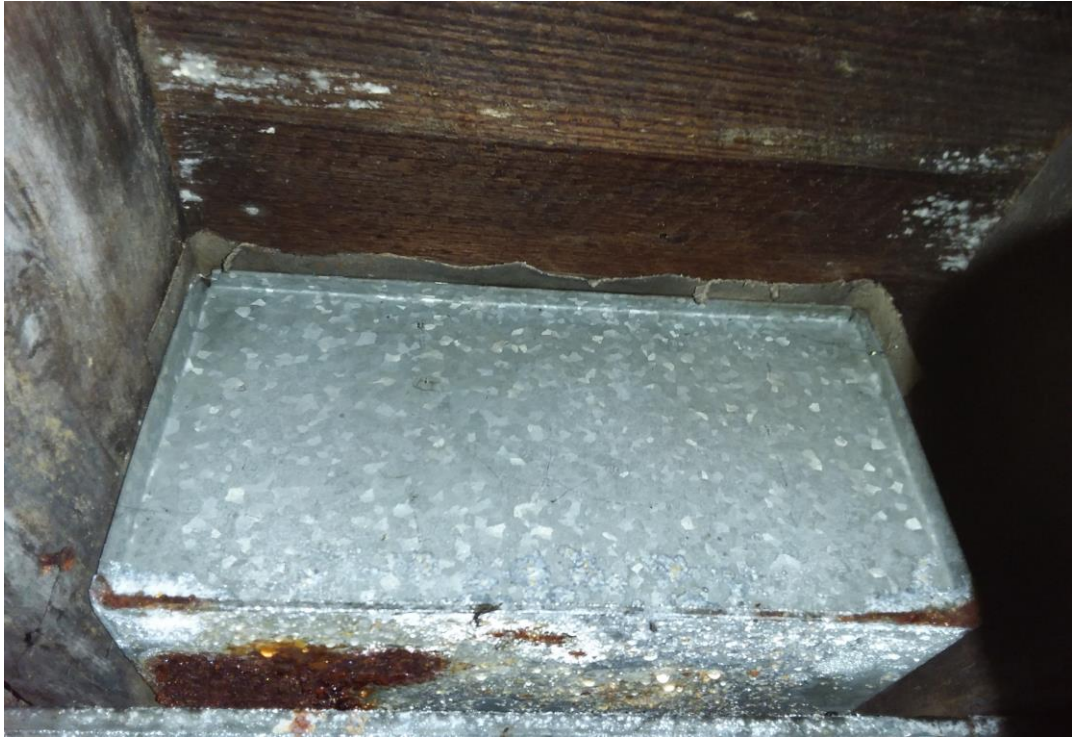
PHOTO: 3
SUBJECT: Typical HVAC Duct Boot Wrap

Asbestos Containing Material Description and Location					
Location	Material Description	Friable	Condition	Material Type	Approx. Quantity
Living (1 register, 10 sq. ft.) Dining (1 register, 10 sq. ft.) Kitchen (1 register, 10 sq. ft.) Bathroom (1 register, 15 sq. ft.) 2 nd Fl. Bedroom duct boot in Bsmt. 10 sq. ft.) 2 nd Fl. Dining duct boot in Bsmt. 10 sq. ft.) 2 nd Fl. Kitchen duct boot in Bsmt. 10 sq. ft.)	HVAC Duct Wrap	Yes	Fair	TSI	75 sq. ft.

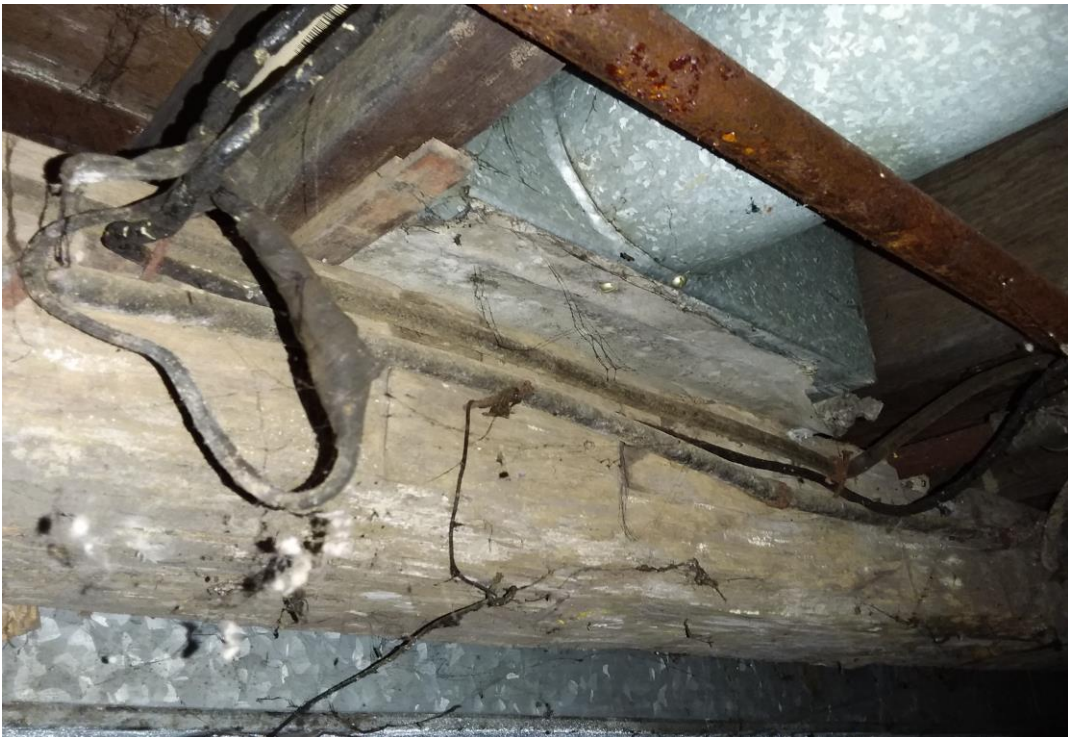
PHOTO: 4
SUBJECT: Typical Register HVAC

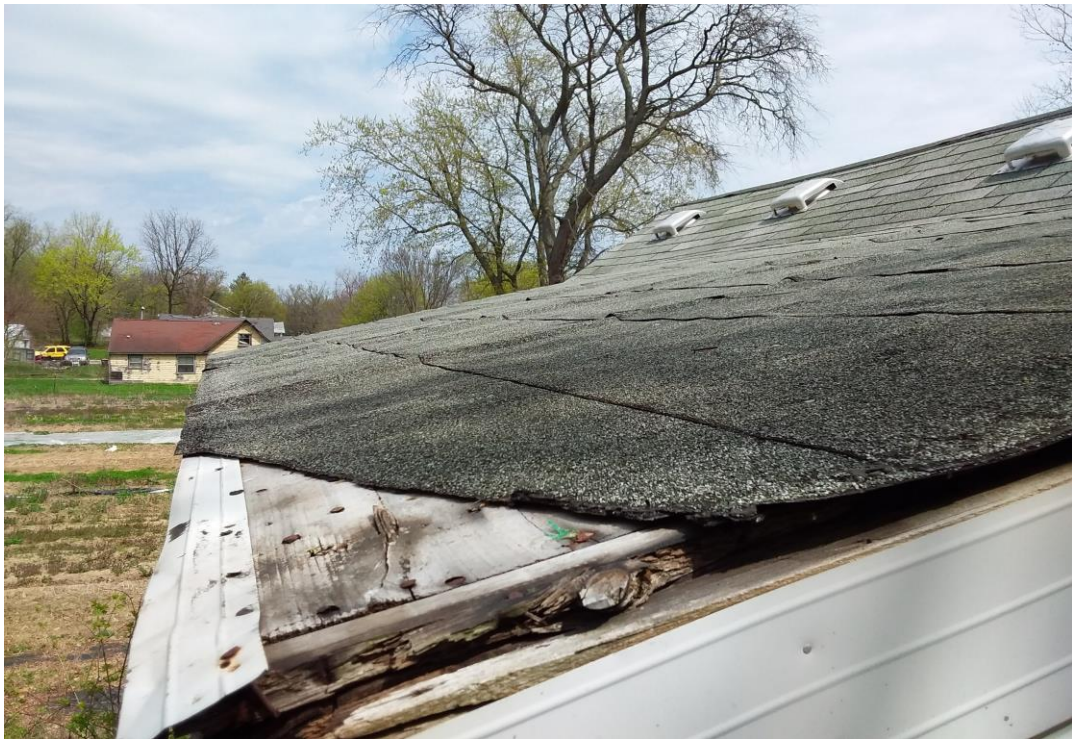
Asphalt roof samples collected during the completion of the inspection were found to contain up to 10% Chrysotile asbestos. The assessment to quantify the extent of this material identified 250 sq. ft. of asphalt roofing materials on the Building.

PHOTO: 2
SUBJECT: View of ACM Roofing/Tar (2nd Fl. W Dormer)

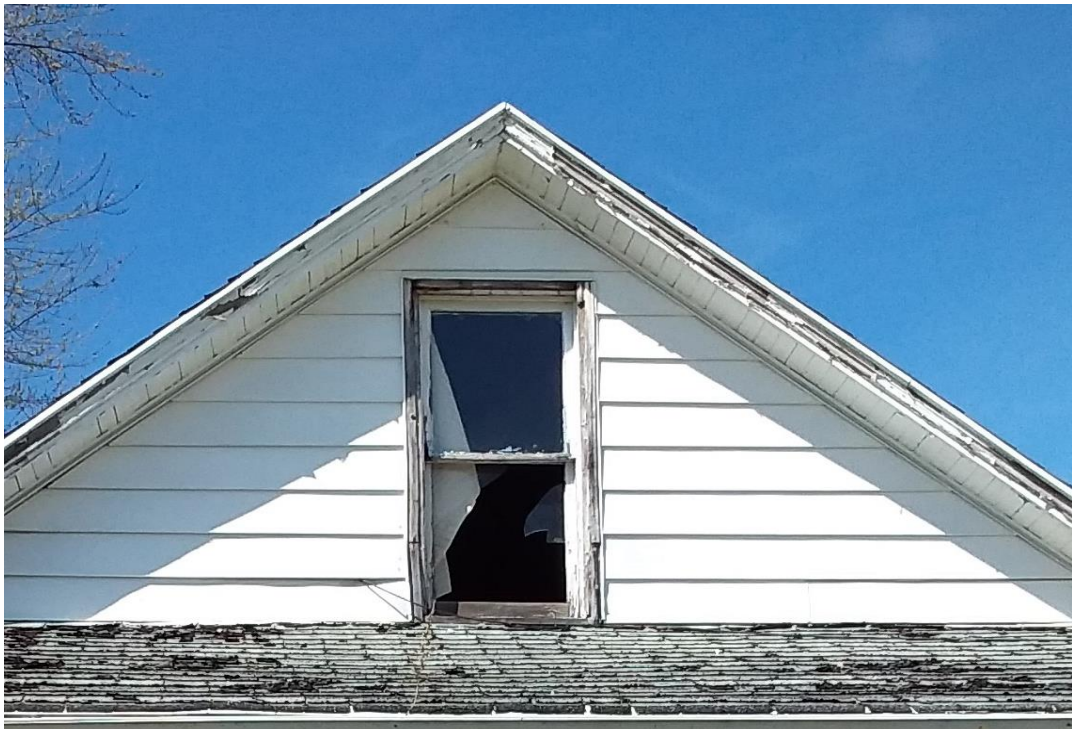
A window glazing sample collected from a window in the 2nd Fl. N. Bedroom was found to contain up to 5% asbestos following analysis. The assessment to quantify the extent of this material identified windows at the following locations that would fall into the same homogenous group. The locations of the windows are listed below:

PHOTO: 2
SUBJECT: Typical Window Glazing

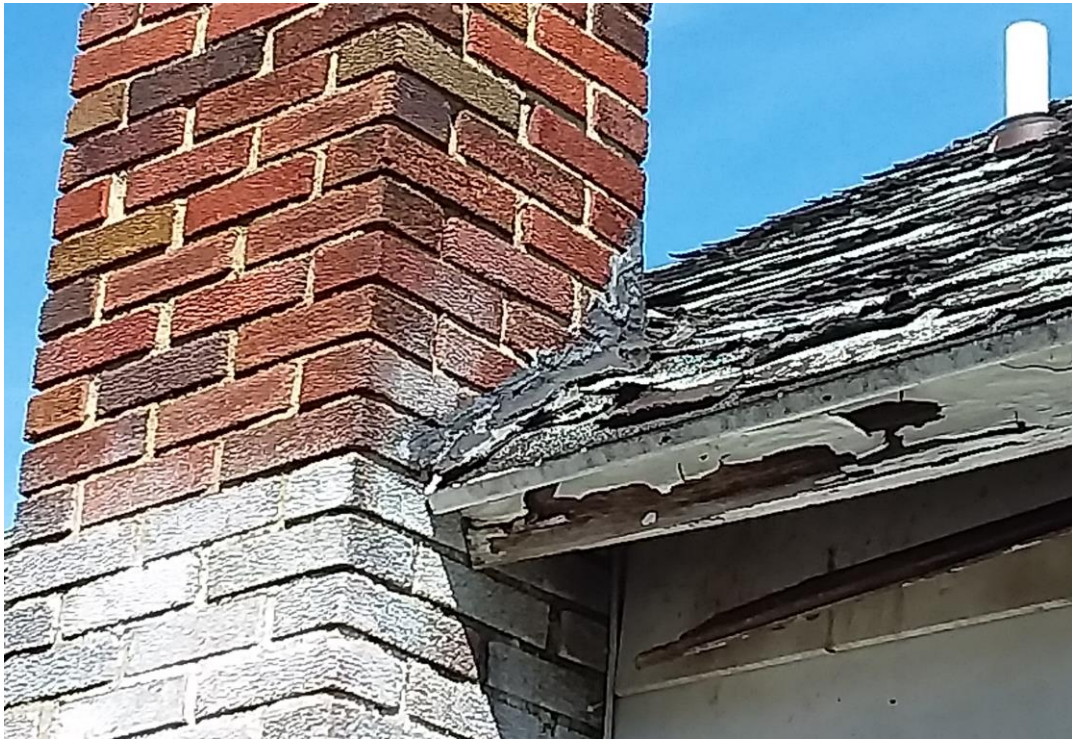
Roof Flashing samples collected during the completion of the inspection were found to contain up to 10% Chrysotile asbestos. The assessment to quantify the extent of this material identified 15 sq. ft. of flashing materials on the Building.

PHOTO: 3
SUBJECT: Roof Flashing

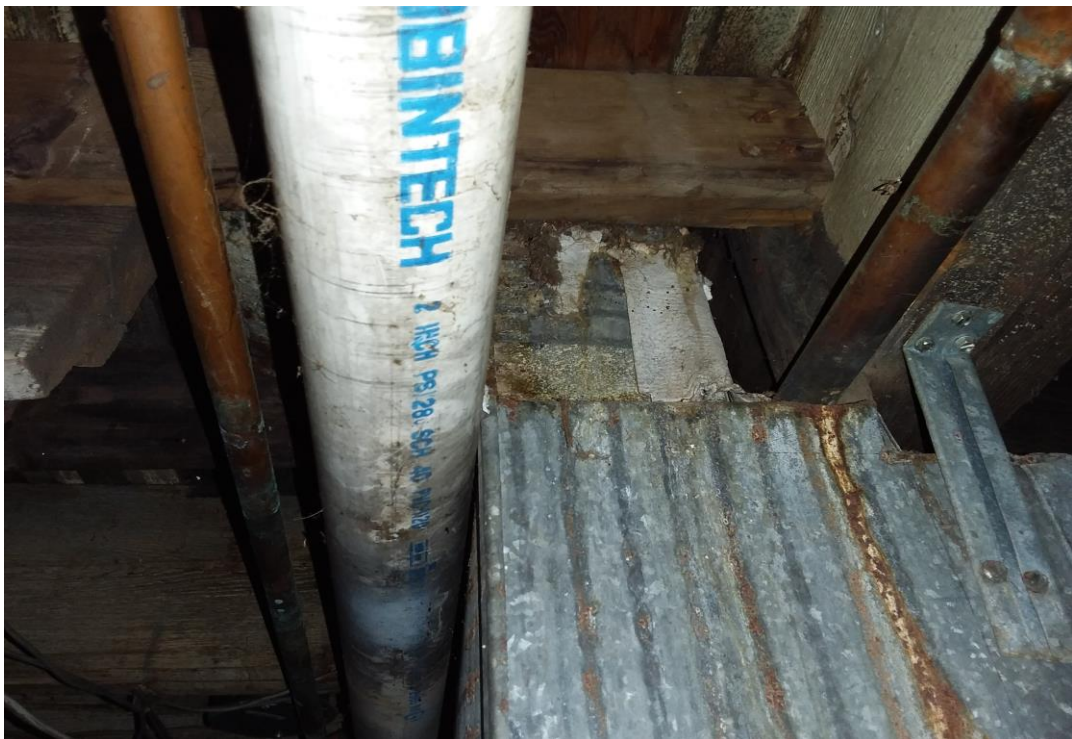
PHOTO: 4
SUBJECT: Typical HVAC Register

Asbestos Containing Material Description and Location					
Location	Material Description	Friable	Condition	Material Type	Approx. Quantity
Kitchen (1 register, 5 sq. ft.) HVAC wrap on 6" diam. Ductwork, 10 sq. ft.)	HVAC Duct Wrap	Yes	Fair	TSI	15 sq. ft.

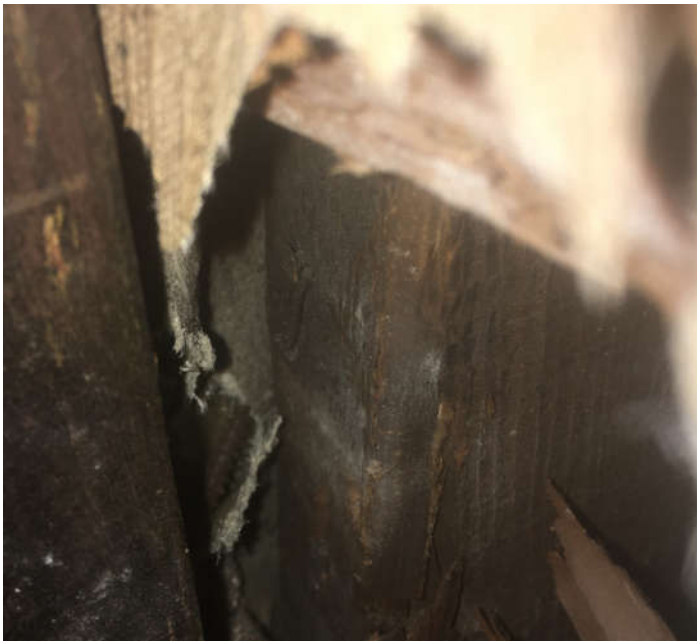
Pos. #4 Duct Wrap

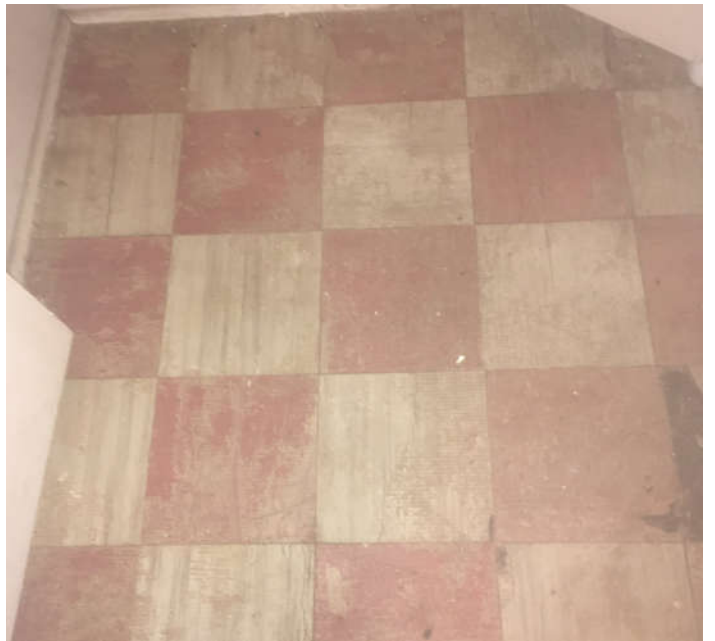
Pos. #21 Floor Tile 9x9 Red

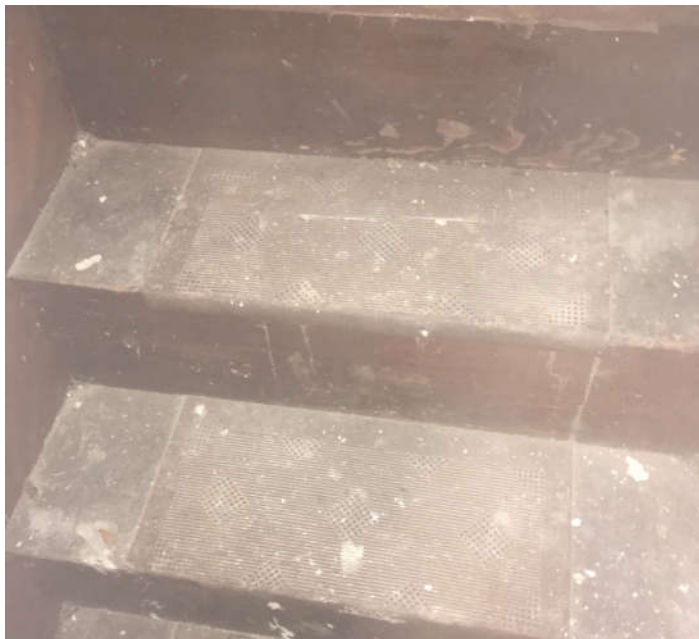
Pos. #27 Stair Tread
