May 15, 2020

RE: Asbestos Containing Material and Hazardous Materials Inspection

1723 Ray St., Lansing, MI 48910 Parcel ID: 33-01-01-21-480-030

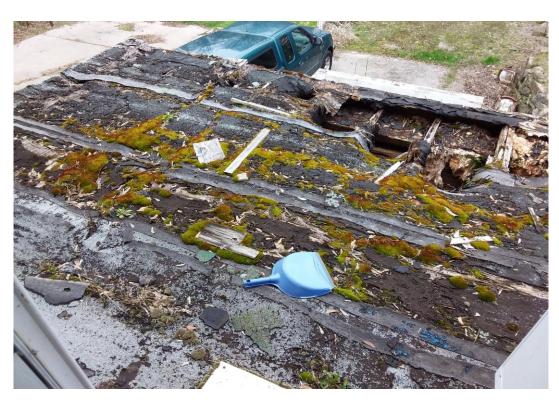
PHOTO: 2 BY: A. Paquet

Rolled Roofing samples collected during the completion of the inspection were found to contain up to 10% Chrysotile asbestos. The assessment to quantify the extent of this material identified 110 sq. ft. of asphalt roofing materials on the Building.

SUBJECT: Asphalt Roofing

The Category I roofing materials and flashings are non-friable ACM's that may be left in place as long as the demolition/renovation activities are completed following the OSHA Asbestos Standards for Construction (29 CFR 1926.1101) which limits employee exposure to asbestos.

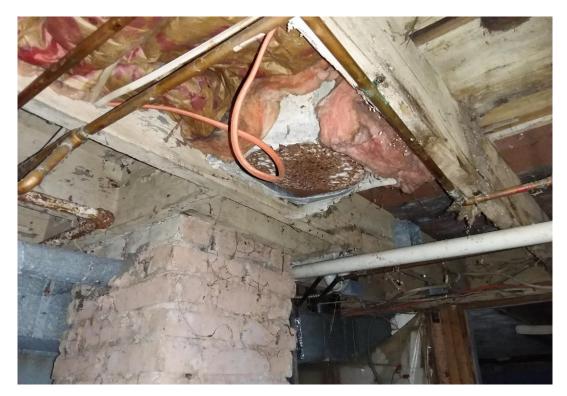
PHOTO: 3 BY: A. Paquet

Duct Wrap identified in the building in conjunction with the forced air heating system is classified as friable ACM. The visual assessment to quantify the extent of this material identified HVAC Duct Wrap at the following locations within the basement, first and second floors:

- Kitchen Abandoned (1 register, 10 sq. ft.)
- Basement (misc. HVAC wrap on Basement framing, 1 sq. ft.)

SUBJECT: Kitchen Register/HVAC

HVAC material identified in the Building system and listed below is classified as friable ACM and should be removed prior to any renovation/demolition activities.

- Kitchen Abandoned (1 register, 10 sq. ft.)
- Basement (misc. HVAC wrap on Basement framing, 1 sq. ft.)

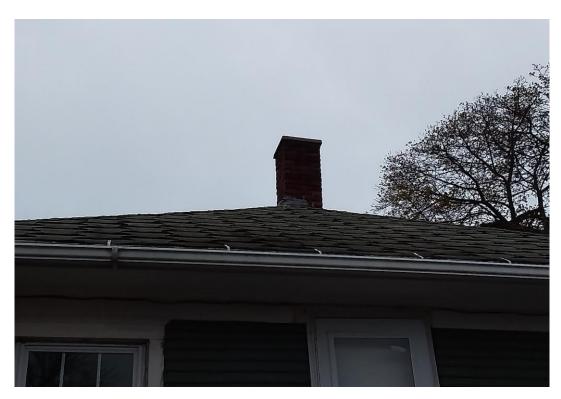
PHOTO: 4 BY: A. Paquet

The HVAC Duct Wrap and Chimney Flashing located in the Building was classified as PACM due to the age of the structure and samples were not collected.

Flashing identified during the completion of the inspection was classified as PACM and no sampled were collected. The assessment to quantify the extent of this material identified 15 sq. ft. of flashing materials on the Building

SUBJECT: Chimney Flashing

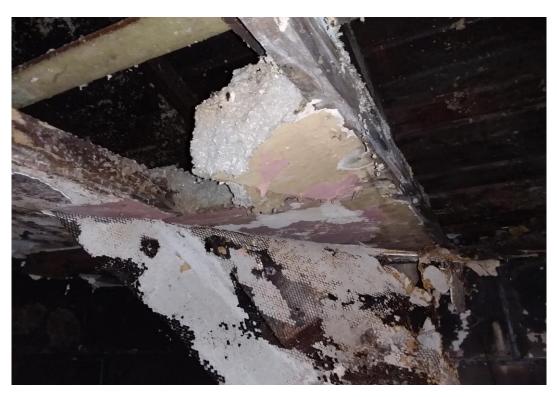
PHOTO: 2 BY: A. Paquet

Transite like Backerboard samples collected from the Kitchen were found to contain up to 20% asbestos following analysis. The assessment to quantify the extent of this material identified approximately 300 sq. ft. of Backerboard and Insulation/Debris within the Building.

SUBJECT: Transite Backer Board

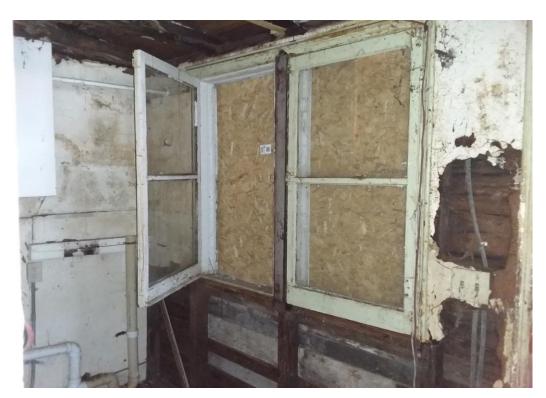
PHOTO: 2 BY: A. Paquet

A window glazing sample collected from a window in the Rear Entry was found to contain up to 1.5% asbestos following analysis. The assessment to quantify the extent of this material identified windows at the following locations that would fall into the same homogenous group. The locations of the windows are listed below:

SUBJECT: Typical Window/Glazing
