Lead Inspection & Risk Assessment Report

125 Ferguson Street

Lansing, MI 48912

Date of Report: 05/22/2024

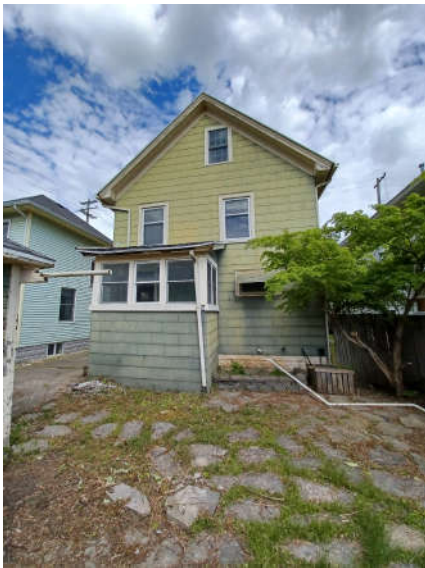
COMPONENT & LOCATION OF HAZARD	SEVERITY*	PRIORITY**	ABATEMENT OPTIONS	INTERIM CONTROL OPTIONS
Side C Window Casing, Sill-Stool, Sash Ext., Stop Ext., Jamb, Parting Bead & Well-Trough represent deteriorated lead paint surface hazards.	3	3	1) Remove and replace with new replacement windows or 2) replace individual lead painted components or 3) enclose all lead painted surfaces or 4) strip all surfaces bare to the substrate, make necessary repairs, stabilize surfaces, and repaint.	1) Use friction reduction treatments (jamb liners, weatherstripping, rubber padding, tread covers, etc.) to reduce wear or 2) Wet plane all friction / impact surfaces, wet scrape all remaining surfaces, make necessary repairs, stabilize all surfaces and repaint.
Exterior Garage # 20				
Sides A, B, C & D Beige & Green Walls represent deteriorated lead paint surface hazards.	3	3	1) Wrap walls with Tyvek or equivalent, apply foam insulation board, seal all seams and install a new vinyl or aluminum siding system or 2) wet scrape/sand all surfaces bare to the substrate, make necessary repairs, stabilize surfaces and encapsulate with a Michigan approved, exterior grade encapsulant or 3) Remove and replace with new components or 4) strip all surfaces bare to the substrate, make necessary repairs, stabilize surfaces, and repaint.	Wet scrape / sand all surfaces, make necessary repairs, stabilize all surfaces and repaint.

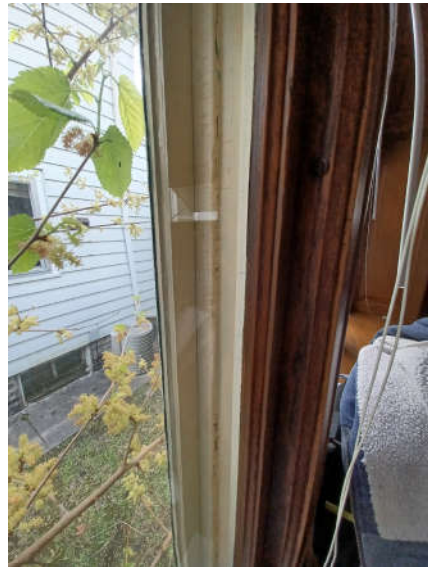
Dining Room 2 Sides B1, B2 & B3

COMPONENT & LOCATION OF HAZARD	SEVERITY*	PRIORITY**	ABATEMENT OPTIONS	INTERIM CONTROL OPTIONS
Dining Room # 2				
Sides B1, B2 & B3 Window Sashes Ext., Stops Ext., Jambs, Parting Beads & Wells-Troughs were inaccessible due to being sealed shut. Is untested other surfaces in deteriorated condition that must be considered to be a lead paint hazards.	3	3	1) Remove and replace with new replacement windows or 2) replace individual lead painted components or 3) enclose all lead painted surfaces or 4) strip all surfaces bare to the substrate, make necessary repairs, stabilize surfaces, and repaint.	1) Use friction reduction treatments (jamb liners, weatherstripping, rubber padding, tread covers, etc.) to reduce wear or 2) Wet plane all friction / impact surfaces, wet scrape all remaining surfaces, make necessary repairs, stabilize all surfaces and repaint.
Kitchen # 3				
Side D Wall & the Ceiling represent deteriorated lead paint surface hazards.	3	3	1) Enclose with drywall or other suitable wallboard material or 2) wet scrape/sand all surfaces, make necessary repairs, stabilize surfaces and encapsulate with a Michigan approved encapsulant.	Wet scrape / sand all surfaces, make necessary repairs, stabilize all surfaces and repaint.

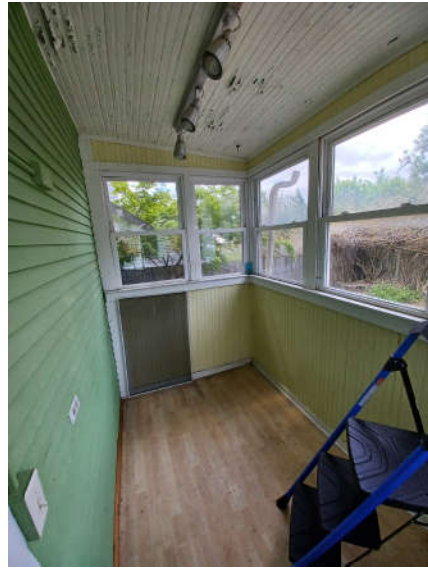
Sunroom 4

Sunroom # 4				
Side A(All) White Wood Door Casings, Stops & Jambs represent deteriorated lead paint surface hazards.	2	2	1) Remove and replace with new door systems or 2) replace individual lead painted components or 3) strip all surfaces on both sides of the door bare to the substrate, stabilize surfaces, and repaint.	1) Refit door to eliminate friction points, wet scrape/sand all surfaces, make necessary repairs, including installation of weatherstripping or other "soft" stop material, stabilize all surfaces and repaint 2) Use friction reduction treatments (jamb liners, weatherstripping, rubber padding, tread covers, etc.) to reduce wear or 3) Wet plane all friction / impact surfaces, wet scrape all remaining surfaces, make necessary repairs, stabilize all surfaces and repaint.

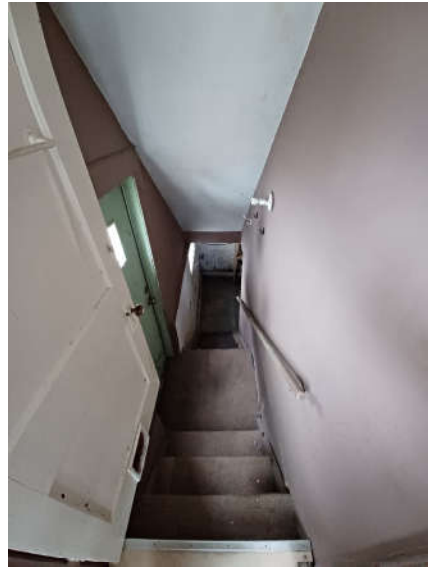
Stairs 16

Basement Stairs # 16				
Side D(All) White Wood Door Jambs Int. represent deteriorated lead paint surface hazards.	2	2	1) Remove and replace with new door systems or 2) replace individual lead painted components or 3) strip all surfaces on both sides of the door bare to the substrate, stabilize surfaces, and repaint.	1) Refit door to eliminate friction points, wet scrape/sand all surfaces, make necessary repairs, including installation of weatherstripping or other "soft" stop material, stabilize all surfaces and repaint 2) Use friction reduction treatments (jamb liners, weatherstripping, rubber padding, tread covers, etc.) to reduce wear or 3) Wet plane all friction / impact surfaces, wet scrape all remaining surfaces, make necessary repairs, stabilize all surfaces and repaint.

COMPONENT & LOCATION OF HAZARD	SEVERITY*	PRIORITY**	ABATEMENT OPTIONS	INTERIM CONTROL OPTIONS
All Stair Stringers, Risers & Tread represent deteriorated lead paint surface hazards.	3	3	1) Remove and replace with new components or 2) wet scrape/sand all surfaces, make necessary repairs, stabilize surfaces and encapsulate with a Michigan approved encapsulant or 3) strip all surfaces bare to the substrate (either chemically or using mechanical wet methods), make necessary repairs and recoat.	Wet scrape / sand all surfaces, make necessary repairs, stabilize all surfaces and repaint.
The Ceiling represents a deteriorated lead paint surface hazard.	3	3	1) Enclose with drywall or other suitable wallboard material or 2) wet scrape/sand all surfaces, make necessary repairs, stabilize surfaces and encapsulate with a Michigan approved encapsulant.	Wet scrape / sand all surfaces, make necessary repairs, stabilize all surfaces and repaint.

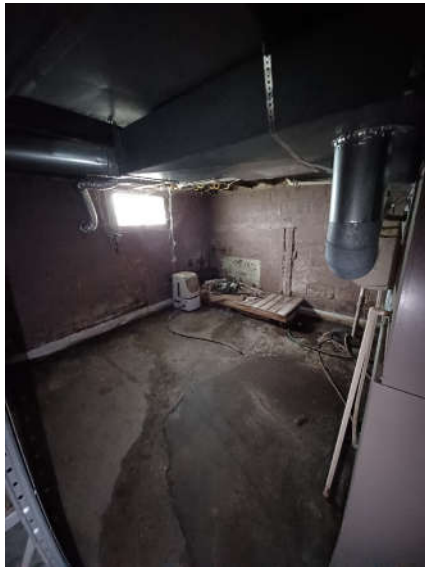
Basement 17

Basement # 17				
Side D Window Casing & Sash Int. represent deteriorated lead paint surface hazards.	3	3	1) Remove and replace with new replacement windows or 2) replace individual lead painted components or 3) enclose all lead painted surfaces or 4) strip all surfaces bare to the substrate, make necessary repairs, stabilize surfaces, and repaint.	1) Use friction reduction treatments (jamb liners, weatherstripping, rubber padding, tread covers, etc.) to reduce wear or 2) Wet plane all friction / impact surfaces, wet scrape all remaining surfaces, make necessary repairs, stabilize all surfaces and repaint.
Side B1 Window Sash Ext., Stop Ext., Jamb, Parting Bead & Well-Trough as well as Side D1 Window Jamb & Well-Trough were inaccessible due to being sealed shut. Is untested other surfaces in deteriorated condition that must be considered to be a lead paint hazards.	3	3	1) Remove and replace with new replacement windows or 2) replace individual lead painted components or 3) enclose all lead painted surfaces or 4) strip all surfaces bare to the substrate, make necessary repairs, stabilize surfaces, and repaint.	1) Use friction reduction treatments (jamb liners, weatherstripping, rubber padding, tread covers, etc.) to reduce wear or 2) Wet plane all friction / impact surfaces, wet scrape all remaining surfaces, make necessary repairs, stabilize all surfaces and repaint.

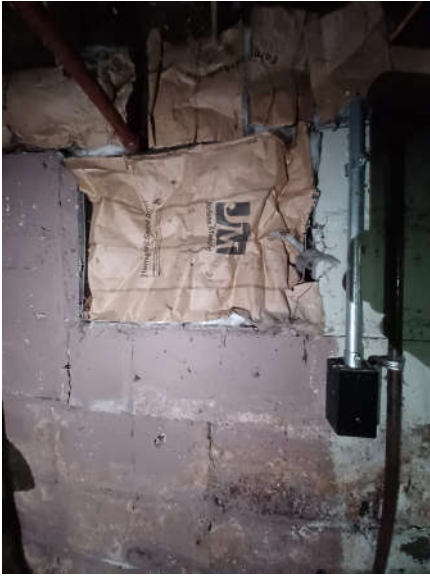
Utility Room 18 Coal Door

COMPONENT & LOCATION OF HAZARD	SEVERITY*	PRIORITY**	ABATEMENT OPTIONS	INTERIM CONTROL OPTIONS
Side D Coal Door represents a deteriorated lead paint surface hazard.	3	3	1) Remove and replace with new components or 2) wet scrape/sand all surfaces, make necessary repairs, stabilize surfaces and encapsulate with a Michigan approved encapsulant or 3) strip all surfaces bare to the substrate (either chemically or using mechanical wet methods), make necessary repairs and recoat.	Wet scrape / sand all surfaces, make necessary repairs, stabilize all surfaces and repaint.
Sides A & D1 Door Casings represent deteriorated lead paint surface hazards.	3	3	1) Remove and replace with new door systems or 2) replace individual lead painted components or 3) strip all surfaces on both sides of the door bare to the substrate, stabilize surfaces, and repaint.	1) Refit door to eliminate friction points, wet scrape/sand all surfaces, make necessary repairs, including installation of weatherstripping or other "soft" stop material, stabilize all surfaces and repaint 2) Use friction reduction treatments (jamb liners, weatherstripping, rubber padding, tread covers, etc.) to reduce wear or 3) Wet plane all friction / impact surfaces, wet scrape all remaining surfaces, make necessary repairs, stabilize all surfaces and repaint.
