Lead Inspection & Risk Assessment Report

127 Ferguson Street

Lansing, MI 48912

Date of Inspection: 05/09/2024

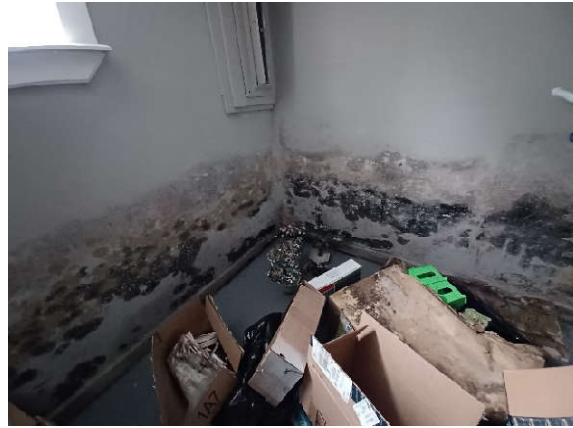
Basement 1 - Mold

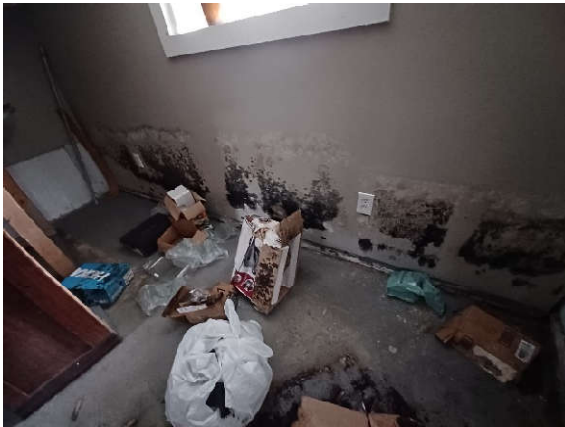
Basement 1 - Mold

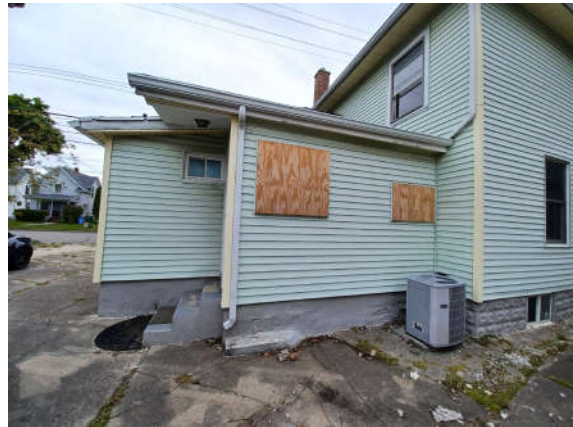
COMPONENT & LOCATION OF HAZARD	SEVERITY*	PRIORITY**	ABATEMENT OPTIONS	INTERIM CONTROL OPTIONS
Stairwell # 1				
Side B Window Stops Ext., Jambs, Wells-Troughs & Sashes Ext. were inaccessible due to the window being boarded shut. These components were of similar construction and visually exhibited a similar painting history to other components tested. Therefore, they were considered part of a testing combination and must be lead paint hazards.	1	1	1) Remove and replace with new replacement windows or 2) replace individual lead painted components or 3) enclose all lead painted surfaces or 4) strip all surfaces bare to the substrate, make necessary repairs, stabilize surfaces, and repaint.	Wet scrape / sand all surfaces, make necessary repairs, stabilize all surfaces and repaint.
Entire Home				
<u>After having completed all other abatement and interim control options.</u>	NA	NA	After completing all abatement and interim control options clean the entire home for lead dust thoroughly using the accepted HEPA-Wash cleaning methods.	After completing all abatement and interim control options clean the entire home for lead dust thoroughly using the accepted HEPA-Wash cleaning methods.

Stairs 4 – Boarded Windows – Side B

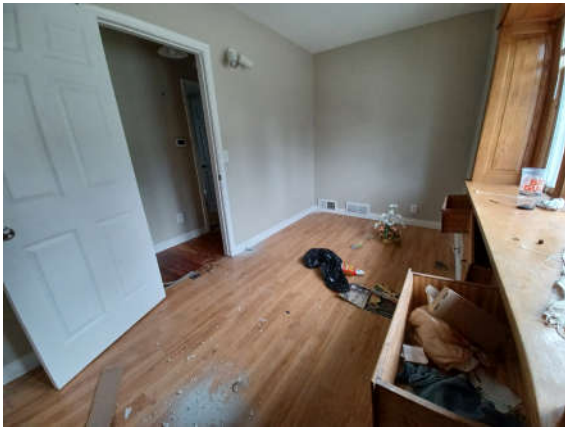
Bedroom 7

Bedroom # 7				
Sides D2, D3 & D4 Window Jambs were inaccessible due to the window being warped/painted shut. These components were of similar construction and visually exhibited a similar painting history to other components tested. Therefore, they were considered part of a testing combination and must be lead paint hazards.	1	1	1) Remove and replace with new replacement windows or 2) replace individual lead painted components or 3) enclose all lead painted surfaces or 4) strip all surfaces bare to the substrate, make necessary repairs, stabilize surfaces, and repaint.	Wet scrape / sand all surfaces, make necessary repairs, stabilize all surfaces and repaint.

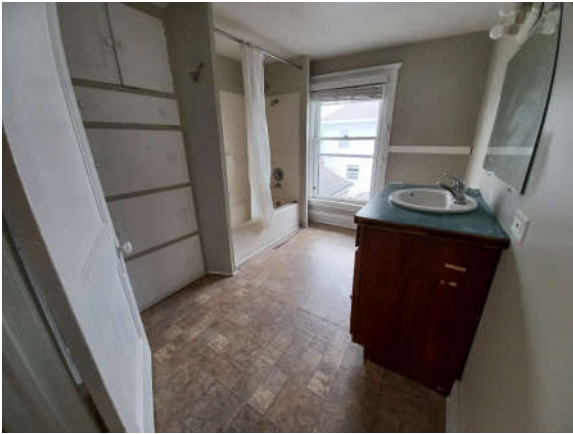
Bathroom 13

COMPONENT & LOCATION OF HAZARD	SEVERITY*	PRIORITY**	ABATEMENT OPTIONS	INTERIM CONTROL OPTIONS
Bathroom # 13				
Side C Window Sash Int. represents a deteriorated lead paint surface hazard.	1	1	1) Remove and replace with new replacement windows or 2) replace individual lead painted components or 3) enclose all lead painted surfaces or 4) strip all surfaces bare to the substrate, make necessary repairs, stabilize surfaces, and repaint.	Wet scrape / sand all surfaces, make necessary repairs, stabilize all surfaces and repaint.
Side C Window Sash Ext, Jamb, Stop Ext. & Well-Trough were inaccessible due to the window being warped/painted shut. These components were of similar construction and visually exhibited a similar painting history to other components tested. Therefore, they were considered part of a testing combination and must be lead paint hazards.	1	1	1) Remove and replace with new replacement windows or 2) replace individual lead painted components or 3) enclose all lead painted surfaces or 4) strip all surfaces bare to the substrate, make necessary repairs, stabilize surfaces, and repaint.	Wet scrape / sand all surfaces, make necessary repairs, stabilize all surfaces and repaint.

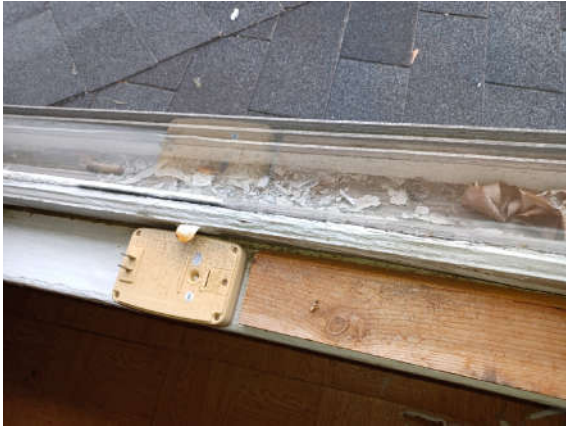
Paint Chips

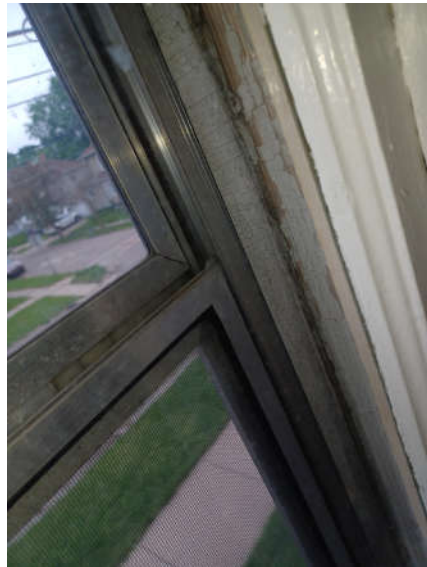
Assumed Positive: Window Components

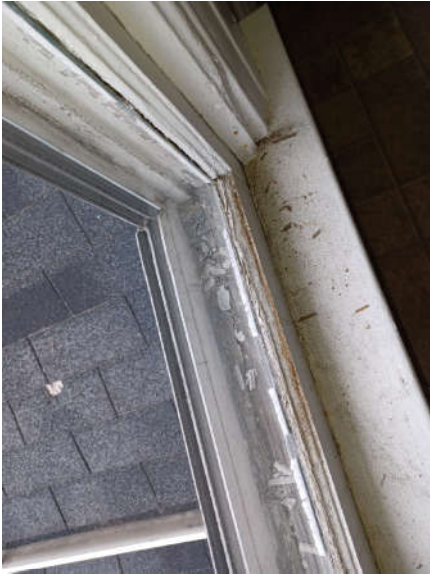
Assumed Positive: Wood Window Trough-
Wells & Jambs
