Lead Inspection & Risk Assessment Report

1316 Jerome Street

Lansing MI 48912

Date of Inspection: 05/06/2024

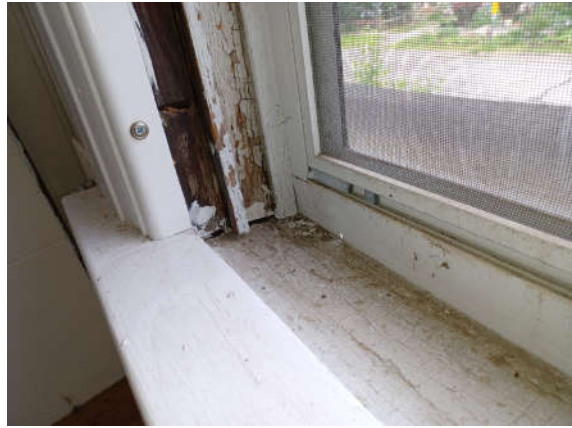
Deteriorated Paint

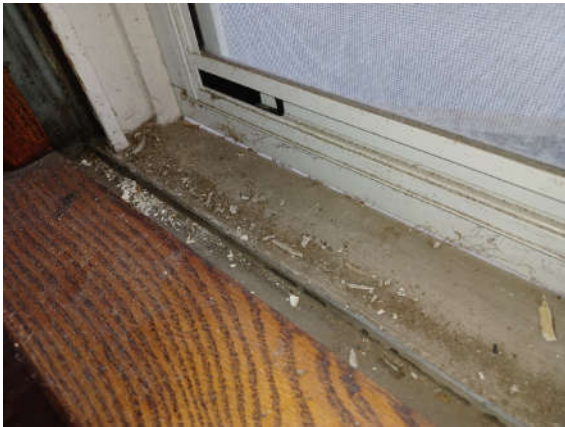
Paint Chips in Troughs

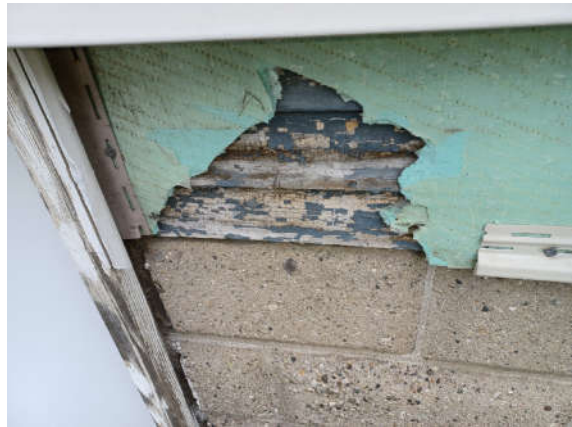
Side D Exposed Siding

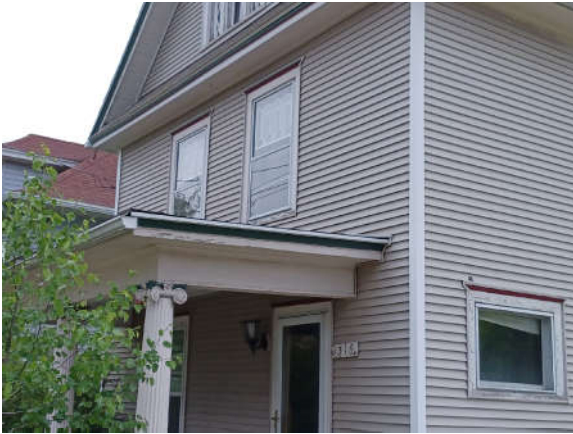
Side A All 2 nd Floor Window Sills-Stools were inaccessible due to being out of reach. These components were of similar construction and visually exhibited a similar painting history to other components tested. Therefore, they were considered part of a testing combination and must be lead paint hazards.	2	2	1) Remove and replace with new replacement windows or 2) replace individual lead painted components or 3) enclose all lead painted surfaces or 4) strip all surfaces bare to the substrate, make necessary repairs, stabilize surfaces, and repaint.	Wet scrape / sand all surfaces, make necessary repairs, stabilize all surfaces and repaint.

Side A 2nd Floor Assumed Windows

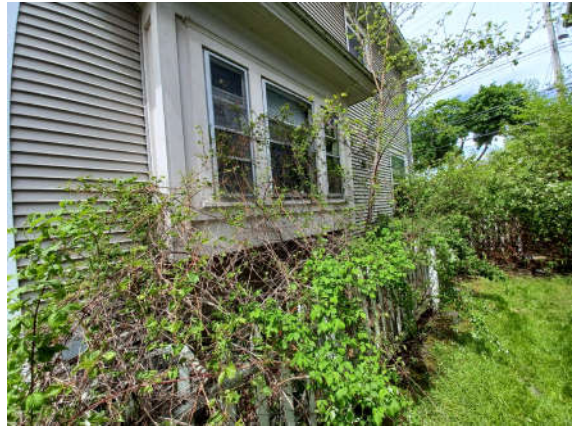
COMPONENT & LOCATION OF HAZARD	SEVERITY*	PRIORITY**	ABATEMENT OPTIONS	INTERIM CONTROL OPTIONS
Side B1 Window Casing & Sill-Stool were inaccessible due to being out of reach due to overgrown brush. These components were of similar construction and visually exhibited a similar painting history to other components tested. Therefore, they were considered part of a testing combination and must be lead paint hazards.	2	2	1) Remove and replace with new replacement windows or 2) replace individual lead painted components or 3) enclose all lead painted surfaces or 4) strip all surfaces bare to the substrate, make necessary repairs, stabilize surfaces, and repaint.	Wet scrape / sand all surfaces, make necessary repairs, stabilize all surfaces and repaint.
Side B2 Window Casing was inaccessible due to being out of reach due to overgrown brush. These components were of similar construction and visually exhibited a similar painting history to other components tested. Therefore, they were considered part of a testing combination and must be lead paint hazards.	2	2	1) Remove and replace with new replacement windows or 2) replace individual lead painted components or 3) enclose all lead painted surfaces or 4) strip all surfaces bare to the substrate, make necessary repairs, stabilize surfaces, and repaint.	Wet scrape / sand all surfaces, make necessary repairs, stabilize all surfaces and repaint.

Side B Exterior Windows Inaccessible

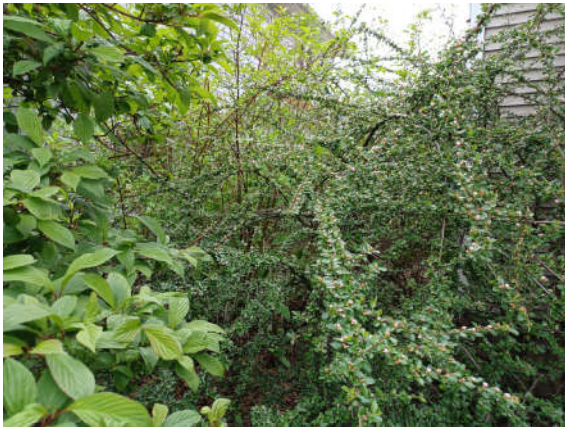
Side B Thorns

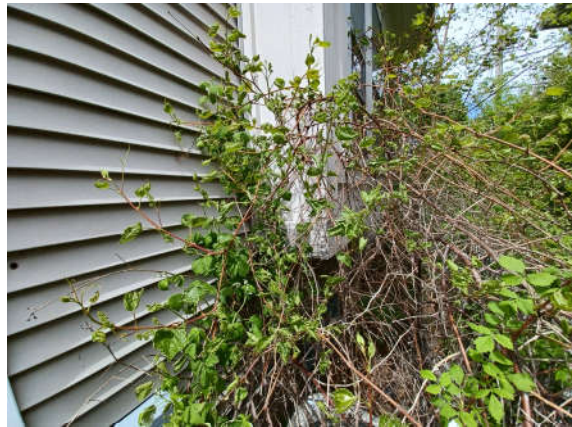
Side B Thorns (2)
