Lead Inspection & Risk Assessment Report

1320 Jerome Street

Lansing, MI 48812

Date of Inspection: 05/07/2024

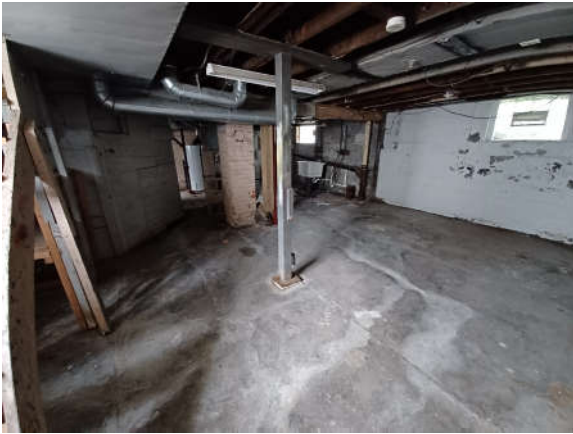
Basement 1

Basement # 1				
Sides A & B Walls represent deteriorated lead paint surface hazards.	1	1	1) Enclose with drywall or other suitable wallboard material or 2) wet scrape/sand all surfaces, make necessary repairs, stabilize surfaces and encapsulate with a Michigan approved encapsulant.	Wet scrape / sand all surfaces, make necessary repairs, stabilize all surfaces and repaint.
Side B Stair Stringer represents a deteriorated lead paint surface hazard.	1	1	1) Remove and replace with new components or 2) strip all surfaces bare to the substrate, make necessary repairs and recoat.	Wet scrape / sand all surfaces, make necessary repairs, stabilize all surfaces and repaint.
Side C Closet Door & Casing represent deteriorated lead paint surface hazards.	1	1	1) Remove and replace with new door systems or 2) replace individual lead painted components or 3) strip all surfaces on both sides of the door bare to the substrate, stabilize surfaces, and repaint.	Wet scrape / sand all surfaces, make necessary repairs, stabilize all surfaces and repaint.

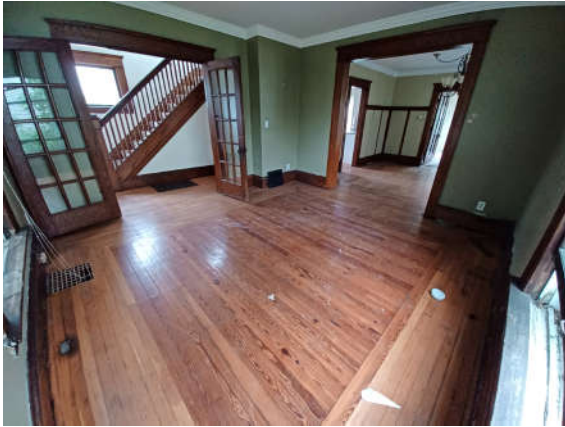
Living Room 3

COMPONENT & LOCATION OF HAZARD	SEVERITY*	PRIORITY**	ABATEMENT OPTIONS	INTERIM CONTROL OPTIONS
Living Room # 3				
Sides A & D Window Wells-Troughs & Jambs represent deteriorated lead paint friction hazards.	1	1	1) Remove and replace with new replacement windows or 2) replace individual lead painted components or 3) enclose all lead painted surfaces or 4) strip all surfaces bare to the substrate, make necessary repairs, stabilize surfaces, and repaint.	Wet scrape / sand all surfaces, make necessary repairs, stabilize all surfaces and repaint.
Entry # 4				
Side A Door Stop & Jamb Ext. represent deteriorated lead paint Friction/impact surface hazards.	1	1	1) Remove and replace with new door systems or 2) replace individual lead painted components or 3) strip all surfaces on both sides of the door bare to the substrate, stabilize surfaces, and repaint.	1) Refit door to eliminate friction points, wet scrape/sand all surfaces, make necessary repairs, including installation of weatherstripping or other "soft" stop material, stabilize all surfaces and repaint 2) Use friction reduction treatments (jamb liners, weatherstripping, rubber padding, tread covers, etc.) to reduce wear or 3) Wet plane all friction / impact surfaces, wet scrape all remaining surfaces, make necessary repairs, stabilize all surfaces and repaint.

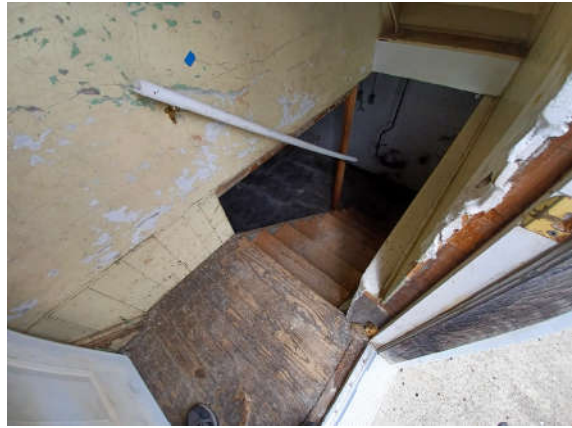
Stairs 6

Stairwell # 6				
Sides B & D Walls represent deteriorated lead paint surface hazards.	1	1	1) Enclose with drywall or other suitable wallboard material or 2) wet scrape/sand all surfaces, make necessary repairs, stabilize surfaces and encapsulate with a Michigan approved encapsulant.	Wet scrape / sand all surfaces, make necessary repairs, stabilize all surfaces and repaint.
Center Stair Stringer, Tread & Riser represent deteriorated lead paint surface hazards.	1	1	1) Remove and replace with new components or 2) strip all surfaces bare to the substrate, make necessary repairs and recoat.	Wet scrape / sand all surfaces, make necessary repairs, stabilize all surfaces and repaint.

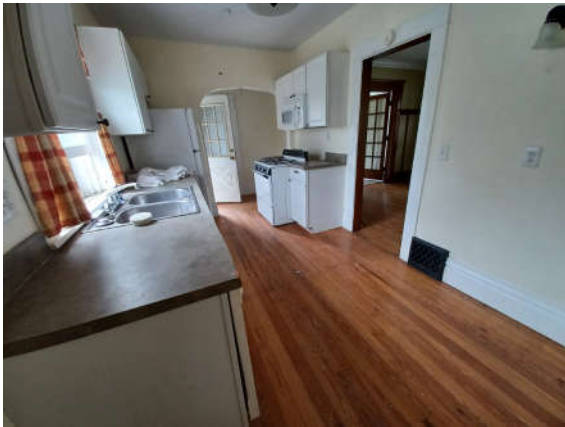
Kitchen 7

COMPONENT & LOCATION OF HAZARD	SEVERITY*	PRIORITY**	ABATEMENT OPTIONS	INTERIM CONTROL OPTIONS
Kitchen # 7				
Sides A, B & D Walls & the Ceiling represent deteriorated lead paint surface hazards.	1	1	1) Enclose with drywall or other suitable wallboard material or 2) wet scrape/sand all surfaces, make necessary repairs, stabilize surfaces and encapsulate with a Michigan approved encapsulant.	Wet scrape / sand all surfaces, make necessary repairs, stabilize all surfaces and repaint.
Side A All Baseboards represent deteriorated lead paint surface hazards.	1	1	1) Remove and replace with new components or 2) strip all surfaces bare to the substrate, make necessary repairs and recoat.	Wet scrape / sand all surfaces, make necessary repairs, stabilize all surfaces and repaint.
Sides A Door Casing represents a deteriorated lead paint surface hazard.	1	1	1) Remove and replace with new door systems or 2) replace individual lead painted components or 3) strip all surfaces on both sides of the door bare to the substrate, stabilize surfaces, and repaint.	Wet scrape / sand all surfaces, make necessary repairs, stabilize all surfaces and repaint.

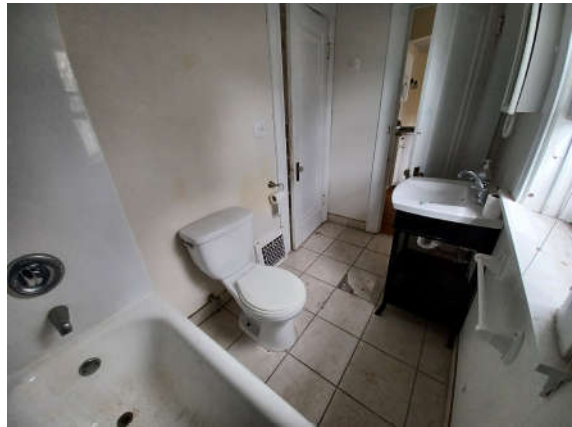
Bathroom 8

Bathroom # 8				
Side B Window Well-Trough & Jamb represent deteriorated lead paint friction surface hazards.	1	1	1) Remove and replace with new replacement windows or 2) replace individual lead painted components or 3) enclose all lead painted surfaces or 4) strip all surfaces bare to the substrate, make necessary repairs, stabilize surfaces, and repaint.	Wet scrape / sand all surfaces, make necessary repairs, stabilize all surfaces and repaint.
Family Room # 9				
Side C1 Window Sash Int. represents a deteriorated lead paint surface hazard.	1	1	1) Remove and replace with new replacement windows or 2) replace individual lead painted components or 3) enclose all lead painted surfaces or 4) strip all surfaces bare to the substrate, make necessary repairs, stabilize surfaces, and repaint.	Wet scrape / sand all surfaces, make necessary repairs, stabilize all surfaces and repaint.

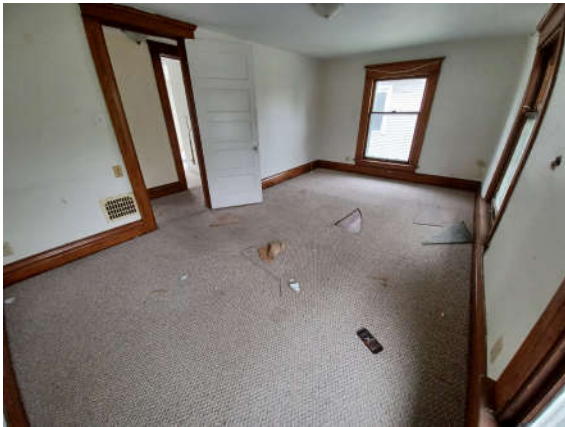
Bedroom 11

Bedroom # 11				
Sides A1, A2 & D Window Wells-Troughs, Stops Int. & Jambs represent deteriorated lead paint surface hazards.	1	1	1) Remove and replace with new replacement windows or 2) replace individual lead painted components or 3) enclose all lead painted surfaces or 4) strip all surfaces bare to the substrate, make necessary repairs, stabilize surfaces, and repaint.	Wet scrape / sand all surfaces, make necessary repairs, stabilize all surfaces and repaint.
Stairwell # 5				
Side B Window Well-Trough, Stop Int. & Jamb represent deteriorated lead paint surface hazards.	1	1	1) Remove and replace with new replacement windows or 2) replace individual lead painted components or 3) enclose all lead painted surfaces or 4) strip all surfaces bare to the substrate, make necessary repairs, stabilize surfaces, and repaint.	Wet scrape / sand all surfaces, make necessary repairs, stabilize all surfaces and repaint.

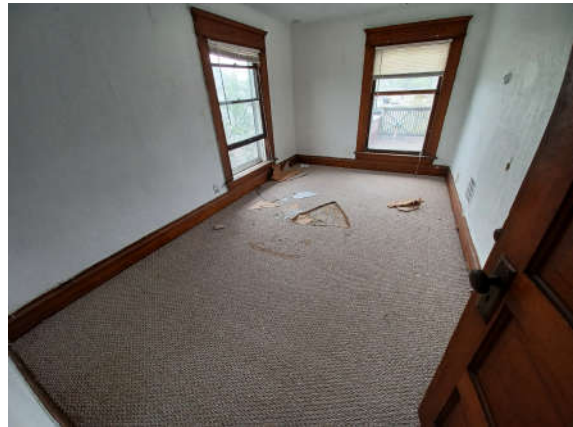
Bedroom 12

COMPONENT & LOCATION OF HAZARD	SEVERITY*	PRIORITY**	ABATEMENT OPTIONS	INTERIM CONTROL OPTIONS
Bedroom # 12				
Sides B & C Window Troughs-Wells & Stops Ext. represent deteriorated lead paint surface hazards.	1	1	1) Remove and replace with new replacement windows or 2) replace individual lead painted components or 3) enclose all lead painted surfaces or 4) strip all surfaces bare to the substrate, make necessary repairs, stabilize surfaces, and repaint.	Wet scrape / sand all surfaces, make necessary repairs, stabilize all surfaces and repaint.
Bedroom # 13				
Side D Window Stops Int., Well-Trough & Jamb represent deteriorated lead paint surface hazards.	1	1	1) Remove and replace with new replacement windows or 2) replace individual lead painted components or 3) enclose all lead painted surfaces or 4) strip all surfaces bare to the substrate, make necessary repairs, stabilize surfaces, and repaint.	Wet scrape / sand all surfaces, make necessary repairs, stabilize all surfaces and repaint.

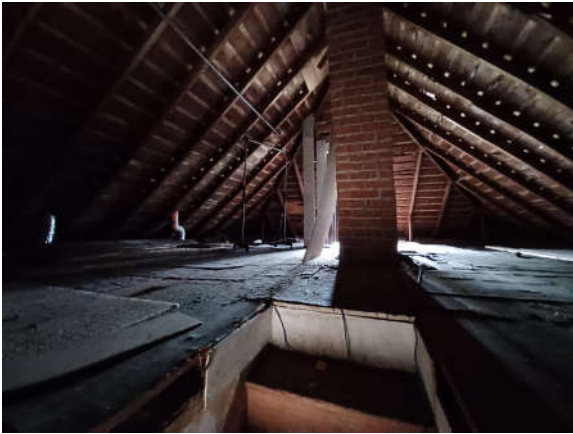
Attic 17

Attic # 17				
Side A1 Window Sash Int. represents a deteriorated lead paint surface hazard.	2	2	1) Remove and replace with new replacement windows or 2) replace individual lead painted components or 3) enclose all lead painted surfaces or 4) strip all surfaces bare to the substrate, make necessary repairs, stabilize surfaces, and repaint.	Wet scrape / sand all surfaces, make necessary repairs, stabilize all surfaces and repaint.
Side A All Window Casings & Sills-Stools represent deteriorated lead paint surface hazards.	2	2	1) Remove and replace with new replacement windows or 2) replace individual lead painted components or 3) enclose all lead painted surfaces or 4) strip all surfaces bare to the substrate, make necessary repairs, stabilize surfaces, and repaint.	Wet scrape / sand all surfaces, make necessary repairs, stabilize all surfaces and repaint.

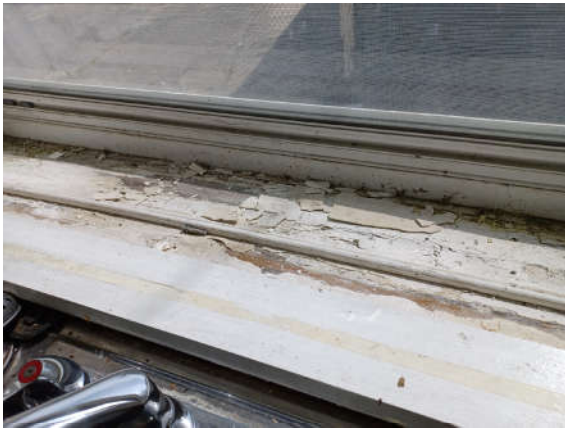
Paint Chips in Window Troughs
