Lead Inspection & Risk Assessment Report

123 Ferguson Street

Lansing, MI 48912

Date of Inspection: 05/13/2024

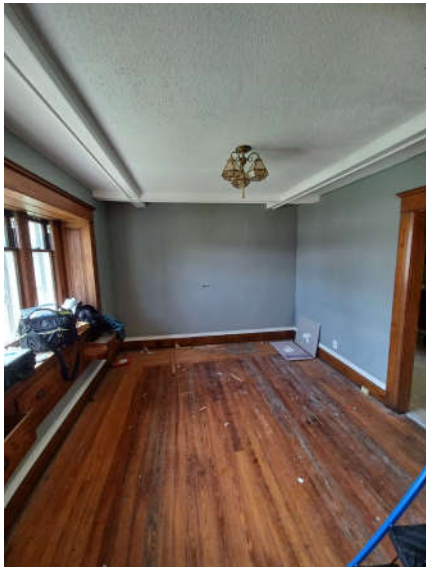
Dining Room 3

COMPONENT & LOCATION OF HAZARD	SEVERITY*	PRIORITY**	ABATEMENT OPTIONS	INTERIM CONTROL OPTIONS
Dining Room # 3				
All White Wood Window Sashes Ext., Stops Ext., Jambs, Parting Beads & Wells-Troughs represent deteriorated lead paint surface hazards.	2	2	1) Remove and replace with new replacement windows or 2) replace individual lead painted components or 3) enclose all lead painted surfaces or 4) strip all surfaces bare to the substrate, make necessary repairs, stabilize surfaces, and repaint.	1) Use friction reduction treatments (jamb liners, weatherstripping, rubber padding, tread covers, etc.) to reduce wear or 2) Wet plane all friction / impact surfaces, wet scrape all remaining surfaces, make necessary repairs, stabilize all surfaces and repaint.
Kitchen # 4				
Side D2 White Wood Window Sash Ext., Stop Ext., Jamb & Parting Bead represent deteriorated lead paint surface hazards.	2	2	1) Remove and replace with new replacement windows or 2) replace individual lead painted components or 3) enclose all lead painted surfaces or 4) strip all surfaces bare to the substrate, make necessary repairs, stabilize surfaces, and repaint.	1) Use friction reduction treatments (jamb liners, weatherstripping, rubber padding, tread covers, etc.) to reduce wear or 2) Wet plane all friction / impact surfaces, wet scrape all remaining surfaces, make necessary repairs, stabilize all surfaces and repaint.

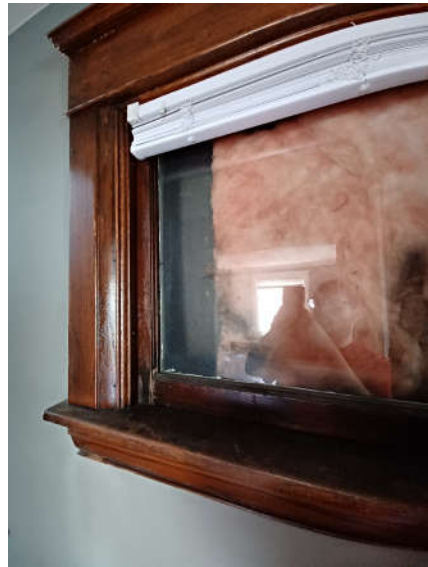
Stairs 7 Side D2 Window

COMPONENT & LOCATION OF HAZARD	SEVERITY*	PRIORITY**	ABATEMENT OPTIONS	INTERIM CONTROL OPTIONS
Side D2 Window Sash Ext., Stop Ext., Jamb, Parting Bead & Well-Trough were inaccessible due to being walled off from the outside. is an untested other surface in deteriorated condition that must be considered to be a lead paint hazard.	3	3	1) Remove and replace with new replacement windows or 2) replace individual lead painted components or 3) enclose all lead painted surfaces or 4) strip all surfaces bare to the substrate, make necessary repairs, stabilize surfaces, and repaint.	1) Use friction reduction treatments (jamb liners, weatherstripping, rubber padding, tread covers, etc.) to reduce wear or 2) Wet plane all friction / impact surfaces, wet scrape all remaining surfaces, make necessary repairs, stabilize all surfaces and repaint.
Bedroom # 9				
Side A(All) White Wood Window Jambs represent deteriorated lead paint surface hazards.	2	2	1) Remove and replace with new replacement windows or 2) replace individual lead painted components or 3) enclose all lead painted surfaces or 4) strip all surfaces bare to the substrate, make necessary repairs, stabilize surfaces, and repaint.	1) Use friction reduction treatments (jamb liners, weatherstripping, rubber padding, tread covers, etc.) to reduce wear or 2) Wet plane all friction / impact surfaces, wet scrape all remaining surfaces, make necessary repairs, stabilize all surfaces and repaint.

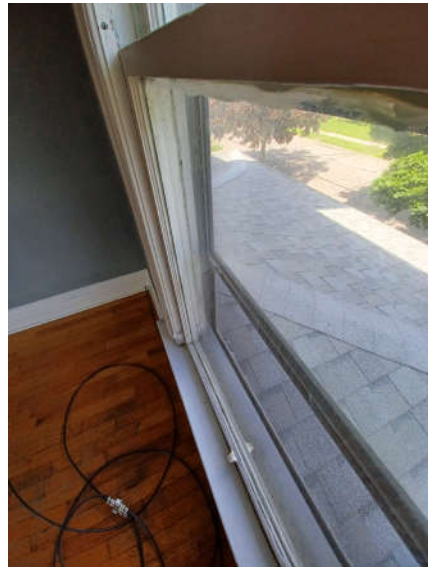
Bedroom 10 Side A Window

COMPONENT & LOCATION OF HAZARD	SEVERITY*	PRIORITY**	ABATEMENT OPTIONS	INTERIM CONTROL OPTIONS
Sides A1 & B1 Window Sashes Ext., Stops Ext., Jambs, Parting Beads & Wells-Trough were inaccessible due to being painted shut. is an untested other surface in deteriorated condition that must be considered to be a lead paint hazard.	2	2	1) Remove and replace with new replacement windows or 2) replace individual lead painted components or 3) enclose all lead painted surfaces or 4) strip all surfaces bare to the substrate, make necessary repairs, stabilize surfaces, and repaint.	1) Use friction reduction treatments (jamb liners, weatherstripping, rubber padding, tread covers, etc.) to reduce wear or 2) Wet plane all friction / impact surfaces, wet scrape all remaining surfaces, make necessary repairs, stabilize all surfaces and repaint.
Kitchen # 11				
Side C1 Window Sash Ext., Stop Ext., Jamb, Parting Bead & Well-Trough were inaccessible due to being painted shut. is an untested other surface in deteriorated condition that must be considered to be a lead paint hazard.	2	2	1) Remove and replace with new replacement windows or 2) replace individual lead painted components or 3) enclose all lead painted surfaces or 4) strip all surfaces bare to the substrate, make necessary repairs, stabilize surfaces, and repaint.	1) Use friction reduction treatments (jamb liners, weatherstripping, rubber padding, tread covers, etc.) to reduce wear or 2) Wet plane all friction / impact surfaces, wet scrape all remaining surfaces, make necessary repairs, stabilize all surfaces and repaint.

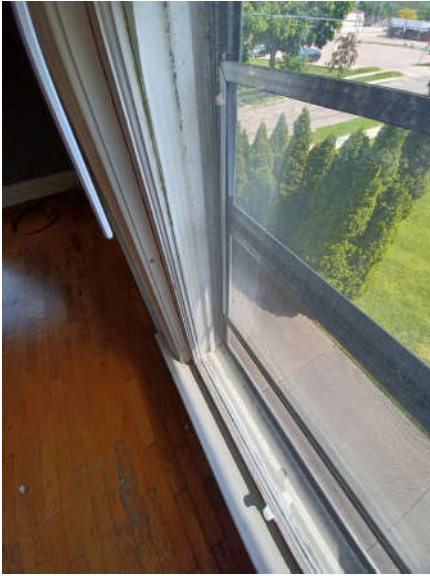
Bedroom 10 Side B Window

Bedroom # 10				
Side B(All) White Wood Window Casing represents deteriorated lead paint surface hazards.	3	3	1) Remove and replace with new replacement windows or 2) replace individual lead painted components or 3) enclose all lead painted surfaces or 4) strip all surfaces bare to the substrate, make necessary repairs, stabilize surfaces, and repaint.	1) Use friction reduction treatments (jamb liners, weatherstripping, rubber padding, tread covers, etc.) to reduce wear or 2) Wet plane all friction / impact surfaces, wet scrape all remaining surfaces, make necessary repairs, stabilize all surfaces and repaint.

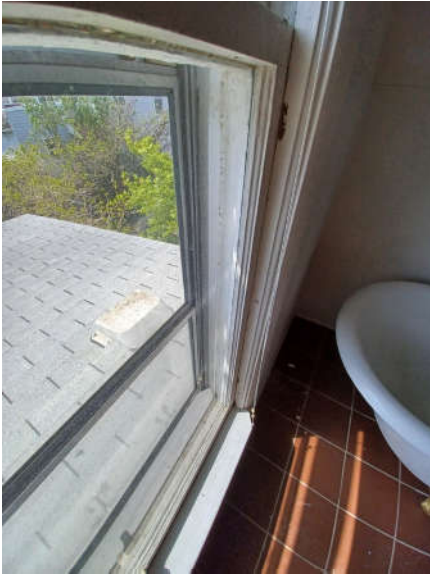
Bathroom 12 Side C

Bathroom # 12				
Side C1 Window Sash Ext., Stop Ext., Jamb, Parting Bead & Well-Trough were inaccessible due to being painted shut. is an untested other surface in deteriorated condition that must be considered to be a lead paint hazard.	2	2	1) Remove and replace with new replacement windows or 2) replace individual lead painted components or 3) enclose all lead painted surfaces or 4) strip all surfaces bare to the substrate, make necessary repairs, stabilize surfaces, and repaint.	1) Use friction reduction treatments (jamb liners, weatherstripping, rubber padding, tread covers, etc.) to reduce wear or 2) Wet plane all friction / impact surfaces, wet scrape all remaining surfaces, make necessary repairs, stabilize all surfaces and repaint.

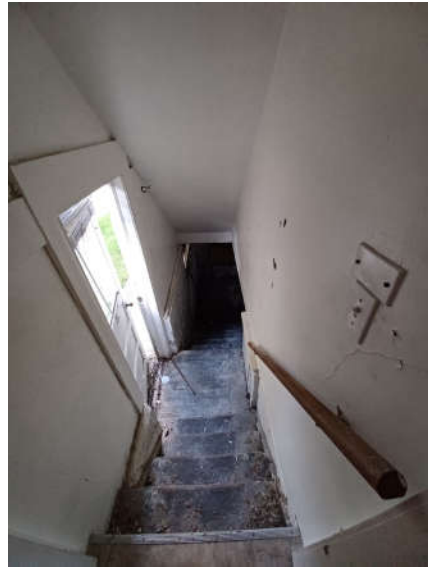
Stairs 13

COMPONENT & LOCATION OF HAZARD	SEVERITY*	PRIORITY**	ABATEMENT OPTIONS	INTERIM CONTROL OPTIONS
Basement Stair # 13				
Side D Door Casing represents a deteriorated lead paint surface hazard.	3	3	1) Remove and replace with new door systems or 2) replace individual lead painted components or 3) strip all surfaces on both sides of the door bare to the substrate, stabilize surfaces, and repaint.	1) Refit door to eliminate friction points, wet scrape/sand all surfaces, make necessary repairs, including installation of weatherstripping or other "soft" stop material, stabilize all surfaces and repaint 2) Use friction reduction treatments (jamb liners, weatherstripping, rubber padding, tread covers, etc.) to reduce wear or 3) Wet plane all friction / impact surfaces, wet scrape all remaining surfaces, make necessary repairs, stabilize all surfaces and repaint.
Attic # 17				
Sides A1 & A2 Window Sashes Ext., Stops Ext., Jambs, Parting Beads & Wells-Trough were inaccessible due to being sealed shut. Is an untested other surface in deteriorated condition that must be considered to be a lead paint hazard.	3	3	1) Remove and replace with new replacement windows or 2) replace individual lead painted components or 3) enclose all lead painted surfaces or 4) strip all surfaces bare to the substrate, make necessary repairs, stabilize surfaces, and repaint.	1) Use friction reduction treatments (jamb liners, weatherstripping, rubber padding, tread covers, etc.) to reduce wear or 2) Wet plane all friction / impact surfaces, wet scrape all remaining surfaces, make necessary repairs, stabilize all surfaces and repaint.
