**RE: *Asbestos Containing Material and Hazardous Materials Inspection***  
***5135 Balzer St. Lansing, MI 48911***  
***Parcel ID: 5135 Balzer St.***

Project No.: 19-1159  
Ingham County Land Bank  
Parcel ID: 5135 Balzer St.

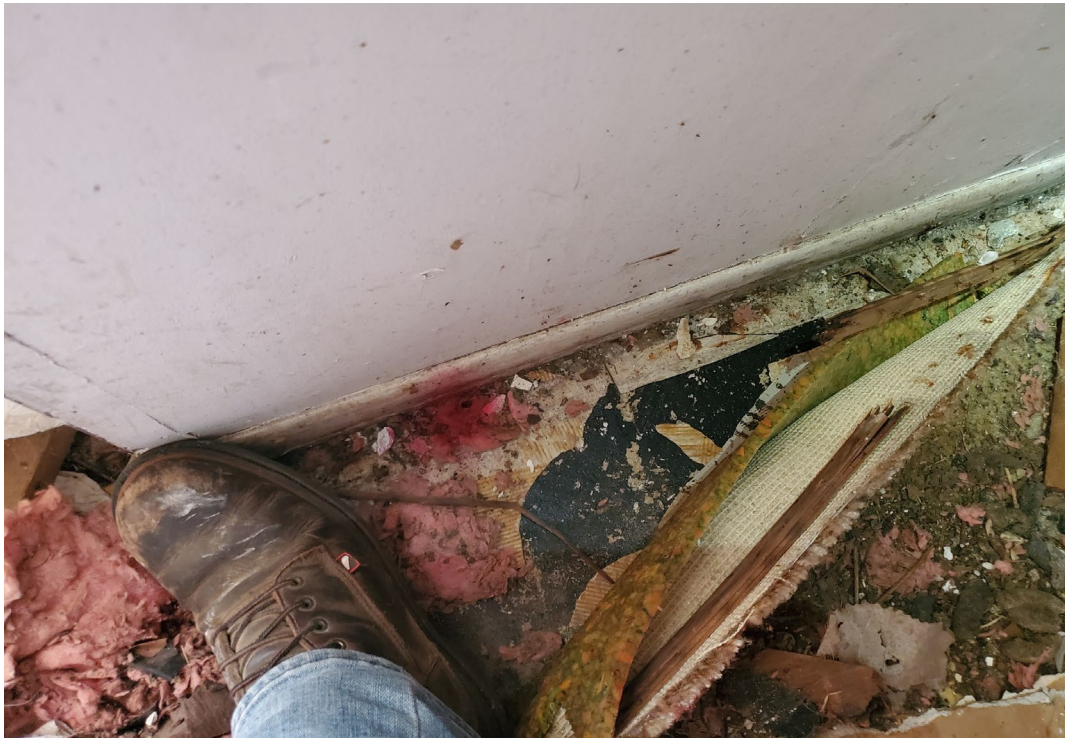
Three types of resilient floor coverings and mastic (12"x12" Floor Tile with Mastic, 12"x12" Tan Floor Tile Multilayer with Mastic and Floor Tile Multilayer with Mastic) located within the living room, kitchen and rear entry were found to contain up to 10% Chrysotile asbestos. The assessment to quantify the extent of this material identified approximately 380 sq. ft. of this material within the Building.

**PHOTO: 2**  
**SUBJECT: Living 12"x12" Floor Tile with Mastic**

The Category I resilient floor coverings (12"x12" Floor Tile with Mastic, 12"x12" Tan Floor Tile Multilayer with Mastic and Floor Tile Multilayer with Mastic) are non-friable ACM's that should be abated to mitigate any future exposure.

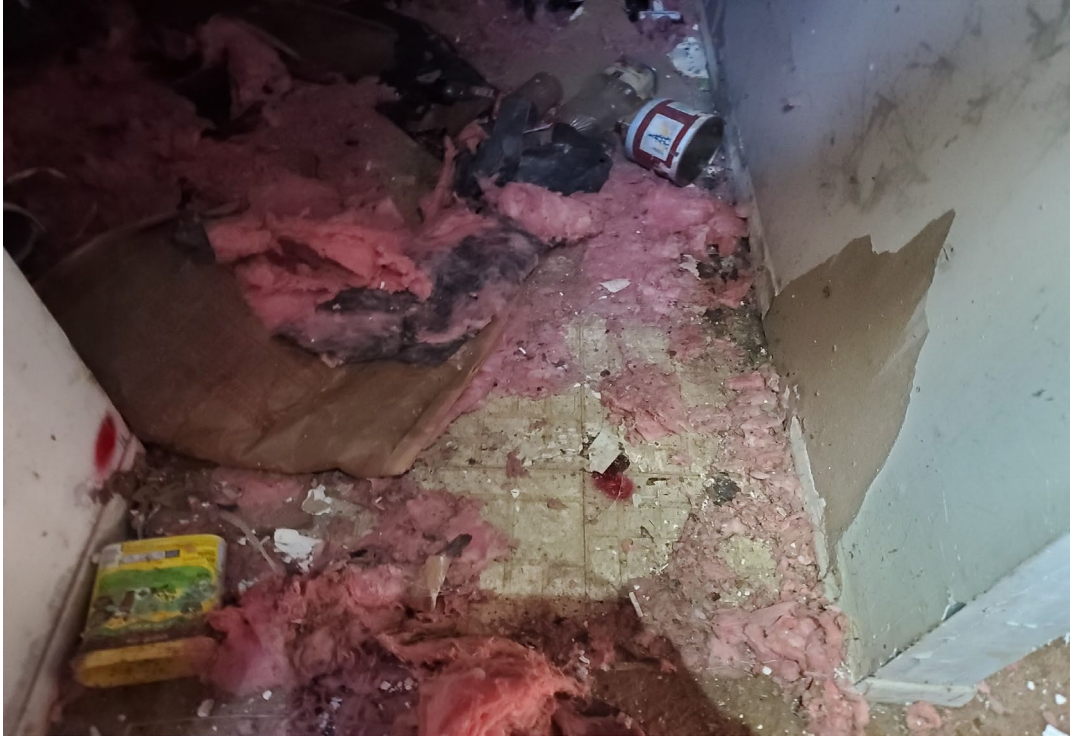
**PHOTO: 3 Kitchen 12"12" Tan Floor Tile Multilayer/Mastic BY: A. Paquet**  
**SUBJECT:**

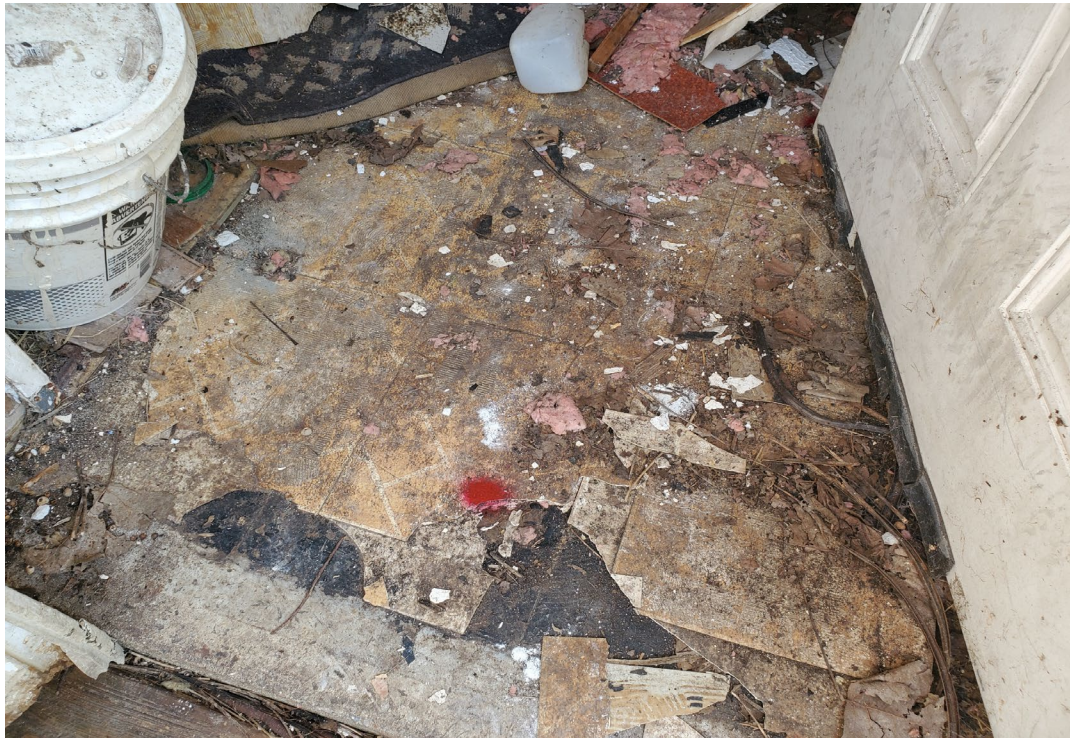
**PHOTO: 4 BY: A. Paquet**  
**SUBJECT: Rear Entry Floor Tile Multilayer with Mastic**
