December 29, 2017

Re: Pre-Demolition Regulated Materials Survey  
 1000 W Saginaw St, Lansing, Ingham County, MI

The Mannik & Smith Group, Inc. (MSG) is pleased to present Ingham County with the results of the limited pre-demolition regulated materials survey (RMS) performed at 1000 W Saginaw St, Lansing, Ingham County, Michigan (hereinafter referred to as the "Site") by Kory McKay (Accreditation Number A47903).

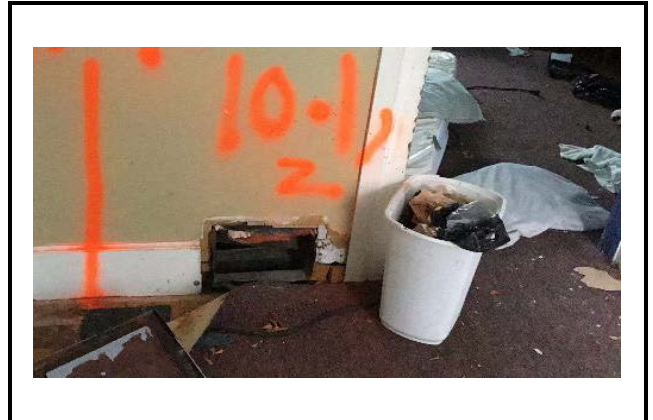
Asbestos Containing Material				
Location	Material Group	Friable/Non Friable	Asbestos	Quantity
RM-8	Gold tile	Non friable	5% Chrysotile	85
RM-7, RM-8	Vent wrap	Friable	40% Chrysotile	200 SF
RM-2, RM-9	Multicolored linoleum	Non friable	20% Chrysotile	100 SF
Exterior	Siding	Non friable	15% Chrysotile	900 SF

Vent wrap sample from room 8

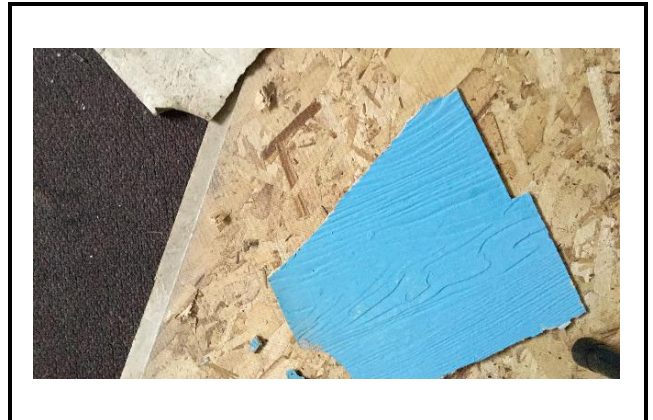
Siding sample from exterior second story
