Lead Inspection & Risk Assessment Report

125 Ferguson Street

Lansing, MI 48912

Date of Report: 05/22/2024

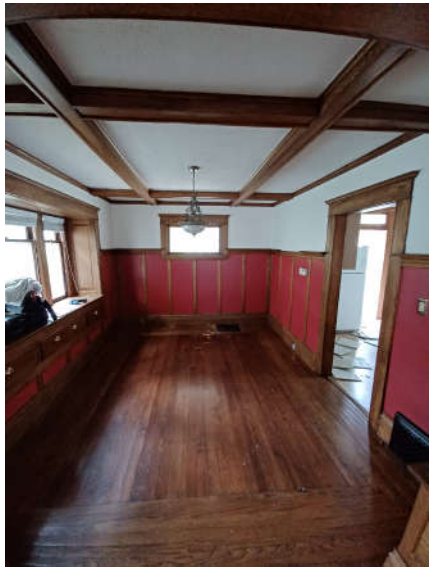
Dining Room 2 Sides B1, B2 & B3

COMPONENT & LOCATION OF HAZARD	SEVERITY*	PRIORITY**	ABATEMENT OPTIONS	INTERIM CONTROL OPTIONS
Dining Room # 2				
Sides B1, B2 & B3 Window Sashes Ext., Stops Ext., Jambs, Parting Beads & Wells-Troughs were inaccessible due to being sealed shut. Is untested other surfaces in deteriorated condition that must be considered to be a lead paint hazards.	3	3	1) Remove and replace with new replacement windows or 2) replace individual lead painted components or 3) enclose all lead painted surfaces or 4) strip all surfaces bare to the substrate, make necessary repairs, stabilize surfaces, and repaint.	1) Use friction reduction treatments (jamb liners, weatherstripping, rubber padding, tread covers, etc.) to reduce wear or 2) Wet plane all friction / impact surfaces, wet scrape all remaining surfaces, make necessary repairs, stabilize all surfaces and repaint.
Kitchen # 3				
Side D Wall & the Ceiling represent deteriorated lead paint surface hazards.	3	3	1) Enclose with drywall or other suitable wallboard material or 2) wet scrape/sand all surfaces, make necessary repairs, stabilize surfaces and encapsulate with a Michigan approved encapsulant.	Wet scrape / sand all surfaces, make necessary repairs, stabilize all surfaces and repaint.

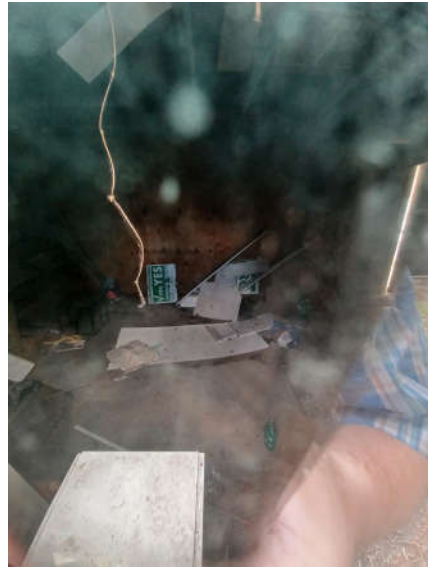
Utility Room 18 Coal Door

COMPONENT & LOCATION OF HAZARD	SEVERITY*	PRIORITY**	ABATEMENT OPTIONS	INTERIM CONTROL OPTIONS
Side D Coal Door represents a deteriorated lead paint surface hazard.	3	3	1) Remove and replace with new components or 2) wet scrape/sand all surfaces, make necessary repairs, stabilize surfaces and encapsulate with a Michigan approved encapsulant or 3) strip all surfaces bare to the substrate (either chemically or using mechanical wet methods), make necessary repairs and recoat.	Wet scrape / sand all surfaces, make necessary repairs, stabilize all surfaces and repaint.
Sides A & D1 Door Casings represent deteriorated lead paint surface hazards.	3	3	1) Remove and replace with new door systems or 2) replace individual lead painted components or 3) strip all surfaces on both sides of the door bare to the substrate, stabilize surfaces, and repaint.	1) Refit door to eliminate friction points, wet scrape/sand all surfaces, make necessary repairs, including installation of weatherstripping or other "soft" stop material, stabilize all surfaces and repaint 2) Use friction reduction treatments (jamb liners, weatherstripping, rubber padding, tread covers, etc.) to reduce wear or 3) Wet plane all friction / impact surfaces, wet scrape all remaining surfaces, make necessary repairs, stabilize all surfaces and repaint.
