Lead Inspection & Risk Assessment Report

127 Ferguson Street

Lansing, MI 48912

Date of Inspection: 05/09/2024

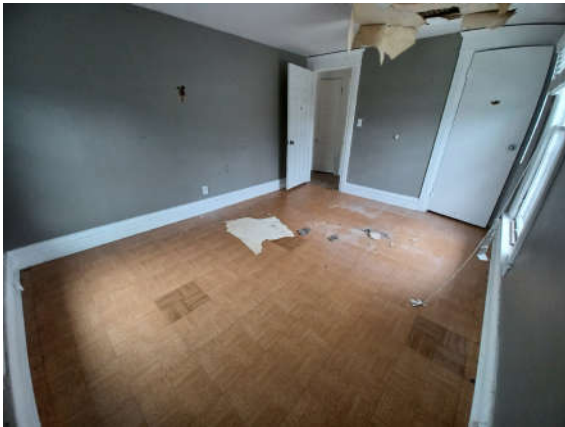
Bedroom 11

COMPONENT & LOCATION OF HAZARD	SEVERITY*	PRIORITY**	ABATEMENT OPTIONS	INTERIM CONTROL OPTIONS
<p align="center">Bedroom # 11</p> <p>Side D Window Well-Trough, Jamb & Sash Ext. were inaccessible due to the window being warped/painted shut. These components were of similar construction and visually exhibited a similar painting history to other components tested. Therefore, they were considered part of a testing combination and must be lead paint hazards.</p>	1	1	<p>1) Remove and replace with new replacement windows or 2) replace individual lead painted components or 3) enclose all lead painted surfaces or 4) strip all surfaces bare to the substrate, make necessary repairs, stabilize surfaces, and repaint.</p>	<p>Wet scrape / sand all surfaces, make necessary repairs, stabilize all surfaces and repaint.</p>
<p align="center">Bedroom # 12</p> <p>Side A Window Stop Ext., Jamb, Well-Trough & Sash Ext. were inaccessible due to the window being warped/painted shut. These components were of similar construction and visually exhibited a similar painting history to other components tested. Therefore, they were considered part of a testing combination and must be lead paint hazards.</p>	1	1	<p>1) Remove and replace with new replacement windows or 2) replace individual lead painted components or 3) enclose all lead painted surfaces or 4) strip all surfaces bare to the substrate, make necessary repairs, stabilize surfaces, and repaint.</p>	<p>Wet scrape / sand all surfaces, make necessary repairs, stabilize all surfaces and repaint.</p>
