Lead Inspection & Risk Assessment Report

1316 Jerome Street

Lansing MI 48912

Date of Inspection: 05/06/2024

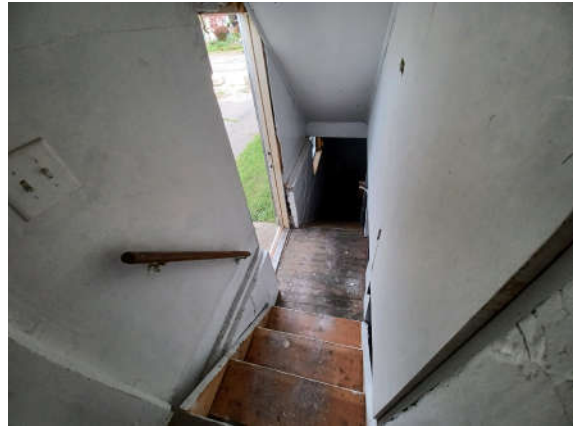
Stairs 6

Stairwell # 6				
Sides B & D Walls represent deteriorated lead paint surface hazards.	1	1	1) Enclose with drywall or other suitable wallboard material or 2) wet scrape/sand all surfaces, make necessary repairs, stabilize surfaces and encapsulate with a Michigan approved encapsulant.	Wet scrape / sand all surfaces, make necessary repairs, stabilize all surfaces and repaint.
Side C Stair Riser represents a deteriorated lead paint surface hazard.	1	1	1) Remove and replace with new components or 2) strip all surfaces bare to the substrate, make necessary repairs and recoat.	Wet scrape / sand all surfaces, make necessary repairs, stabilize all surfaces and repaint.

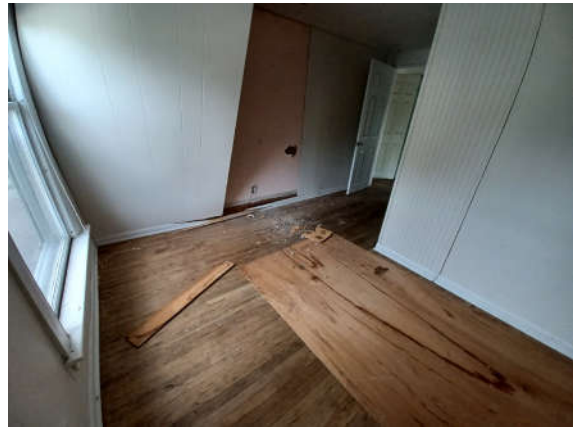
Bedroom 8

COMPONENT & LOCATION OF HAZARD	SEVERITY*	PRIORITY**	ABATEMENT OPTIONS	INTERIM CONTROL OPTIONS
Bedroom # 8				
Side A Window Well-Trough & Jamb represent deteriorated lead paint surface hazards.	1	1	1) Remove and replace with new replacement windows or 2) replace individual lead painted components or 3) enclose all lead painted surfaces or 4) strip all surfaces bare to the substrate, make necessary repairs, stabilize surfaces, and repaint.	Wet scrape / sand all surfaces, make necessary repairs, stabilize all surfaces and repaint.
Bedroom # 9				
Side A Window Well-Trough & Jamb represent deteriorated lead paint surface hazards.	1	1	1) Remove and replace with new replacement windows or 2) replace individual lead painted components or 3) enclose all lead painted surfaces or 4) strip all surfaces bare to the substrate, make necessary repairs, stabilize surfaces, and repaint.	Wet scrape / sand all surfaces, make necessary repairs, stabilize all surfaces and repaint.
