Lead Inspection & Risk Assessment Report

1320 Jerome Street

Lansing, MI 48812

Date of Inspection: 05/07/2024

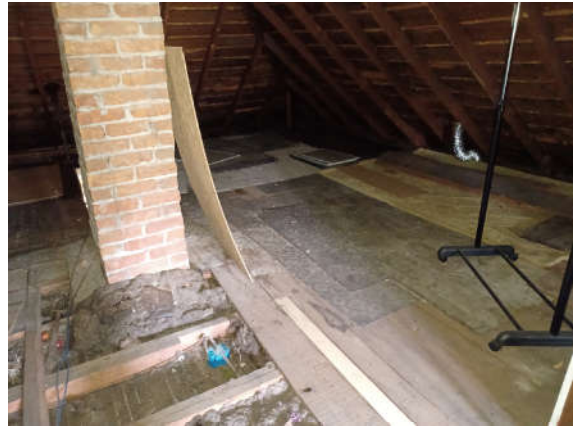
Attic 17 (2)

Attic # 17				
Side A1 Window Sash Int. represents a deteriorated lead paint surface hazard.	2	2	1) Remove and replace with new replacement windows or 2) replace individual lead painted components or 3) enclose all lead painted surfaces or 4) strip all surfaces bare to the substrate, make necessary repairs, stabilize surfaces, and repaint.	Wet scrape / sand all surfaces, make necessary repairs, stabilize all surfaces and repaint.
Side A All Window Casings & Sills-Stools represent deteriorated lead paint surface hazards.	2	2	1) Remove and replace with new replacement windows or 2) replace individual lead painted components or 3) enclose all lead painted surfaces or 4) strip all surfaces bare to the substrate, make necessary repairs, stabilize surfaces, and repaint.	Wet scrape / sand all surfaces, make necessary repairs, stabilize all surfaces and repaint.
