Lead Inspection & Risk Assessment Report

123 Ferguson Street

Lansing, MI 48912

Date of Inspection: 05/13/2024

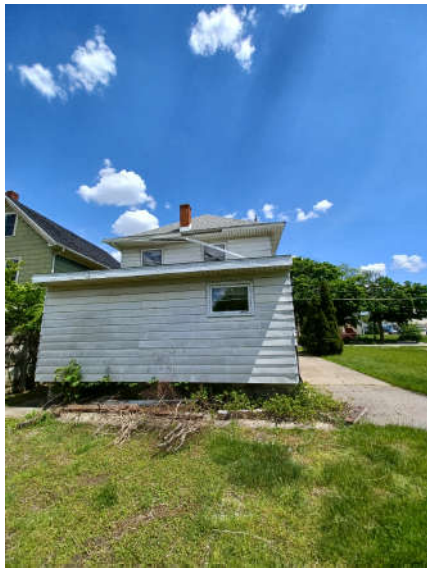
COMPONENT & LOCATION OF HAZARD	SEVERITY*	PRIORITY**	ABATEMENT OPTIONS	INTERIM CONTROL OPTIONS
Side C White Wood Window Casing represents a deteriorated lead paint surface hazard.	3	3	1) Remove and replace with new replacement windows or 2) replace individual lead painted components or 3) enclose all lead painted surfaces or 4) strip all surfaces bare to the substrate, make necessary repairs, stabilize surfaces, and repaint.	1) Use friction reduction treatments (jamb liners, weatherstripping, rubber padding, tread covers, etc.) to reduce wear or 2) Wet plane all friction / impact surfaces, wet scrape all remaining surfaces, make necessary repairs, stabilize all surfaces and repaint.
Living Room # 2				
All White Wood Window Sashes Ext., Stops Ext., Jambs, Parting Beads & Wells-Troughs represent deteriorated lead paint surface hazards.	2	2	1) Remove and replace with new replacement windows or 2) replace individual lead painted components or 3) enclose all lead painted surfaces or 4) strip all surfaces bare to the substrate, make necessary repairs, stabilize surfaces, and repaint.	1) Use friction reduction treatments (jamb liners, weatherstripping, rubber padding, tread covers, etc.) to reduce wear or 2) Wet plane all friction / impact surfaces, wet scrape all remaining surfaces, make necessary repairs, stabilize all surfaces and repaint.

Side C Closet Shelf represents a deteriorated lead paint surface hazard.	3	3	1) Remove and replace with new components or 2) wet scrape/sand all surfaces, make necessary repairs, stabilize surfaces and encapsulate with a Michigan approved encapsulant or 3) strip all surfaces bare to the substrate (either chemically or using mechanical wet methods), make necessary repairs and recoat.	Wet scrape / sand all surfaces, make necessary repairs, stabilize all surfaces and repaint.
Side C Closet Wall represents a deteriorated lead paint surface hazard.	3	3	1) Enclose with drywall or other suitable wallboard material or 2) wet scrape/sand all surfaces, make necessary repairs, stabilize surfaces and encapsulate with a Michigan approved encapsulant.	Wet scrape / sand all surfaces, make necessary repairs, stabilize all surfaces and repaint.

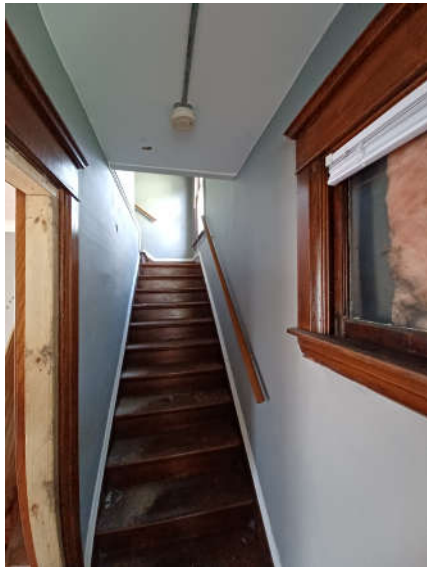
Stairs 7

Stairwell # 7				
Side D1 Window Jamb, Stop Ext. & Sash Ext. represent deteriorated lead paint surface hazards.	2	2	1) Remove and replace with new replacement windows or 2) replace individual lead painted components or 3) enclose all lead painted surfaces or 4) strip all surfaces bare to the substrate, make necessary repairs, stabilize surfaces, and repaint.	1) Use friction reduction treatments (jamb liners, weatherstripping, rubber padding, tread covers, etc.) to reduce wear or 2) Wet plane all friction / impact surfaces, wet scrape all remaining surfaces, make necessary repairs, stabilize all surfaces and repaint.

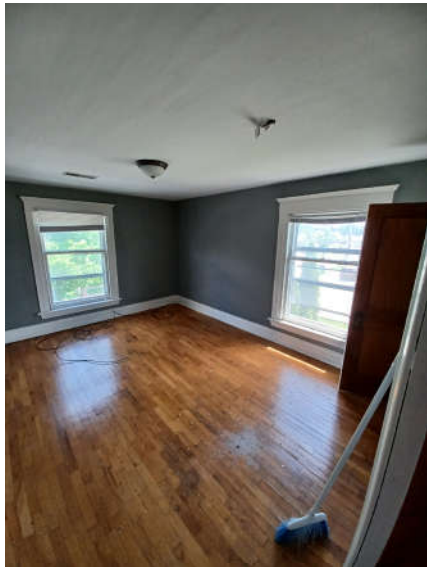
Bedroom 10

Bedroom # 10				
Side B(All) White Wood Window Casing represents deteriorated lead paint surface hazards.	3	3	1) Remove and replace with new replacement windows or 2) replace individual lead painted components or 3) enclose all lead painted surfaces or 4) strip all surfaces bare to the substrate, make necessary repairs, stabilize surfaces, and repaint.	1) Use friction reduction treatments (jamb liners, weatherstripping, rubber padding, tread covers, etc.) to reduce wear or 2) Wet plane all friction / impact surfaces, wet scrape all remaining surfaces, make necessary repairs, stabilize all surfaces and repaint.

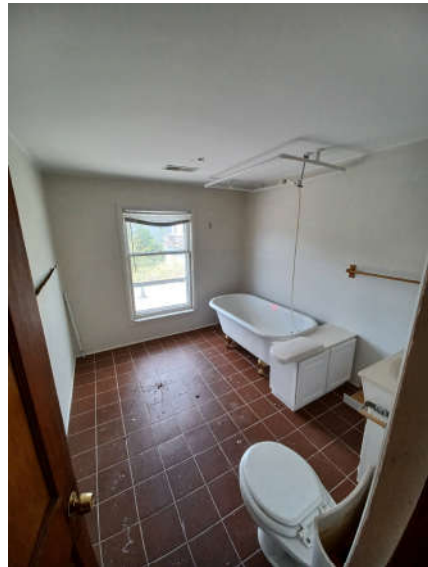
Bathroom 12

Bathroom # 12				
Side C1 Window Sash Ext., Stop Ext., Jamb, Parting Bead & Well-Trough were inaccessible due to being painted shut. is an untested other surface in deteriorated condition that must be considered to be a lead paint hazard.	2	2	1) Remove and replace with new replacement windows or 2) replace individual lead painted components or 3) enclose all lead painted surfaces or 4) strip all surfaces bare to the substrate, make necessary repairs, stabilize surfaces, and repaint.	1) Use friction reduction treatments (jamb liners, weatherstripping, rubber padding, tread covers, etc.) to reduce wear or 2) Wet plane all friction / impact surfaces, wet scrape all remaining surfaces, make necessary repairs, stabilize all surfaces and repaint.

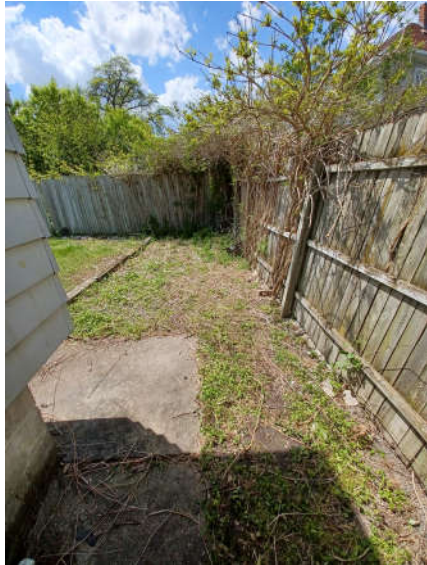
SAMPLE #	LOCATION OF BARE SOIL AREA	APPROXIMATE AREA IN SQUARE- FEET (FT ²)	LEAD HAZARD?	LAB RESULT IN PARTS PER MILLION (PPM)
SS-1	House Dripline Side A	45	No	337
SS-2	Bare Soil Side C	250	No	282
