December 29, 2017

Ms. Roxanne Case
Grant Manager
Ingham County Land Bank
3024 Turner Street
Lansing, Ingham County, Michigan 48906

Re: Pre-Demolition Regulated Materials Survey
1556 Ballard St, Lansing, Ingham County, MI

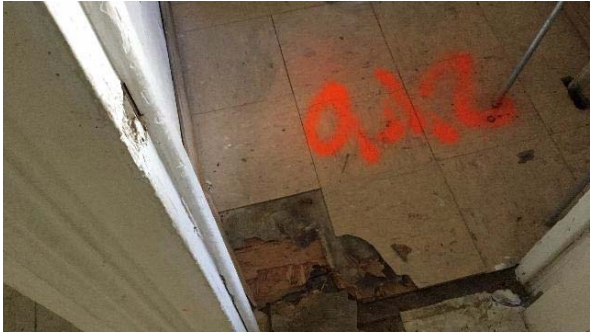
Orange tile sample from room 11

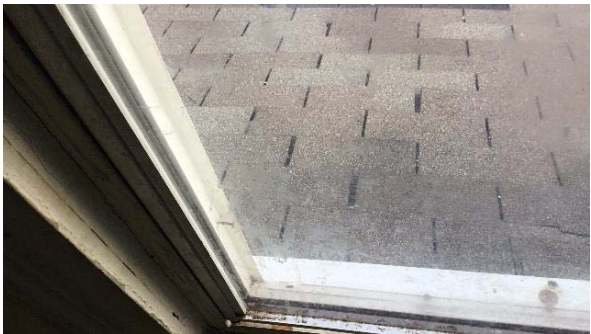
Shingle sample from roof

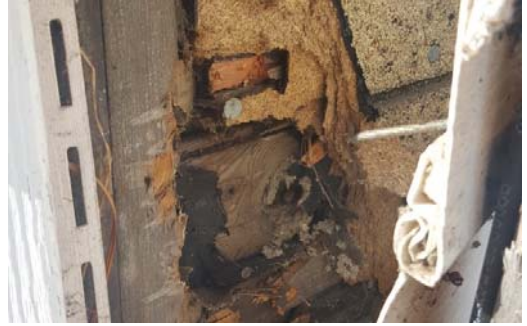
Exterior fabric backing sample AS4-1

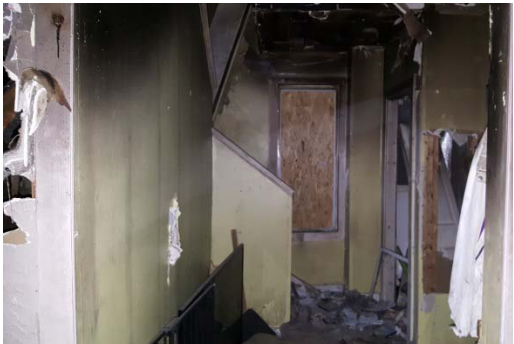
View of collapsing ceiling facing east

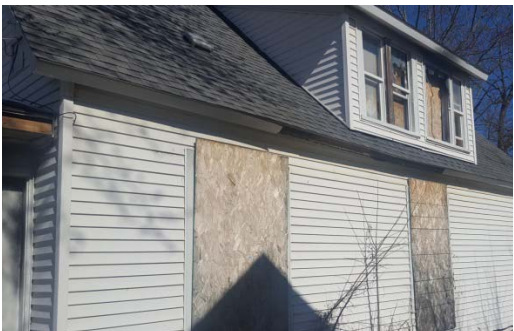
Exterior asphalt shingle sample AS2-1

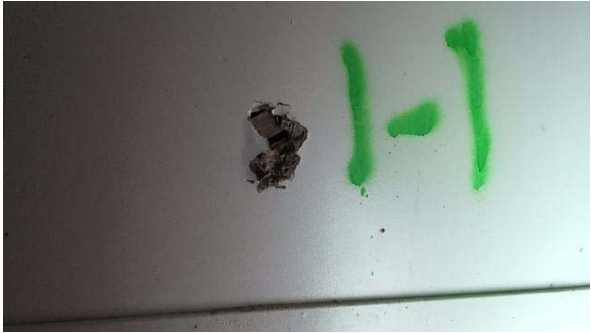
Plaster sample from room 2

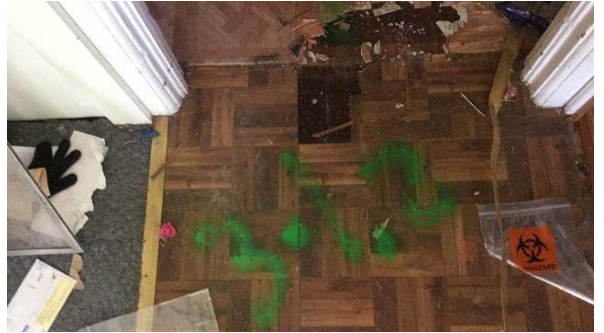
Faux wood 6x6 tile sample from room 2

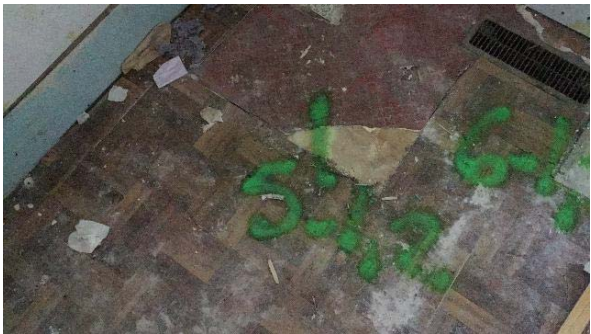
Red linoleum sample from room 5

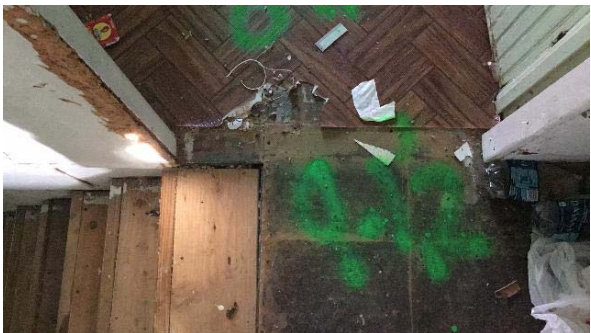
Faux wood linoleum sample from room 10

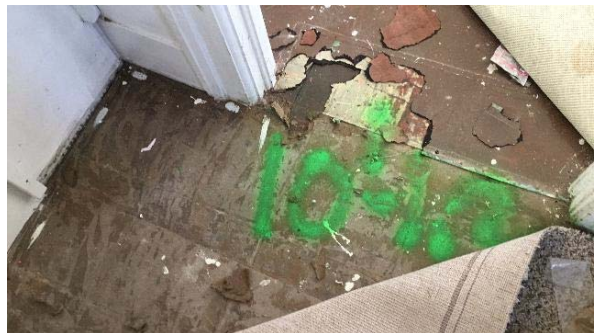
Multi-colored linoleum from room 7

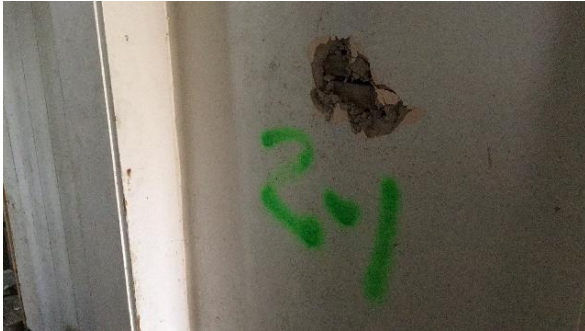
Plaster sample from room 1

Sample Information	Asbestos Type/Percent	Non-Asbestos
Lab ID #: 73723 - 03 Cust. #: AS2-1 Material: Plaster Location: Room 1 Appearance: grey,nonfibrous,homogenous Layer: 1 of 1	Asbestos Present: YES Chrysotile - 2%	Hair - 2% Other - 96%
Lab ID #: 73723 - 04 Cust. #: AS3-1 Material: Window Glaze Location: Room 4 Appearance: white,nonfibrous,homogenous Layer: 1 of 1	Asbestos Present: NO No Asbestos Observed	Other - 100%
Lab ID #: 73723 - 05 Cust. #: AS3-2 Material: Window Glaze Location: Room 4 Appearance: white,nonfibrous,homogenous Layer: 1 of 1	Asbestos Present: NO No Asbestos Observed	Other - 100%

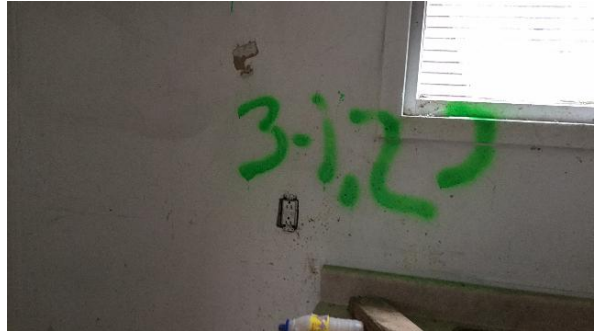
Window glaze sample from room 4

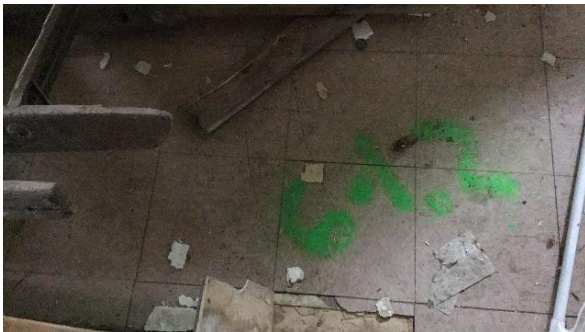
Red tile sample from room 1

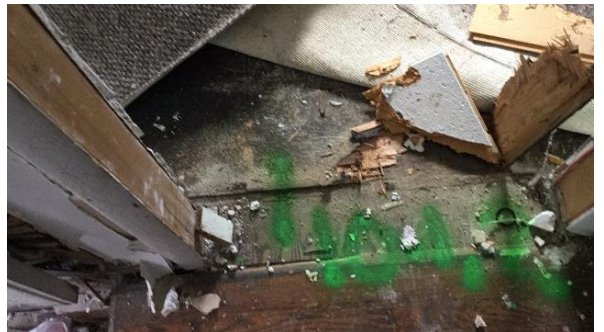
Black flooring sample from room 5

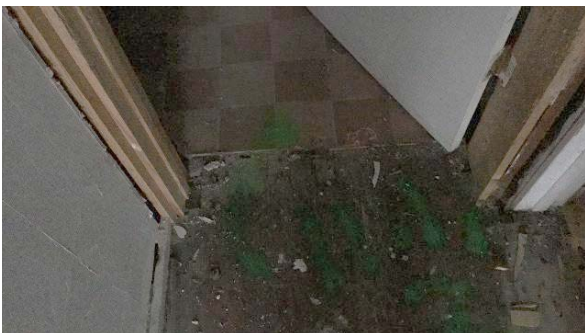
Brown linoleum sample from room 6

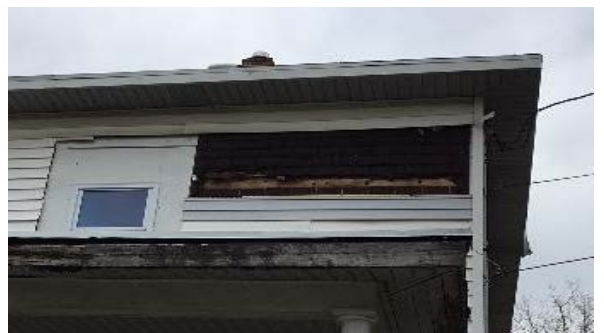
Asphalt siding sample from exterior

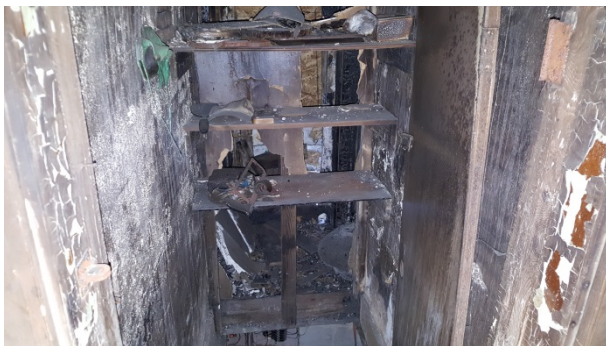
View facing east from kitchen

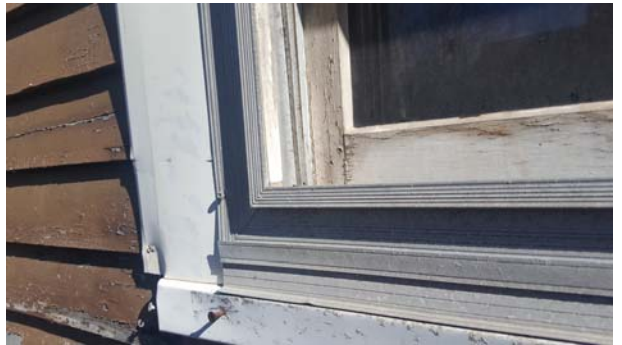
Window glaze sample AS1-1

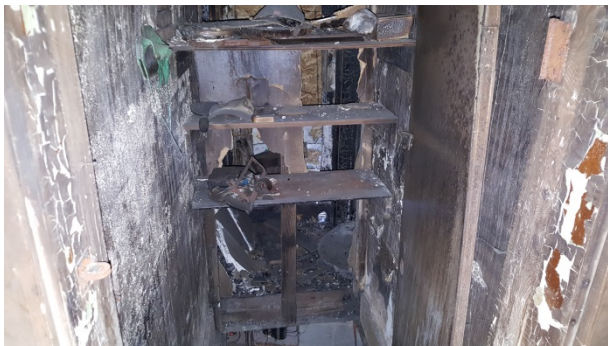
View facing east from kitchen

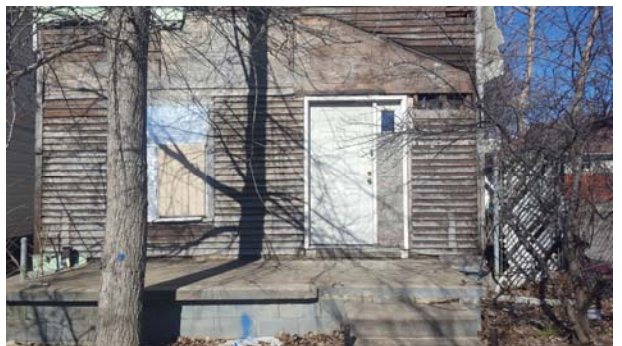
Exterior concrete sample AS3-1

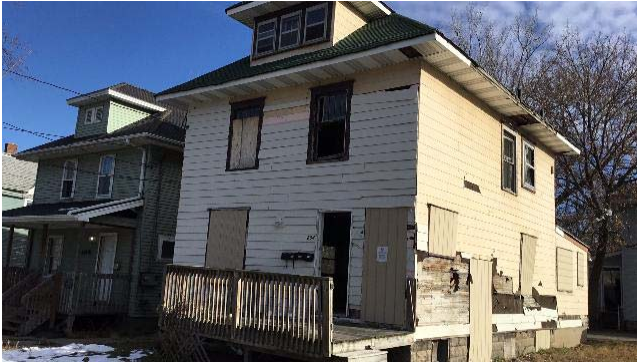
804 N Pennsylvania Ave, Front of House

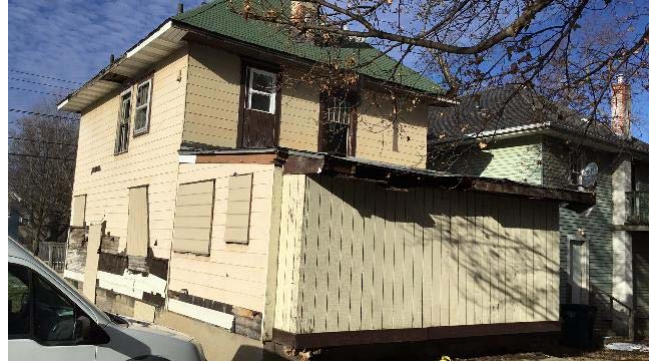
Back of House

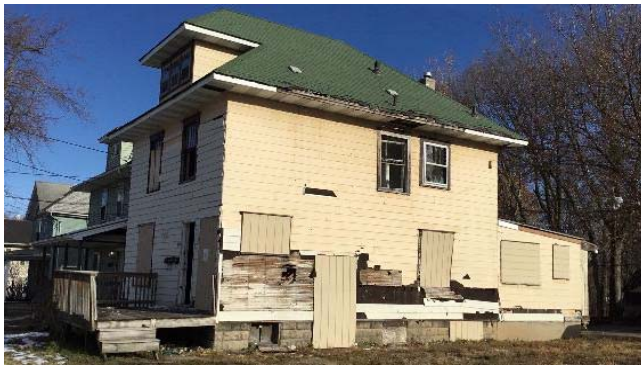
Side of House

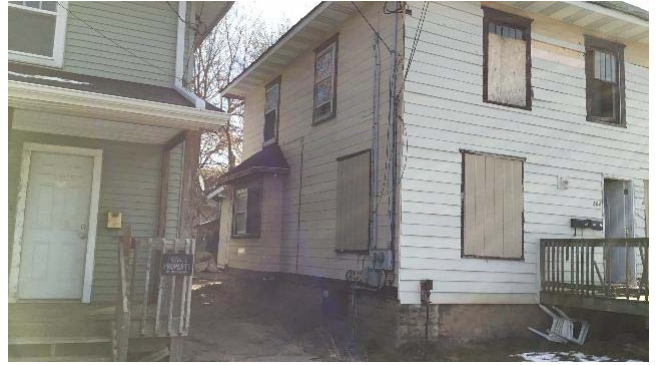
Side of House
