December 29, 2017

Re: Pre-Demolition Regulated Materials Survey  
 1000 W Saginaw St, Lansing, Ingham County, MI

The Mannik & Smith Group, Inc. (MSG) is pleased to present Ingham County with the results of the limited pre-demolition regulated materials survey (RMS) performed at 1000 W Saginaw St, Lansing, Ingham County, Michigan (hereinafter referred to as the "Site") by Kory McKay (Accreditation Number A47903).

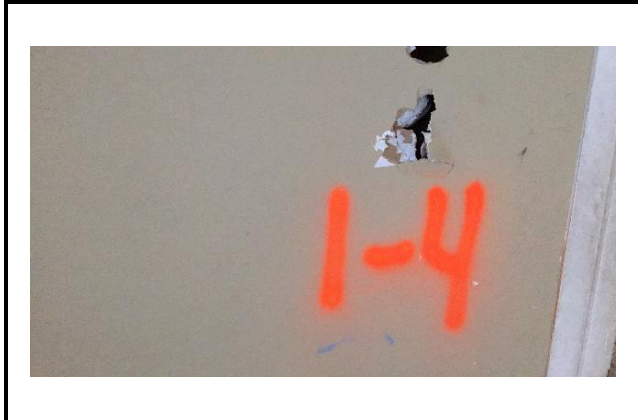
Drywall sample from room 8

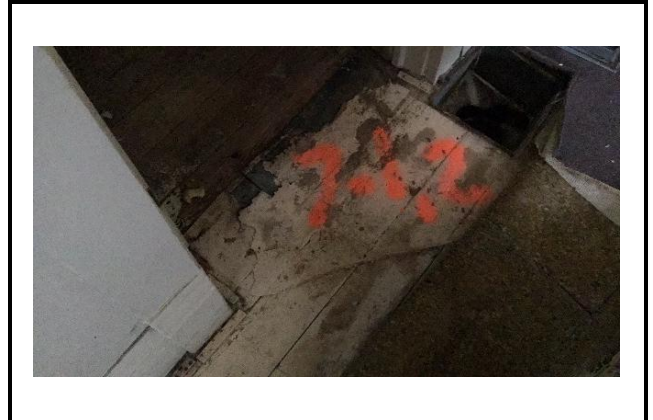
Yellow linoleum sample from room 4

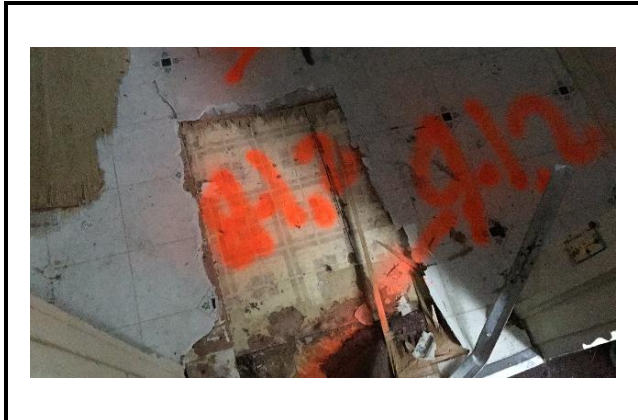
Asbestos Containing Material				
Location	Material Group	Friable/Non Friable	Asbestos	Quantity
RM-8	Gold tile	Non friable	5% Chrysotile	85
RM-7, RM-8	Vent wrap	Friable	40% Chrysotile	200 SF
RM-2, RM-9	Multicolored linoleum	Non friable	20% Chrysotile	100 SF
Exterior	Siding	Non friable	15% Chrysotile	900 SF

Multicolored linoleum sample from room 2

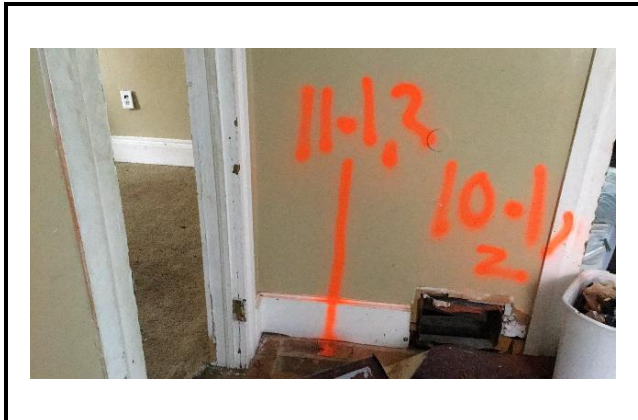
RM-8	2	AS 11-1	HA-11	Gold tile	Non-Friable	Good	Miscellaneous	Yes	5% Chrysotile	85 SF
RM-8	2	AS 11-2	HA-11	Gold tile	Non-Friable	Good	Miscellaneous	Yes	NA	85 SF
Roof	E	AS 12-1	HA-12	Shingles	Non-Friable	Good	Miscellaneous	No	No	500 SF
Roof	E	AS 12-2	HA-12	Shingles	Non-Friable	Good	Miscellaneous	No	No	500 SF
Basement	B	AS 13-1	HA-13	Basement cement floor	Non-Friable	Good	Miscellaneous	No	No	400 SF
Basement	B	AS 13-2	HA-13	Basement cement floor	Non-Friable	Good	Miscellaneous	No	No	400 SF
Exterior	E	AS 14-1	HA-14	Siding	Non-Friable	Good	Miscellaneous	Yes	15% Chrysotile	900 SF
Exterior	E	AS 14-2	HA-14	Siding	Non-Friable	Good	Miscellaneous	Yes	NA	900 SF

Gold tile sample from room 8

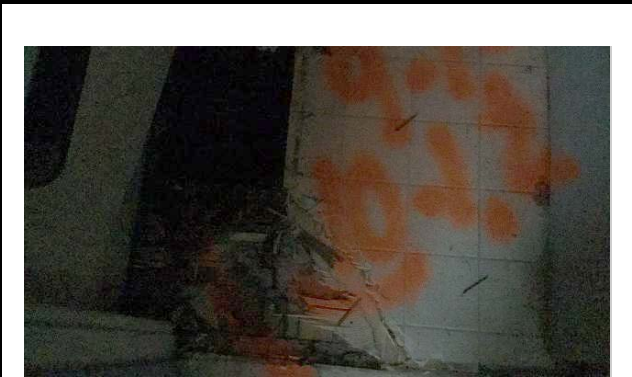
Faux brick linoleum sample from room 3

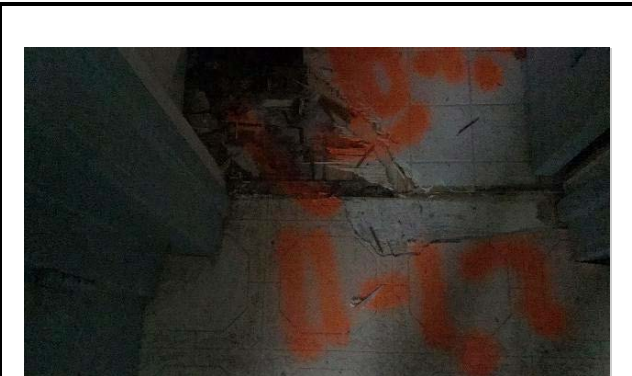
Red tile sample from room 3

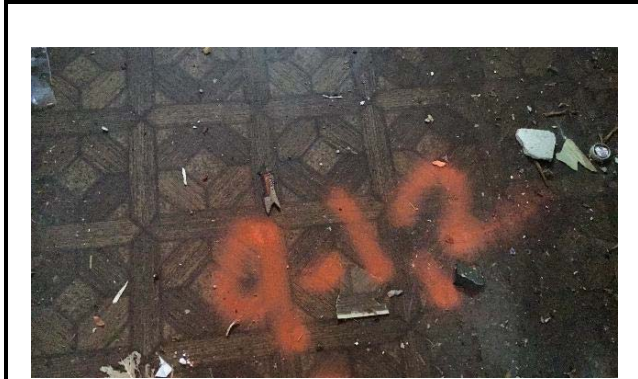
Faux wood linoleum sample from room 3

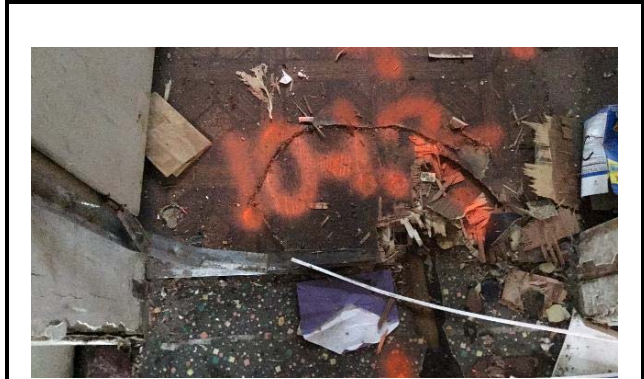
Tan linoleum sample from room 3

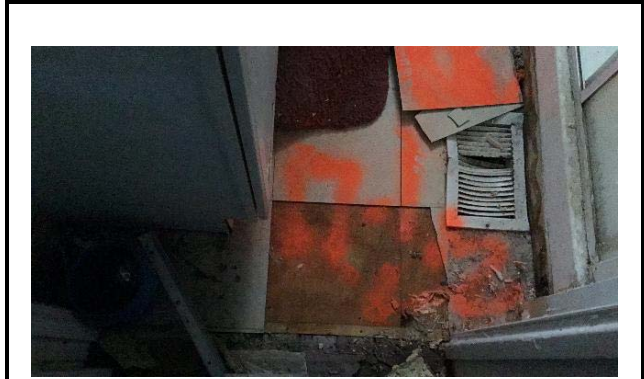
White tile sample from room 8

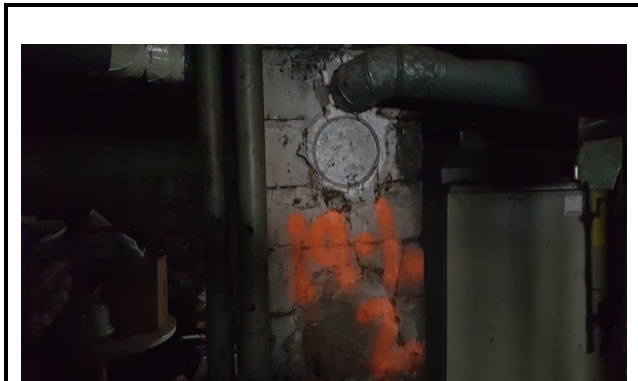
Stack cement sample from basement

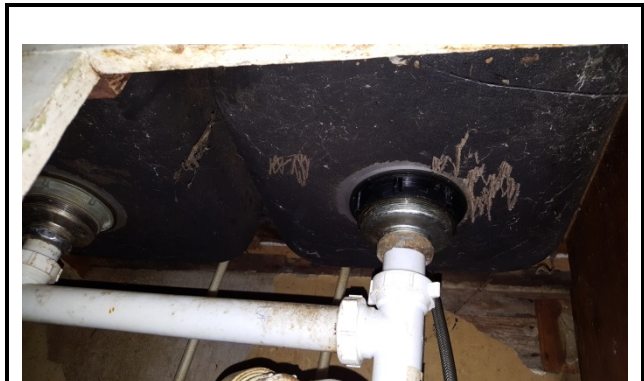
Sink undercoating sample from room 3
