# PRE-DEMOLITION ENVIRONMENTAL INSPECTION SUMMARY REPORT

Parcel:	33-01-01-21-428-045
House No:	1418 Bailey St, Lansing MI 48910
Date Inspected:	12/20/2017
Inspected By:	Wade Wiltse
Inspectors State Card #	A-51051

Parcel:	33-01-01-22-305-101
House No:	1441 Bailey St, Lansing, MI 48910
Date Inspected:	12/21/2017 & 2/27/2018
Inspected By:	Heather Davis
Inspectors State Card #	A-48908

Parcel:	33-01-01-22-351-061
House No:	1531 Bailey St, Lansing, MI 48910
Date Inspected:	1/2/2018
Inspected By:	Wade Wiltse
Inspectors State Card #	A-51051

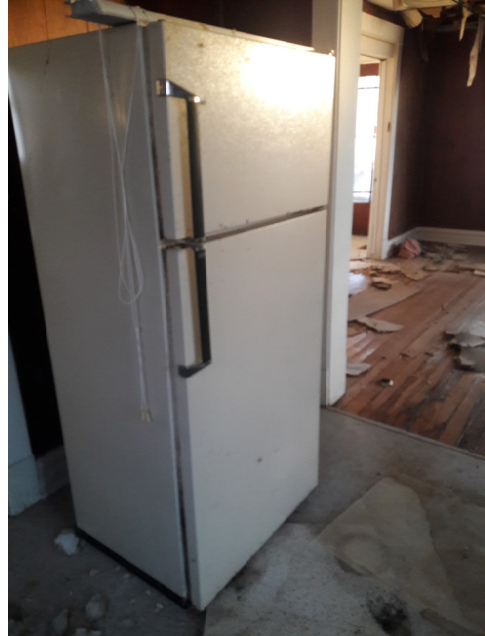
Refrigerator

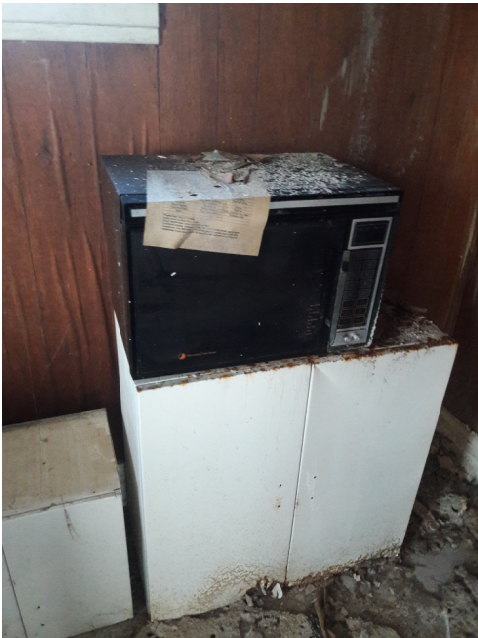
Electronics

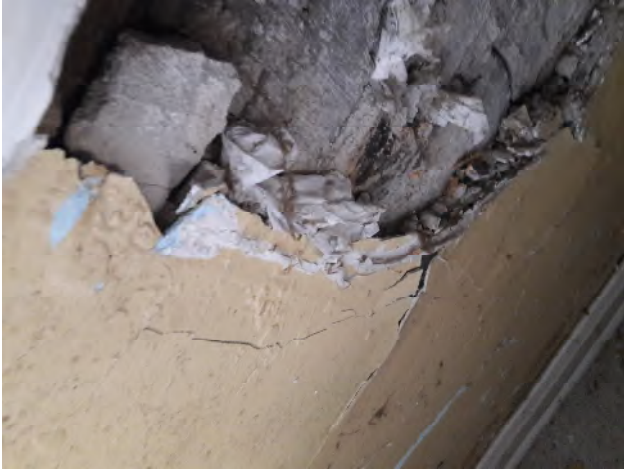
Plaster

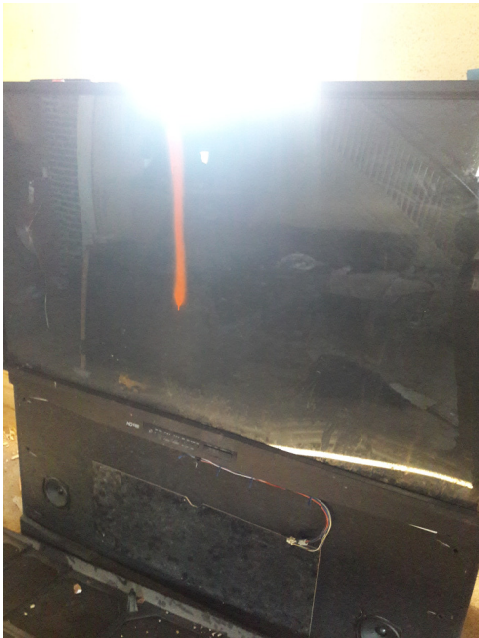
TV Screen

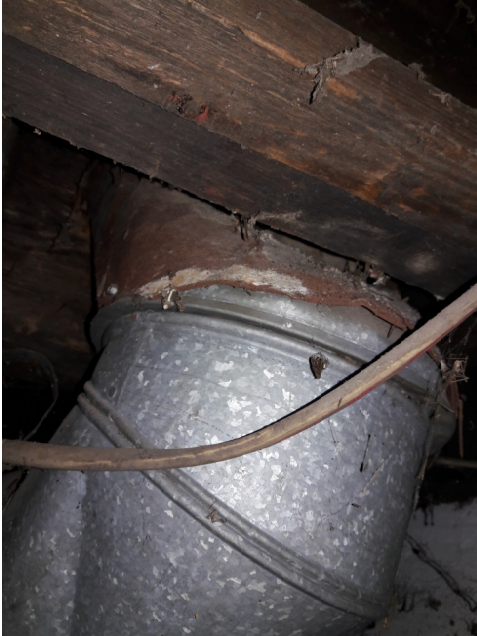
Duct Wrap

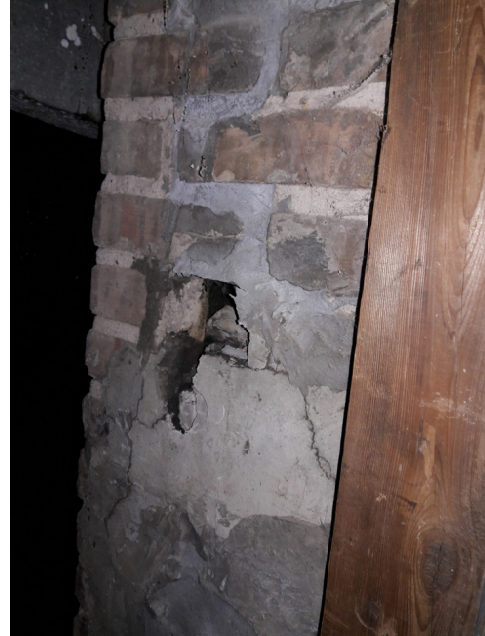
Stacked Pipe Cement

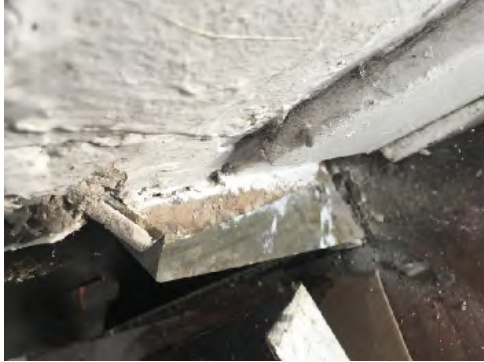
Duct wrap, white

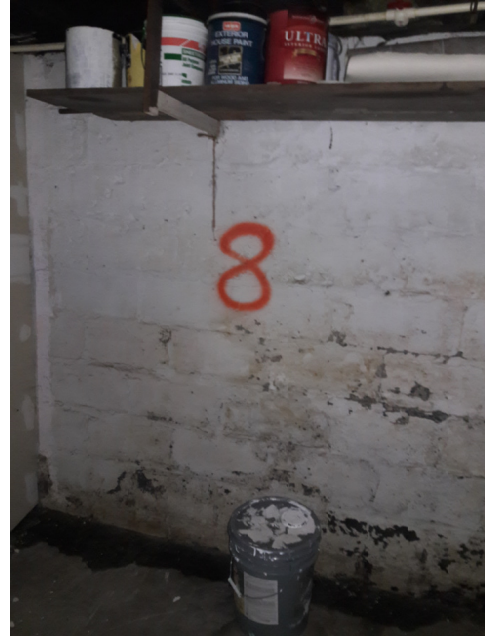
Paint Cans

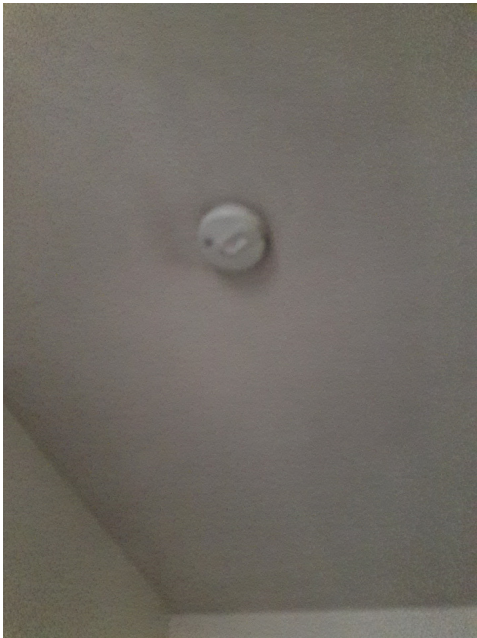
Smoke Detectors

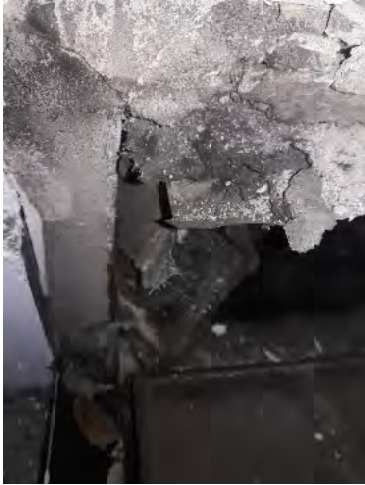
Duct wrap, grey

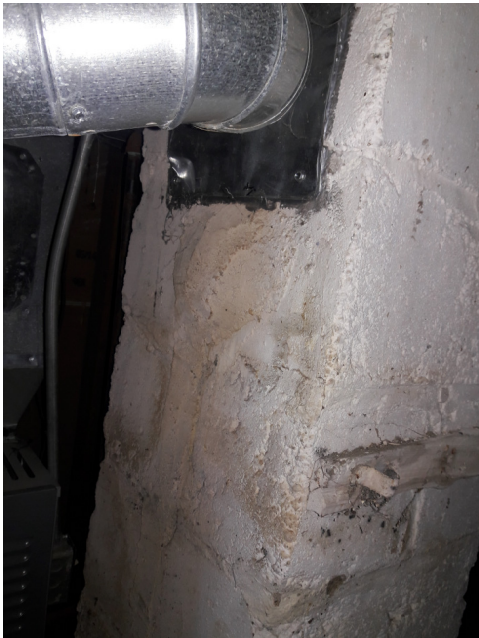
Chimney stack pipe cement, grey

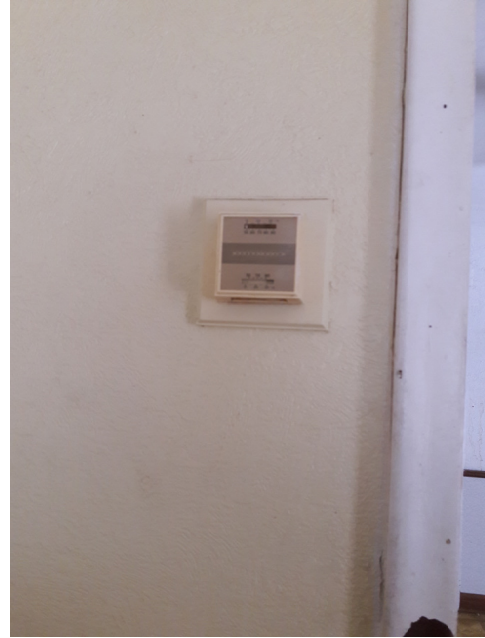
Thermostats

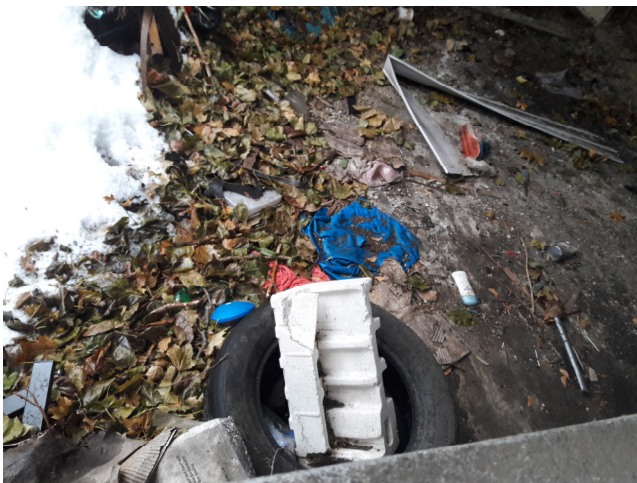
Tires

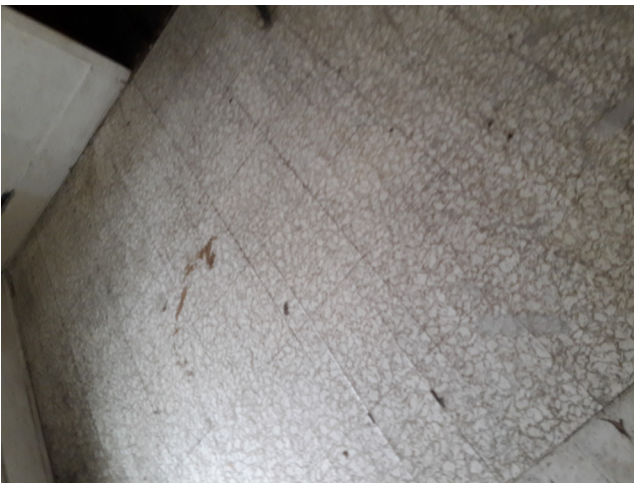
12x12 Peel and Stick, white/gold

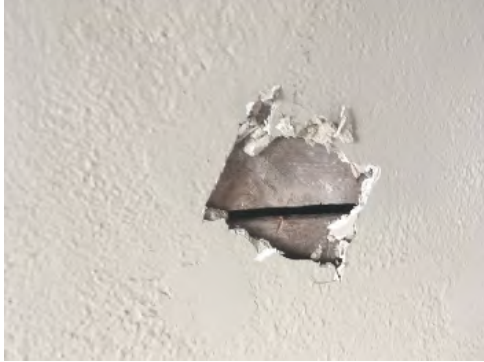
Wall skim, green
