# PRE-DEMOLITION ENVIRONMENTAL INSPECTION SUMMARY REPORT

**Ingham County Land Bank**  
 3024 Turner Street  
 Lansing, MI 48906

Parcel:	33-01-01-28-403-011
House No:	2609 Maplewood Ave, Lansing, MI 48910
Date Inspected:	11/28/2017
Inspected By:	Jake Gleason
Inspectors State Card #	A-49991

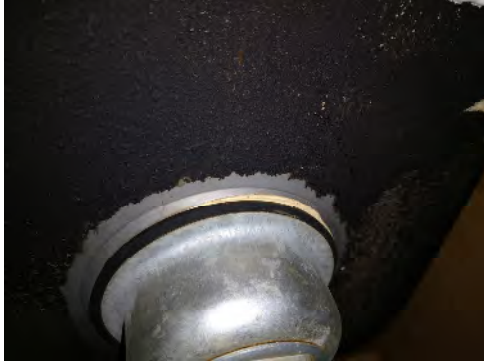
Sink Undercoat
