PRE-DEMOLITION ENVIRONMENTAL INSPECTION SUMMARY REPORT

Ingham County Land Bank
3024 Turner Street
Lansing, MI 48906

Parcel:	33-01-01-32-126-152
House No:	1733 Holmes Rd, Lansing, MI 48910
Date Inspected:	12/22/2017
Inspected By:	Heather Davis
Inspectors State Card #	A-48908

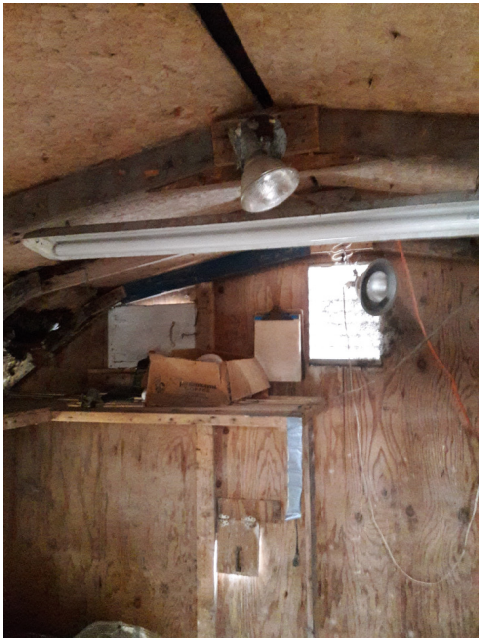
Light Ballasts

Fluorescent lighting systems have ballasts that have the potential to contain polychlorinated biphenyls (PCBs). Although PCBs are no longer commercially produced in the United States, they may be present in U.S. products that were produced prior to 1979, and may still be commercially available from other countries. Fluorescent bulbs, thermostats, and thermometers may contain mercury and can be treated as Universal Waste, which are streamlined standards for managing common types of hazardous waste.

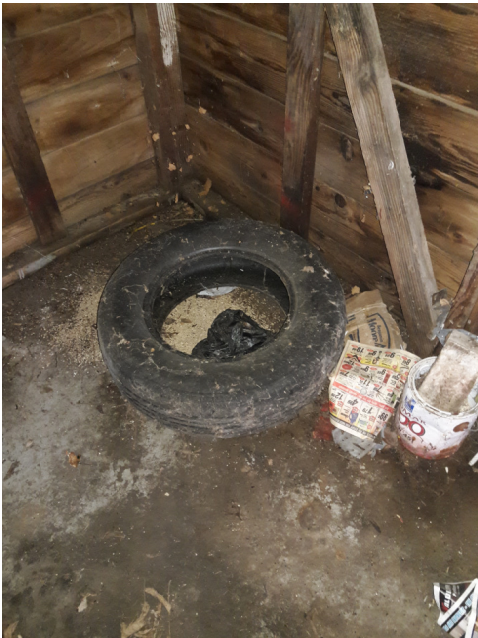
Tires

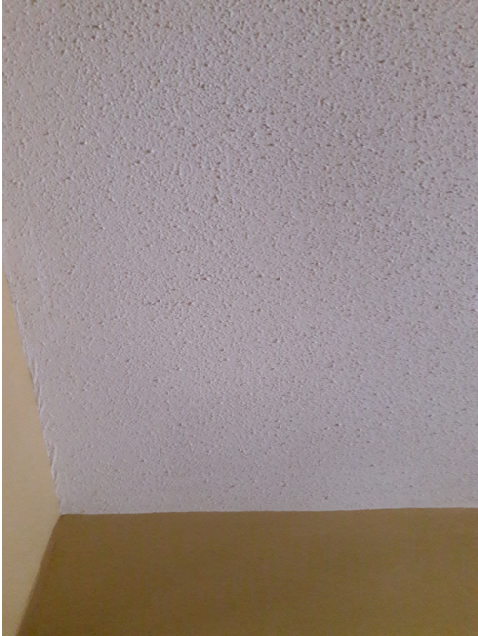
Texture Plaster

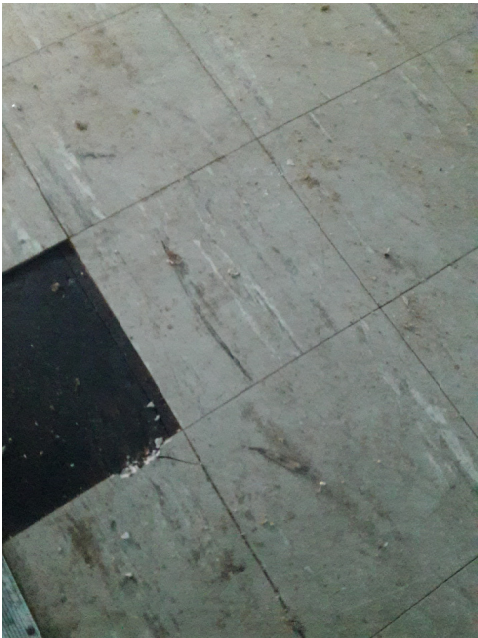
9x9 Tile, grey; Mastic, black

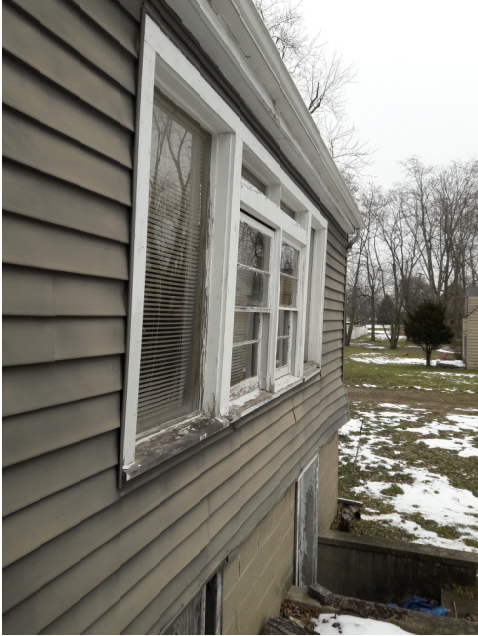
Window Caulk, white

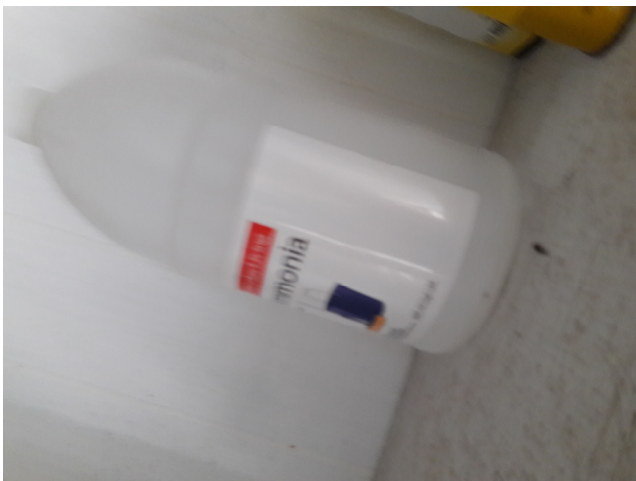
Misc. Items (solvents, cleaners)

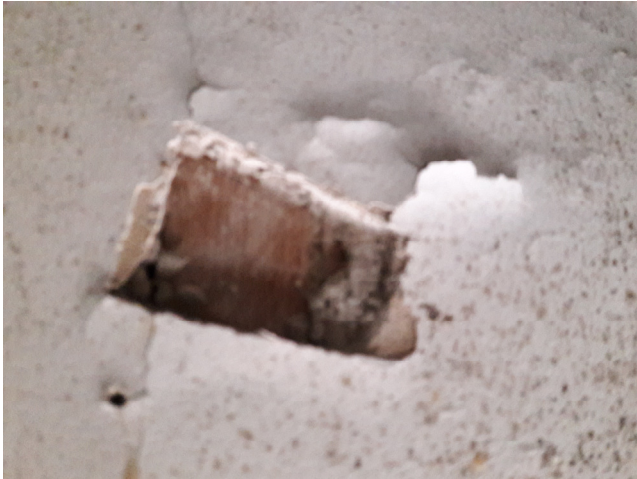
Skim coat, white

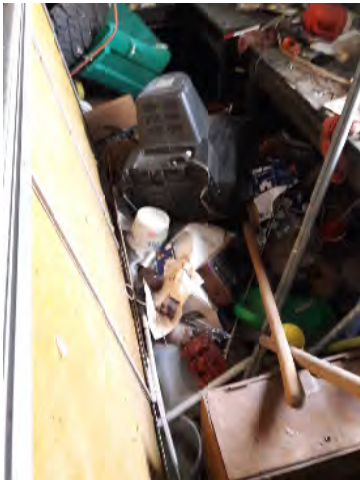
TV Screens, Monitors, Electronics

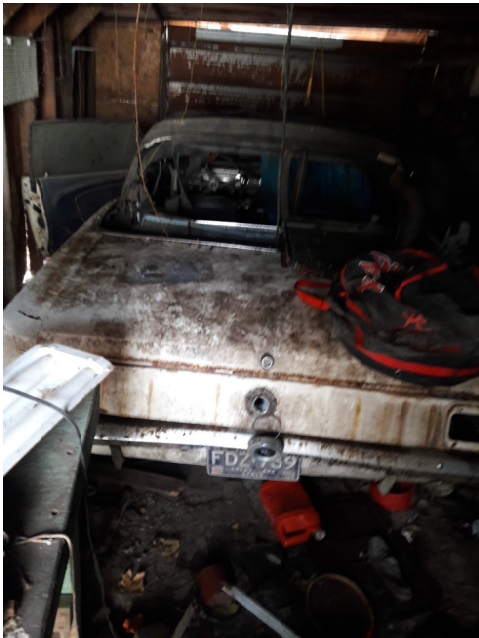
Car

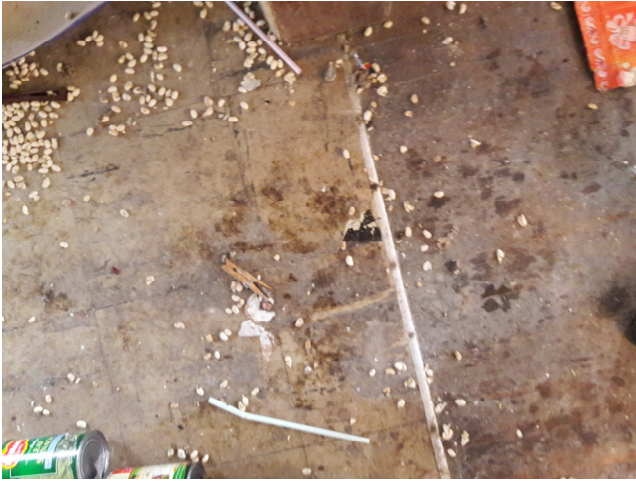
9x9 Floor tile, beige

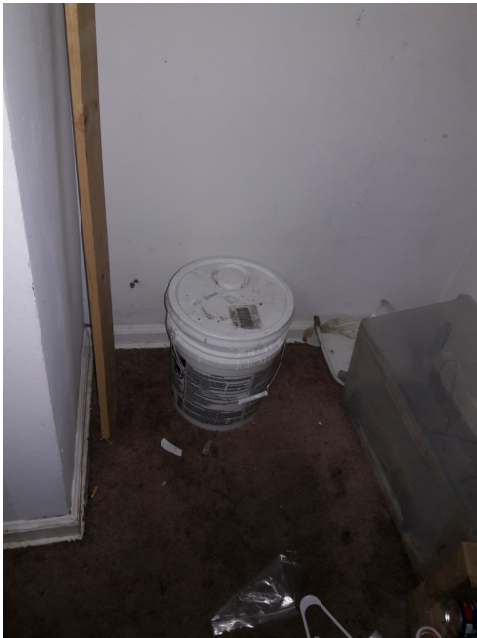
Paint Cans

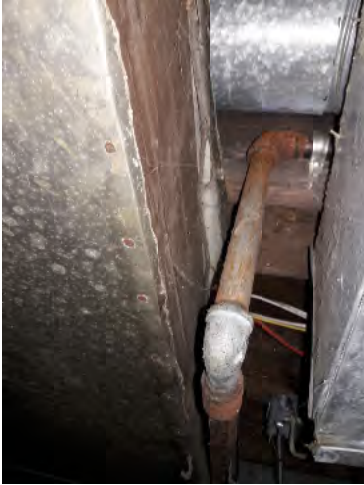
Duct wrap, grey
