PRE-DEMOLITION ENVIRONMENTAL INSPECTION SUMMARY REPORT

Ingham County Land Bank
3024 Turner Street
Lansing, MI 48906

Parcel:	33-01-05-376-201
House No:	5861 S MLK Blvd, Lansing, MI 48911
Date Inspected:	11/22/2017
Inspected By:	Bryan Dryer
Inspectors State Card #	A-40292

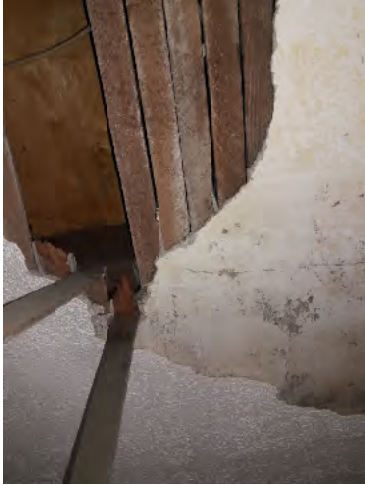
Popcorn Ceiling

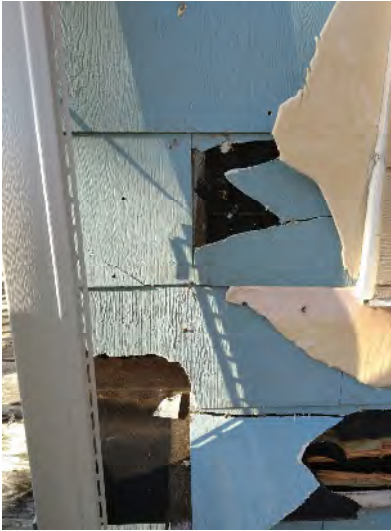
Transite, blue
